Move In Inspection

Property inspected by Property Inspect

1 Sample Street
Irvine
California
92614

February
28th 2017

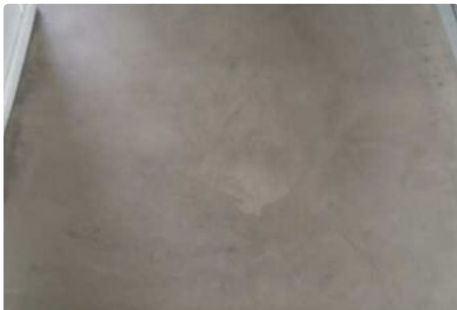
Ref # 1.1

1. ENTRANCE HALL / STAIRS		
Ref	Name	Condition
1.1	Floor/Carpets/ Tiles	Floor covering is concrete in good condition Skirting at front door coming loose
1.2	Doors/ Frames/Handles/ Locks	Door in good condition can open and close properly without any visible damages or any marks

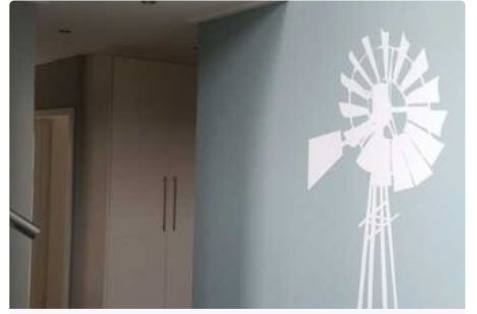
Ref # 1.3

1.3	Walls	Walls in Fair good condition Normal wear and tear 2 hilties in the wall next to the garage door
1.4	Light Switches	Light switches in working condition with covers intact

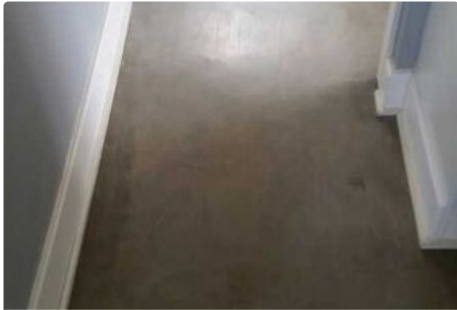
Ref # 2.1

Ref	Name	Condition
2.1	Floor/Carpets/ Tiles	Concrete floor with cracks visible
2.2	Walls	Walls in fear good condition normal wear and tear
2.3	Light Switches	Light switches in working condition with covers intact
2.4	Light fittings	Light fittings in working condition with all globes working
2.5	Ceiling	Ceiling in good condition with no visible damages or any marks
2.6	Curtains/ Curtain Rail/ Blinds	Blinds in perfect condition can open and close properly
2.7	Other	1 key m36b-door underneath stairs

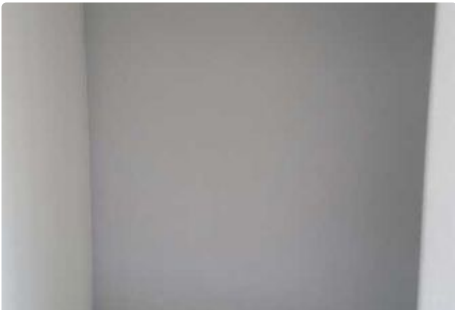
Ref # 3.1

Ref	Name	Condition
3.1	Floor/Carpets/ Tiles	Floor covering is concrete fair wear and tare with visible cracks
3.2	Doors/ Frames/Handles/ Locks	Door in good condition can open and close properly and lock no visible damages but fair wear and tear Sliding door in good condition can close and open comfortably No Cracked Glass
3.3	Walls	One Hilti next to the sliding door Holes have been painted not in good condition and clearly visible Normal fair wear and tare and scratch marks
3.4	Light Switches	Light switches in working condition and covers intact
3.5	Light fittings	Light fittings in working condition all Shades intact no breakages and all globes working
3.6	Windows/ Frames/Handles	Windows can open and close properly no broken glass 1 curtain pole about the sliding door

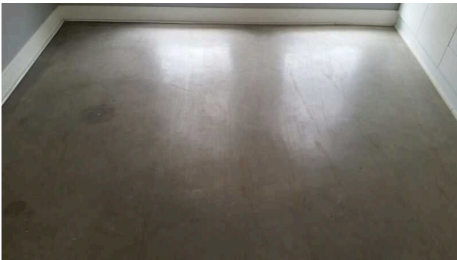
Ref # 4.1

Ref	Name	Condition
4.1	Floor/Carpets/ Tiles	Flooring is concrete in good condition stains coming through as shown on photos Skirtings swollen
4.2	Doors/ Frames/Handles/ Locks	Door in good condition can open and close properly and lock. No visible damages or any holes
4.3	Walls	Walls in fair good condition with normal wear and tear A few light marks and scratches Peeling paint
4.4	Light Switches	Light switches in working condition with covers intact
4.5	Light fittings	All lights working no visible damages on the globe fused
4.6	Windows/ Frames/Handles	Windows in good condition can open and close properly with no Cracked Glass Sliding door in good condition can open and close properly without any Cracked Glass

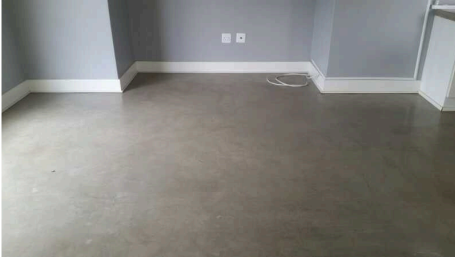
Ref # 11.1

Ref	Name	Condition
11.1	Floor/ Carpets/Tiles	Floor in Fair good condition with cracks visible on the edges Construction flaw
11.2	Doors/ Frames/Handles/ Locks	Sliding Doors can open and close comfortably with no Cracked Glass Door leading to the braai in good condition without any holes although a little bit of chip marks around the lock. 2 keys without codes and can open and close properly and lock

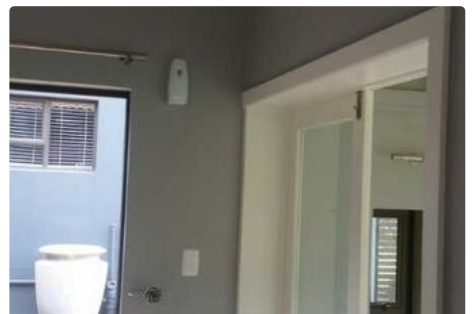
Ref # 11.3

11.3	Walls	Walls have been badly painted with closed holes standing out. Only holes painted and not the entire wall Stickers in good condition and forms part of the property

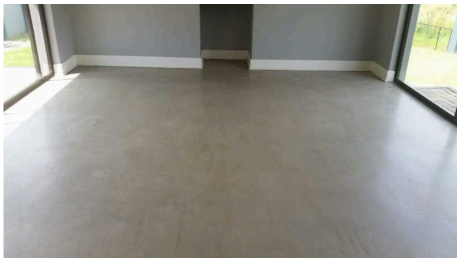
Ref # 12.1

12. UTILITY ROOM		
Ref	Name	Condition
12.1	Floor/ Carpets/Tiles	Cement floor in fair good condition with visible cracks around the edges and at the doors. Foundation problems
