# Commercial Property

**ABC COMMERCIAL  
PROPERTY MANAGEMENT**

Commercial Small  
Warehouse  
Industrial Estate  
Anywhere  
PO1 1AB

**May  
14th 2021**

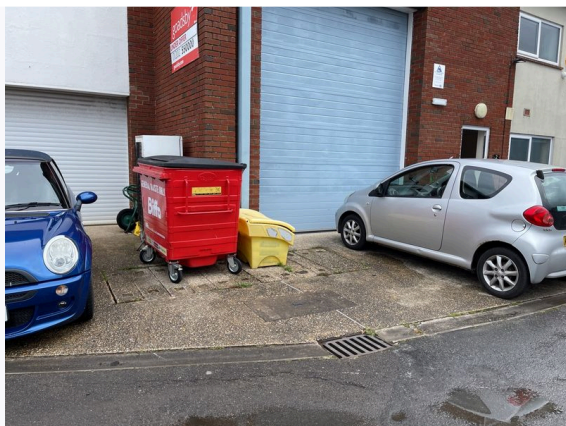
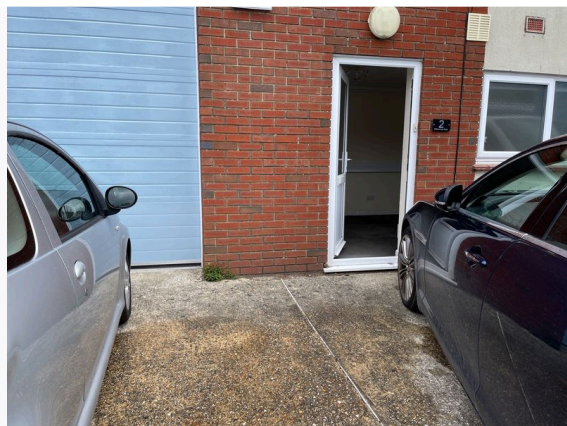
Ref #5

Ref	Name	Description	Condition
5.1	Parking	2 x space to front of building Concrete flooring	Weathered / grubby No defining lines

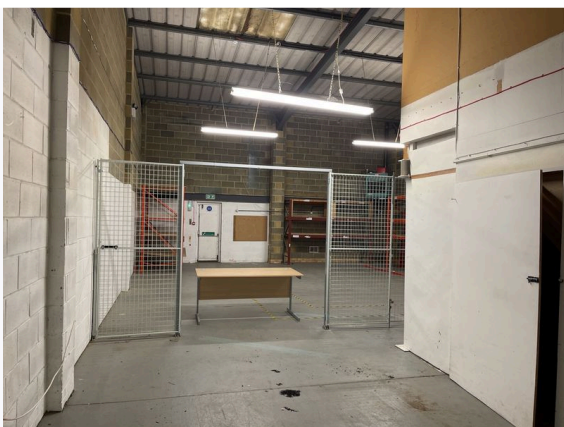
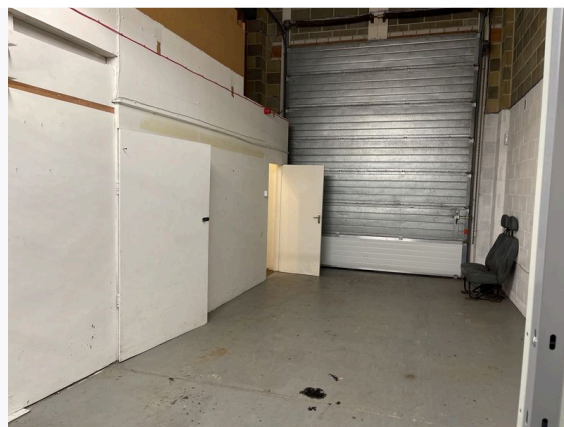
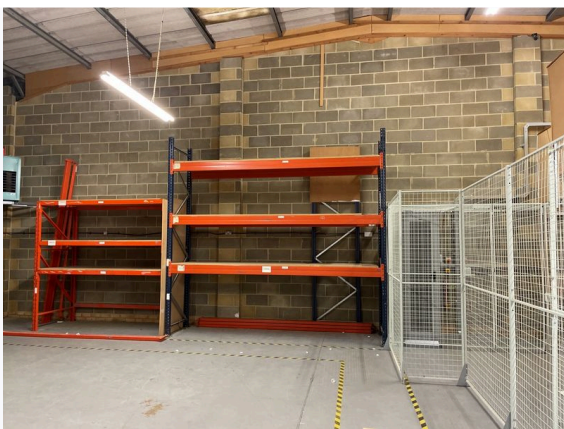
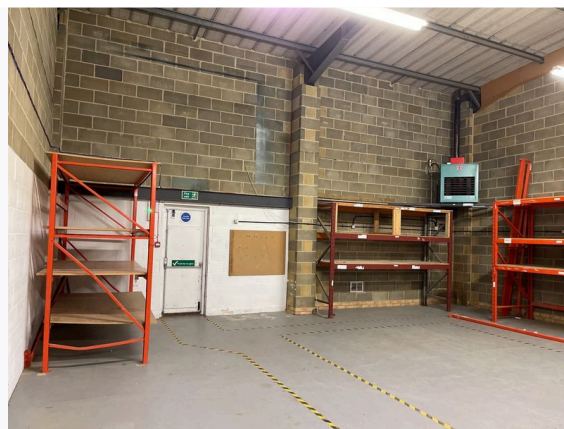
Ref #7

Ref	Name	Description	Condition
7.1	Safety / Security	4 x smoke integrated smoke detectors Red emergency call point 2 x Red alarm sounder 5 x wall mounted sensors  Wall mounted brackets and signs for extinguishers only	Not tested Not tested Not tested Not tested
7.2	Warehouse Door	External: Blue metal; handles, Yale lock Internal: bare metal; pull chain; slide bolts	Minor marks and defects; grubby Minor marks and defects; grubby
7.3	Door to Stairs	Painted white; lever handles, lock, no key	Marks and defects; grubby

7. STORAGE / WAREHOUSE AREA (CONT.)			
7.4	Door Frame	Painted white	Chipped to edges around receiver Minor marks and defects; grubby
7.5	Ceiling	Galvanised steel frame Interlocking panels Inset perspex light panels	Perspex grubby

7.6	Lighting	Emergency lighting bulkhead 4 x Linear high bay suspended lights	Not tested Working
7.7	Walls	Breeze block; partially painted white Grey metal security gates with door; bolted to floor Armoured cabling	Marks mainly to lower aspects not extensive Marks and removal holes mainly to main door Minor marks and defects

7.8	Under Stair Storage	Painted white door Internal: breeze block; concrete floor Paint pots Liquid containers Wiring reel Blue unit with wiring	Marked to door Bottom hinge is very loose Minor marks and defects

7.9	Switches	White plastic; fused	Not tested Grubby
7.10	Sockets	White plastic 2 x double sockets 1 x RJ45 network/data point 1 x metal single socket 1 x metal double socket  Noted where seen	Not tested Not tested Not tested Not tested

7.11	Flooring	Concrete; painted grey	Black/yellow edgings strips Visible worn and marked - not excessive Some indents / damage to joins at entrance to main warehouse Oil stains to kitchen approach

7.12	Air Conditioning	Powmatic model; mounted to brackets; associated cabling Green combat engineering unit	Not tested Not tested
7.13	Rear Security Door	White; surface mounted bolts; pull bar Emergency signs Sensors	Minor marks and defects; grubby

7.14	Racking	Orange metal racking; wood boards. Fixed to floor	Minor marks and defects Stickers to front edges Large single steel to floor
7.15	Furniture	1 x late wood effects office table; metal frame. media access Grey double seats	Minor marks and defects Grubby / stained to fabric

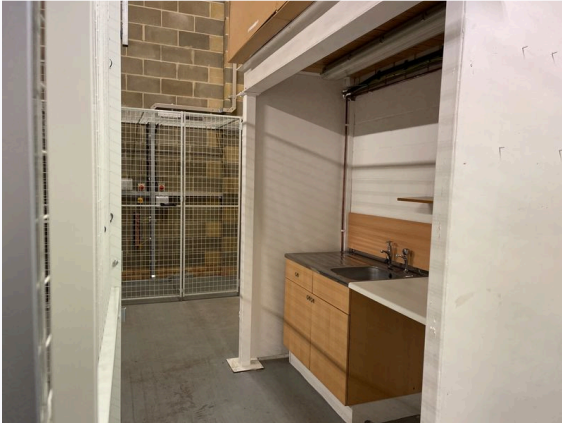
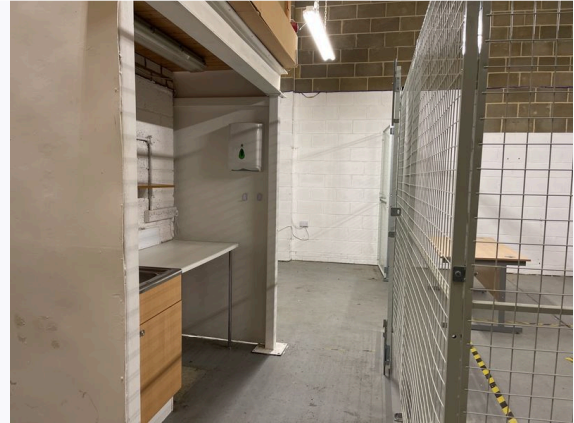
Ref #8

Ref	Name	Description	Condition
8.1	Caged Area	Grey metal cage access with locks 3 x keys Network/data unit/storage - empty 2 x Isolator switches 1 x metal switch	Not tested Not tested Some marks to flooring

8.2	Ceiling	Partially boarded White metal supports 1 x Red alarm sounder	Not tested Minor marks and defects
8.3	Lighting	Ceiling mounted fluorescent tube	Not tested

8.4	Walls	Painted white breeze block Wall mounted dispenser	Marked below worktop 2 x stick on hooks Minor marks and defects
8.5	Sockets	White plastic 3 x double sockets	Not tested Grubby and marked

8.6	Heating	None present	
8.7	Kitchen Unit	Wood effect base unit	Backboard detached Minor marks and defects
8.8	Worktop(s)	Grey melamine Metal support	Small hole to top left corner Minor marks and defects

8.9	Sink	Stainless steel effect; single bowl; double taps	Not tested Minor surface marks
8.10	Flooring	Concrete; painted grey	Visible marks; worn paint Minor marks and defects

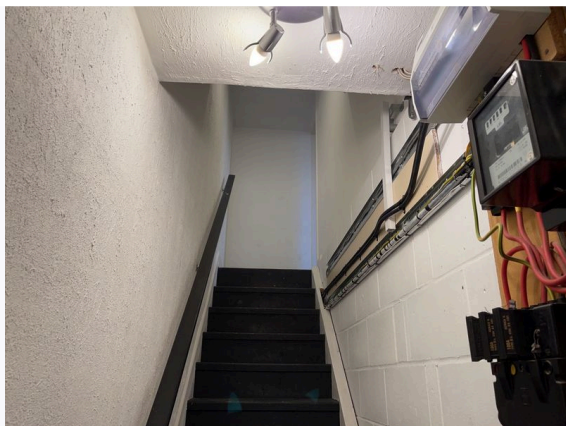
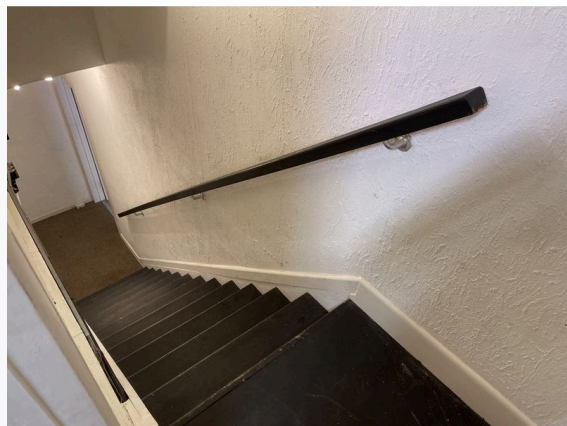
Ref #9

Ref	Name	Description	Condition
9.1	Door to Stairs / Reception	Painted white; fire door Metal pull handle; strike plate Self closer	Sticker Minor marks and defects
9.2	Door Frame	Painted white; fire safety strip	Minor marks and defects

9. STAIRS (CONT.)			
9.3	Ceiling	Painted white	Removal holes Minor marks and defects
9.4	Lighting	3 x Emergency lighting bulkheads 1 x circular plate; 3 x spotlights, bulbs 1 x spotlight, bulb	Not tested Working Working
9.5	Walls	Painted white; partial textures and breeze block  Fuse board; associated cabling Electric meter; associated cabling	Minor marks and defects  Not tested Not tested
9.6	Skirting	Painted white	Minor marks and defects
9.7	Switches	1 x Metal double light switch 1 x fused switch	Working Not tested
9.8	Socket	White plastic Wall mounted unit	Not tested
9.9	Heating	Not present	
9.10	Staircase	Painted dark grey wood - not carpeted Wall mounted handrail; to left wall	Visible wear to centre of treads Chipped to top of stairs- not extensive  Minor marks and defects
9.11	Flooring	Brown/black textured carpet tiles	Minor spots / stains

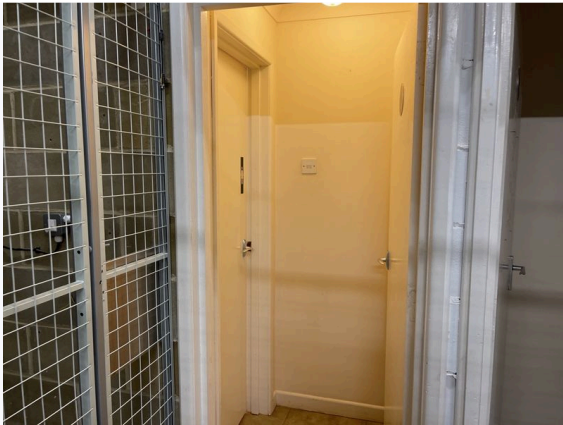
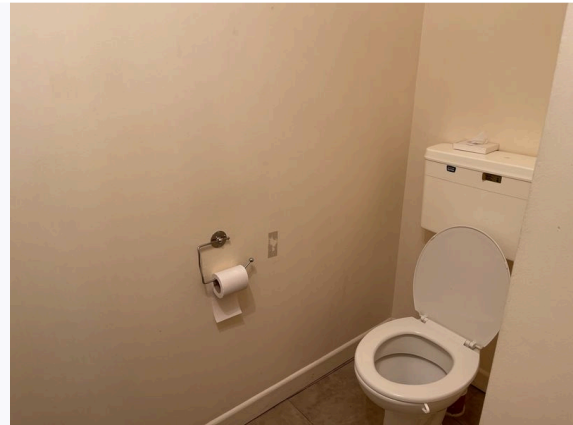
Ref #10

Ref	Name	Description	Condition
10.1	Door(s)	Outer: Painted white; lever handles, plaque Inner: Painted white; lever handles, thumb turn lock, plaque	Minor marks and defects Inner: 1 x hook

10.2	Door Frame	Outer: Painted white Inner: Painted white	Minor marks and defects Minor marks and defects
10.3	Ceiling	Painted white; textured, coving to match	Minor marks and defects

10.4	Extractor Fan	White plastic Steeple model.	Not tested but activates with light switches - on timer
10.5	Lighting	Semi globe cover; bulb Circular metal plate; 3 x spotlights with bulbs, circular feature surround	Working Working

10.6	Walls	Painted magnolia Brown patterned tiles above basin Brown/beige marble effect worktop; metal support; ope shelving below	Entrance: 1 x picture nail Main toilet area: indent behind too at handle height, previous fixings holes x 2 Hot water warning sticker above water unit Peeled paint to toilet area  Minor marks and defects

10.7	Skirting	Painted white	Minor marks and defects
10.8	Toilet	White ceramic; floor mounted, metal lever handle, plastic cistern, white seat and lid	Not tested Grubby residue to base sealant  Minor marks and defects

10.9	Basin	White ceramic wall mounted, metal single tap, plug and chain White wall mounted hot water heater; Vortex instant 3 model. Associated pipework/cable	Not tested Limescale to waste surround; not excessive Not tested

10.10	Switch	White plastic 1 x double light switch 1 x fused switch	Working Not tested
10.11	Heating	None present

10. LEFT TOILET (CONT.)			
10.12	Accessories	Wall mounted; metal toilet roll holder White plastic toilet brush/holder	Brush - in used condition
10.13	Flooring	Beige/grey laminate tiles; black threshold	Slightly grubby

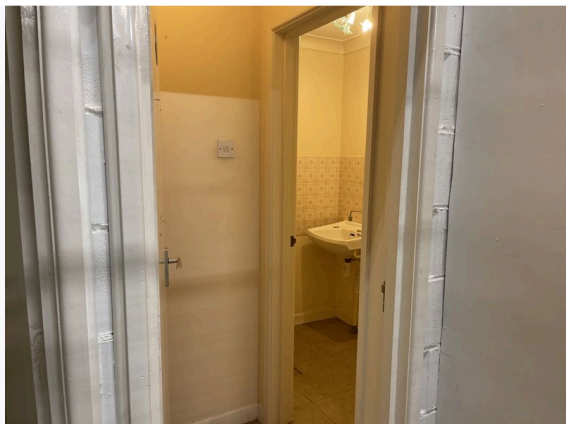
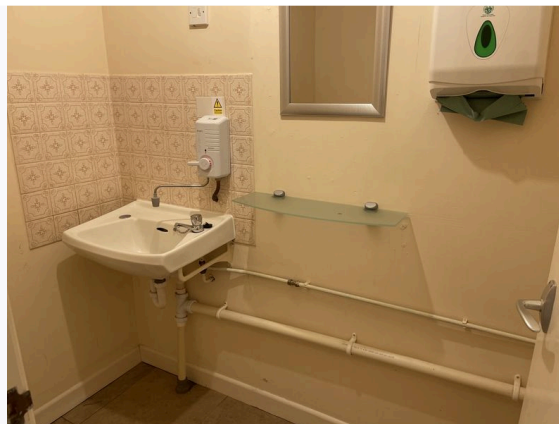
Ref #11

Ref	Name	Description	Condition
11.1	Door	Outer: Painted white; lever handles, plaque Inner: Painted white; lever handles, thumb turn lock, plaque	Outer Door: scratched / marked to plaque surround; sticky pad residue below. Minor marks and defects to internal aspect Inner Door: hook with grey towel. Minor marks and defects

11.2	Door Frame	Outer: Painted white Inner: Painted white	Minor marks and defects
11.3	Ceiling	Painted white; textured, coving to match	
11.4	Extractor Fan	White plastic Steeple model.	Not tested but activates with light switch - on timer

11.5	Lighting	Semi globe cover; bulb Circular metal plate; 3 x spotlights with bulbs, circular feature surround	Not tested - some debris to internal cover Not tested

11.6	Walls	Painted magnolia Brown patterned tiles above basin	Entrance: 1 x picture nail Main Toilet Area: Small indent behind door at handle height  Minor marks and defects

11.7	Skirting	Painted white	Minor marks and defects; slightly grubby
11.8	Toilet	White ceramic; floor mounted, metal lever handle, plastic cistern, white seat and lid	Minor debris below water line

11.9	Basin	White ceramic wall mounted, metal single tap, plug White wall mounted hot water heater; Vortex instant 3 model. Associated pipework/cable	Not tested; some limescale to waste surround Not tested

11.10	Switch	White plastic 1 x double light switch 2 x fused switches	Minor surface marks to plates
11.11	Heating	None present

11. RIGHT TOILET (CONT.)			
11.12	Accessories	Wall mounted; metal toilet roll holder, towel ring White plastic toilet brush/holder Wall mounted towel dispenser - with paper towels Wall mounted mirror; grey frame Wall mounted green frosted shelf; metal brackets	Toilet brush - in used condition
11.13	Flooring	Beige/grey laminate tiles; black threshold Metal access hatch - not accessed	Slightly grubby

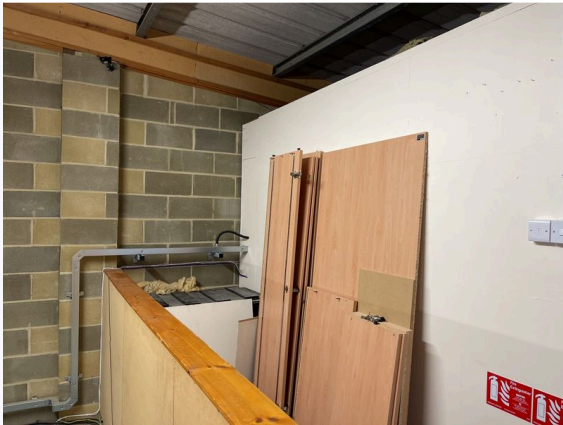
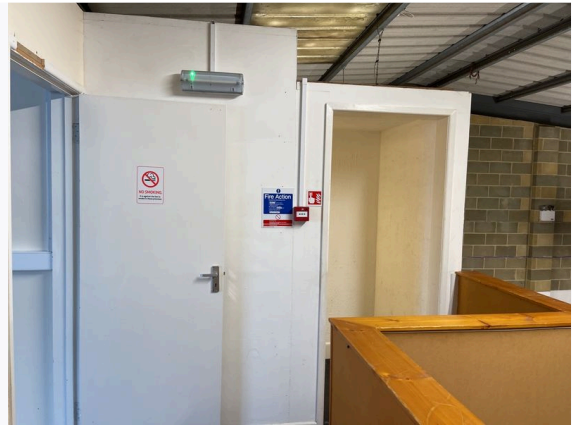
Ref #12

Ref	Name	Description	Condition
12.1	Security / Safety	Metal brackets and signage for fire extinguishers only Fire action sticker / signage to left of main room Red emergency call point

12.2	Ceiling	Galvanised steel frame Interlocking panels Inset perspex light panels	Perspex grubby
12.3	Lighting	Emergency lighting bulkhead	Not tested
12.4	Walls	Open plan white boarding; white frame to top of stairs Wood panel and banister overlooking main storage / warehouse	Picture nails to left fo main room Minor marks and defects

12.5	Skirting	Painted white	Minor marks and defects
12.6	Switch	White plastic 1 x light switch 1 x fused switch	Not tested Not tested
12.7	Heating	None present

12.8	Flooring	Grey speckled carpet tiles	Minor wear to main thoroughfare
12.9	Cold Water Tank	Black moulded plastic; lid, ballcock; associated pipework	Dusty to lid / casing to water unit; some debris to base to base of tank

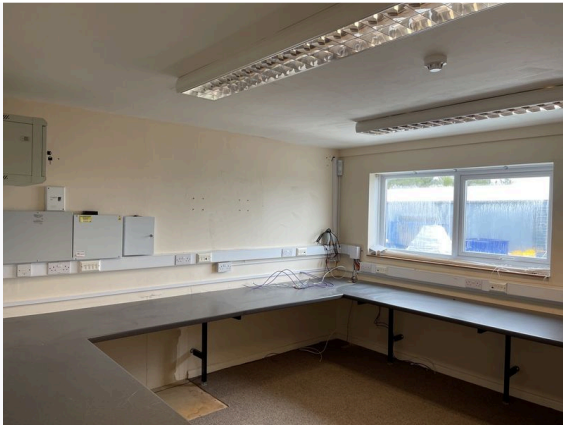
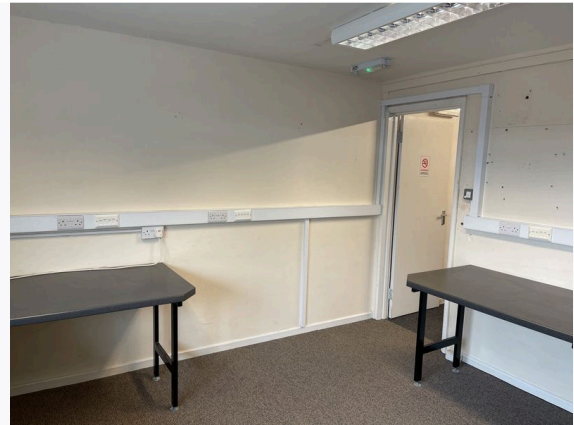
Ref #13

Ref	Name	Description	Condition
13.1	Security / Safety	Wall mounted sensor Red alarm sounder	Not tested Not tested
13.2	Pest Control	Pest control trap	
13.3	Door	Painted white; metal lever handles, lock, no key No Smoking stickers	Minor marks and defects

13.4	Door Frame	Painted white	External: missing section to top left Internal: cabling to top left  Minor marks and defects
13.5	Ceiling	Painted white Integrated smoke detector	Removal marks / holes to right as you enter

13.6	Lighting	2 x Louvered florescent light units	Working
13.7	Walls	Painted Magnolia Conduit Grey speckled worktops metal supports Wall mounted metal data point cabinet; glass panel, lock with keys present Wall mounted grey metal cabinet; lock, 3 x keys - empty Honeywell data point cabinet - not accessed; associated cabling	Removal holes and large holes to entrance left; far left corner to sensor Some wires visible to back wall right of window Visible scratches to worktops  Minor marks and defects

13.8	Skirting	Painted white	Minor marks and defects
13.9	Window(s) / Sill	White UPVC; lever handle, lock, no key Stained wood sill	Condensation to both glass panels

13.10	Blinds	Brackets to top recess White paper blind	Not fitted
13.11	Switches	Metal Single fused switch White plastic 3 x fused switches	Not tested Not tested

13. TOP OFFICE (CONT.)			
13.12	Sockets	White plastic 16 x double sockets 10 x RJ45 network/data points 2 x open boxes - no plates 2 x Openreach points 2 x Opnereach telephone points	Not tested Not tested Not tested Not tested Not tested
13.13	Heating	None present	
13.14	Flooring	Grey flecked carpet tiles	Section missing to main back wall left under worktop Minor spots marks in places
