RICS Home Survey Level 2 + Valuation

HOME SURVEY TEST - Level 2 +
Valuation, Portsmouth, Hampshire,
PO1 1JJ

JP Chartered Surveyors

June 18th 2021

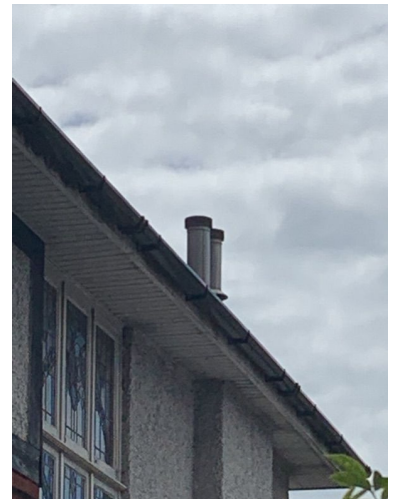
All chimneys have been removed down to ceiling level and replaced with flue terminals.
1 x flue situated to front of property. 2 x flues situated to rear of property. Sky satellite dish and T.V aerial located to left side of property.

The metal flues are in a satisfactory condition. No repairs are currently needed. Metal flues, fillets and flashings although they could not be seen from ground level they are very exposed and should be regularly inspected and maintained in good condition.

Condition Rating - 1

Your legal adviser should check that local authority approvals have been obtained, if necessary, for the stacks which have been removed.

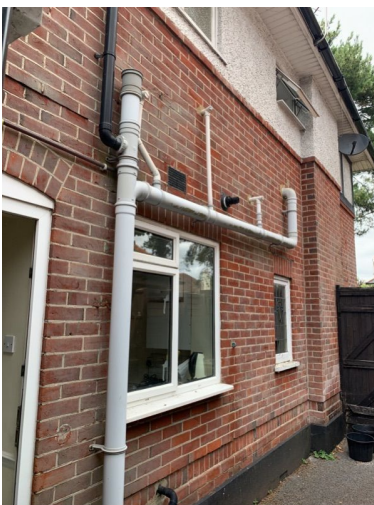
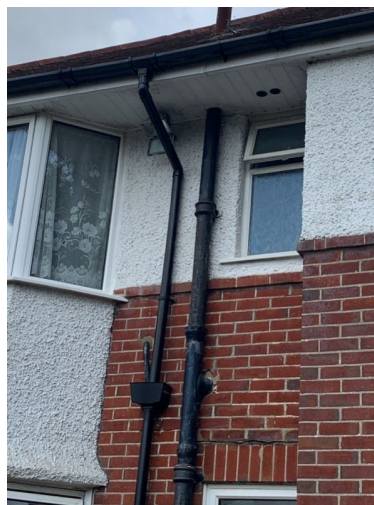
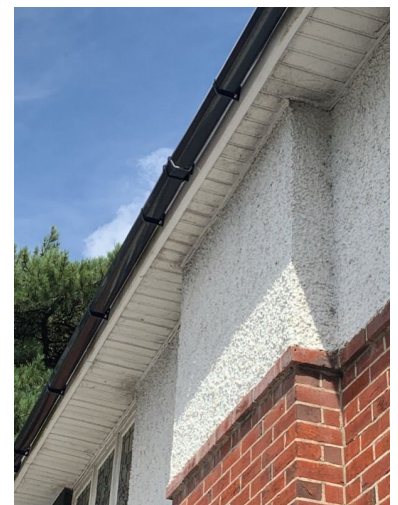
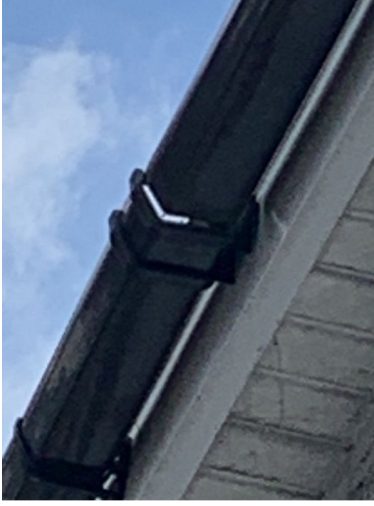
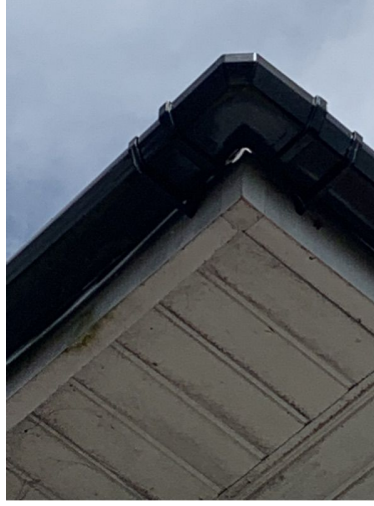
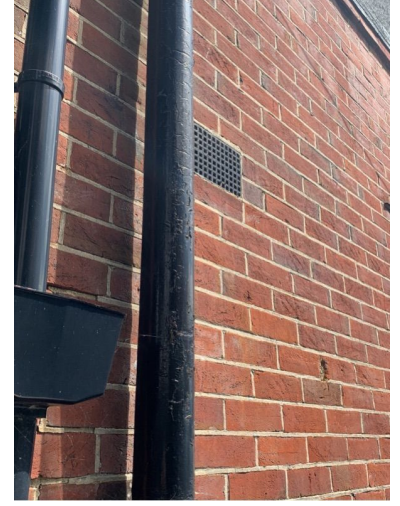
The type of trees to the front of the property have the ability to drop a larger amount of pine needles mainly around autumn time. If left unchecked these have the potential to block the guttering. I would recommend gutter covers to prevent this from occurring.

The waste water and soil pipes are of a mixture of plastic and cast iron material. The waste water leads into the soil pipe which discharges to below ground drainage. There is no caged cover over the top of the soil pipe to prevent obstructions and birds/animals blocking any ventilation. The original cast iron soil pipes although appear worn function perfectly well.

Condition Rating - 1

Due to a cage for the top of the soil pipe can be placed during normal maintenance. The gutter repair and cleaning can be completed during normal maintenance.

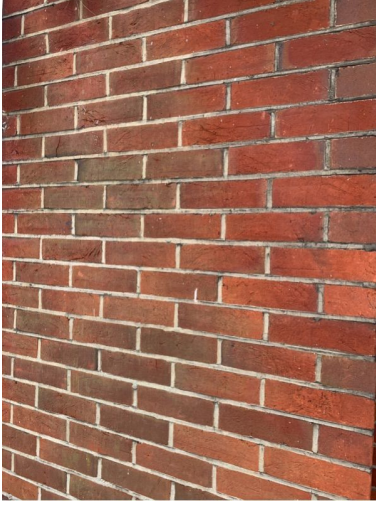
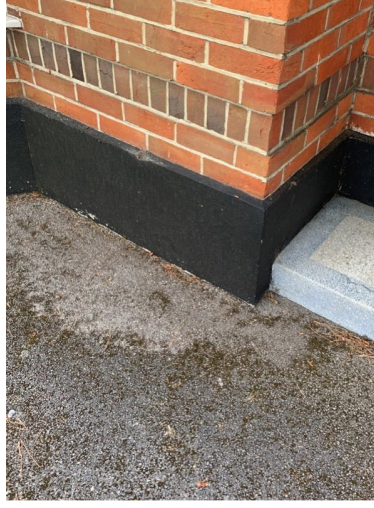
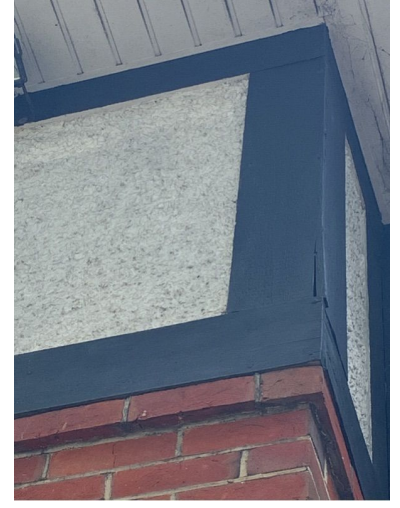
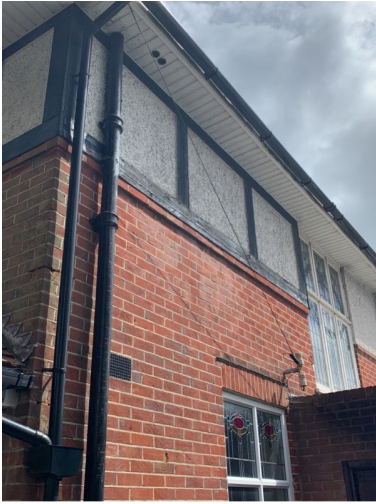
D4 Main Walls

The main walls are not true and plumb but are in satisfactory structural condition. The external surfaces are weathered but are in acceptable condition with no serious defects apparent. We found no evidence of significant dampness within the scope of our inspection and report. No major repairs are currently needed.

The damp proof course is covered by the cement plinth externally and therefore cannot be verified as to its existence and material. Internally the main walls were tested with a damp meter and no damp was noted. It therefore appears that the main walls are adequately protected against rising damp.

Brick work appears in good condition for the age of the property. Paintwork to rendering and mock Tudor timber is slightly worn.

Condition Rating - 1

The repainting of the render and mock Tudor timbering can be completed during normal maintenance.

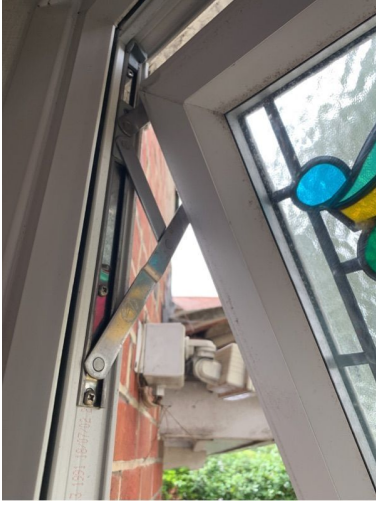
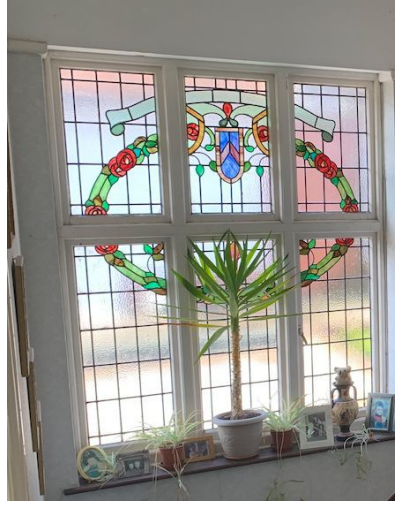
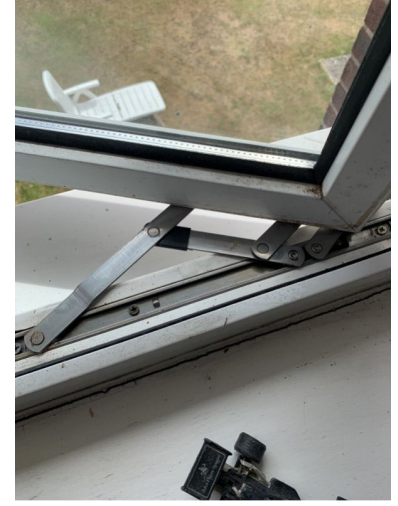
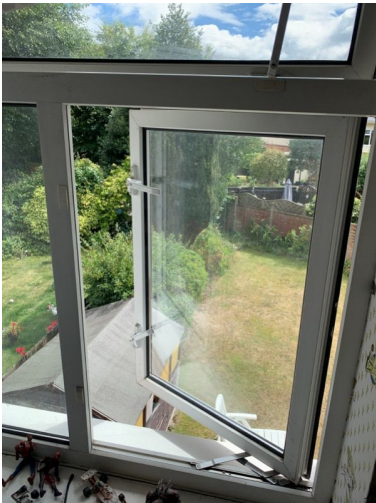
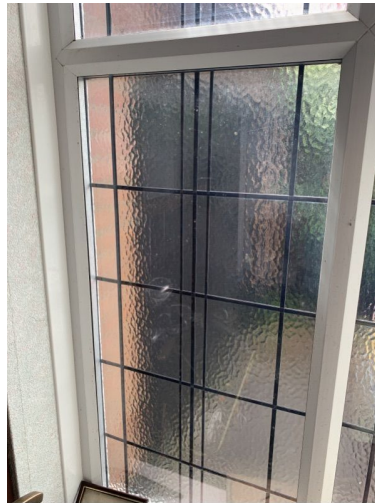
D5 Windows

Most of the windows are plastic double glazed 22mm casement windows, with stained glass to the upper casements and mock lead strips to panels to match the original windows they are white in colour to both aspects. They are friction hinged with lockable handles. There are no trickle vents fitted to any window. There is one original window to the west elevation which is single glazed and of timber frame.

Condition Rating - 1

When replacing windows going forward ensure trickle vents are fitted to aid in ventilation and prevent any damp issues that may occur.

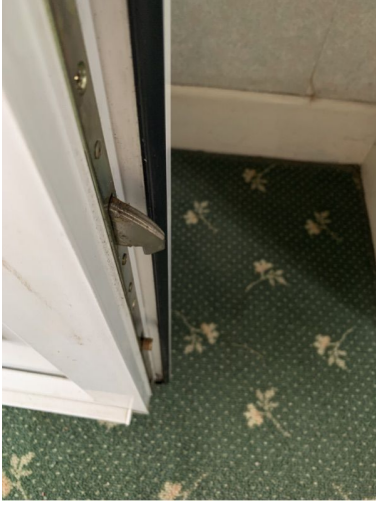
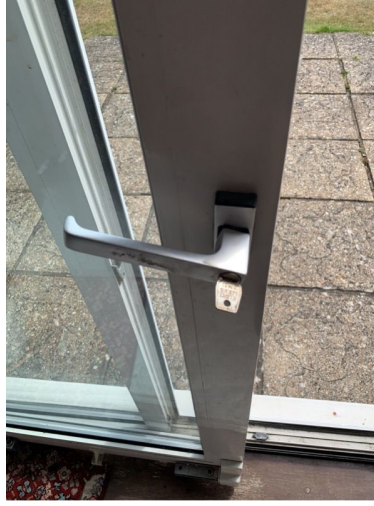
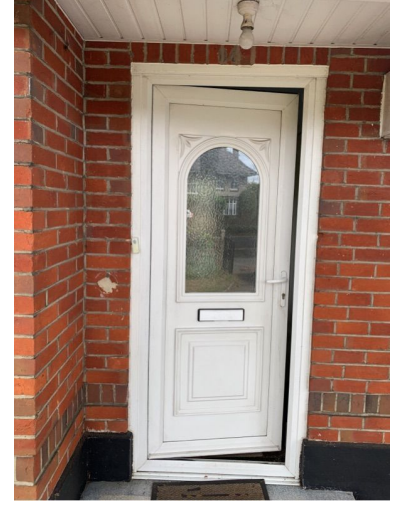
D6 Outside Doors (including patio doors)

Condition Rating - 1

Since 2002, double glazing should have either Building Regulation approval or should have been installed by a contractor registered with an association such as FENSA, CERTAS or BM Trada which has been recognised by the Government under the 'Competent Person Scheme'. Your legal adviser should check this.

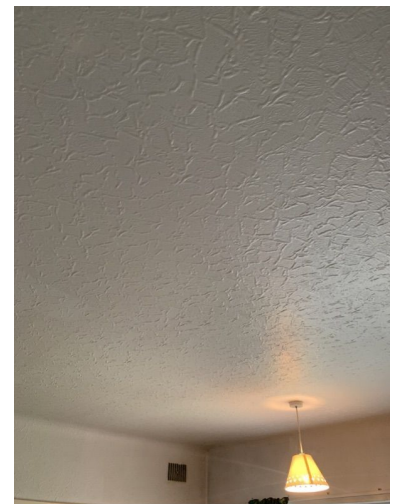
E2 Ceilings

The ceilings are in satisfactory condition but some are uneven in a few places which is not unusual in older properties. Plaster finishes are also in satisfactory order. However, there are a number of minor superficial cracks present. No repairs are currently needed. The ceilings should be inspected from time to time and finishes maintained in the normal way. The ceilings are in satisfactory condition. No repairs are currently needed. The ceilings should be inspected from time to time and finishes maintained in the normal way.

Condition Rating - 1

Cracking in plaster often occurs due to movement of the floor above, the general ageing of the material and loss of adhesion over time and normal shrinkage of the material. The cracking is not considered serious or significant. If repaired and filled, the cracking may re-occur from time to time.

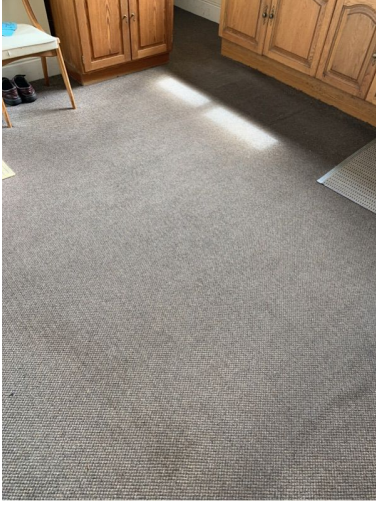
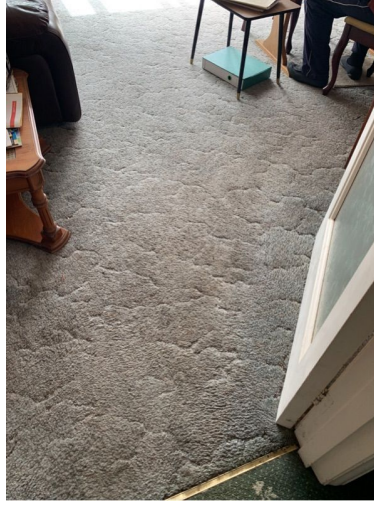
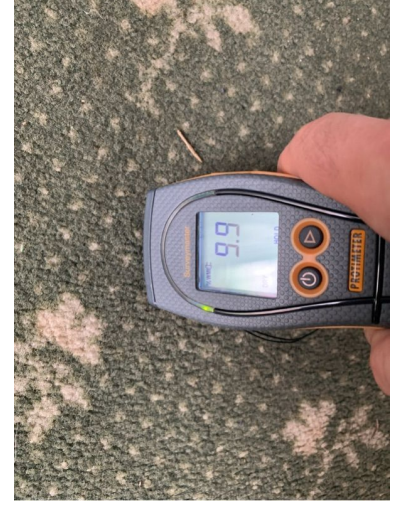
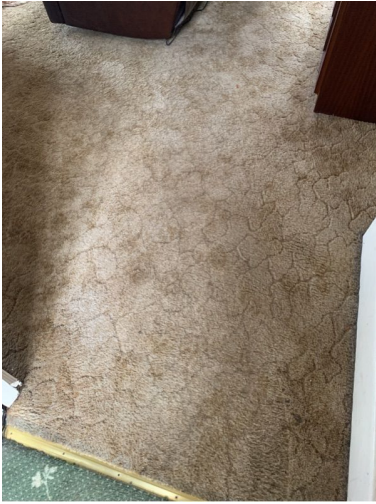
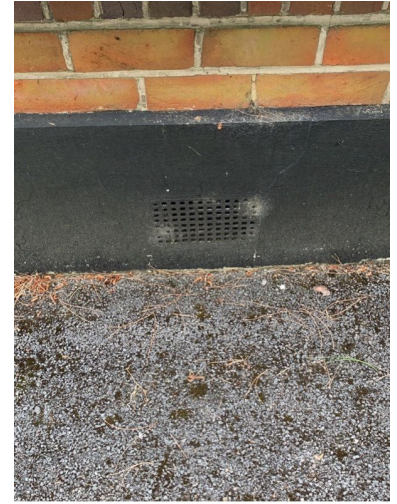
The floors are in satisfactory condition with no obvious serious defects but some move and creak underfoot which is not unusual for the age of the property. The floor finishes, where visible, also appear satisfactory. We found no evidence of significant dampness within the scope of our inspection and report. There were an adequate number of air vents to ventilate under-floor areas. No repairs are currently needed.

Condition Rating - 1

Where floors are springing the movement is not sufficient or serious enough to warrant the expense and disruption of removing the finishes and strengthening the floor structure. Nevertheless care should be taken when furnishing rooms which suffer from such movement.

Whilst no signs of wood-boring beetle attack were found, older properties such as this one are very susceptible to such infestation which may well be discovered when the property is completely emptied. Should an outbreak be discovered, localised treatment may be necessary. As much of the property was covered up it would be prudent to carry out a more detailed inspection of the whole property now for any such infestation.

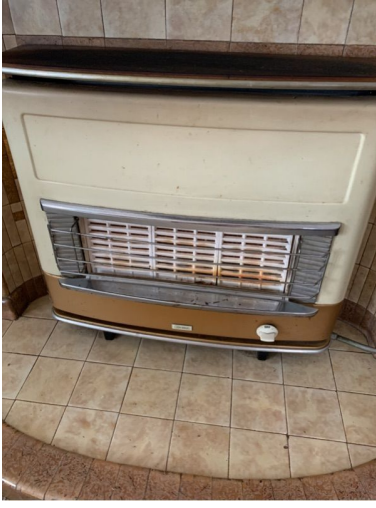
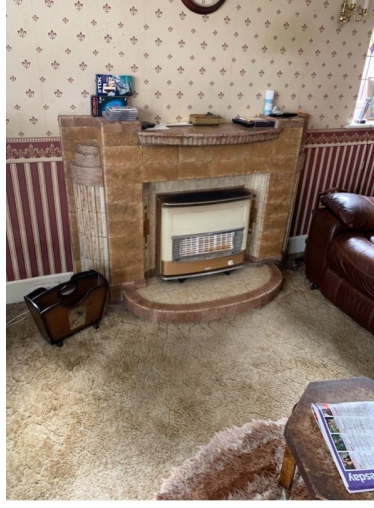
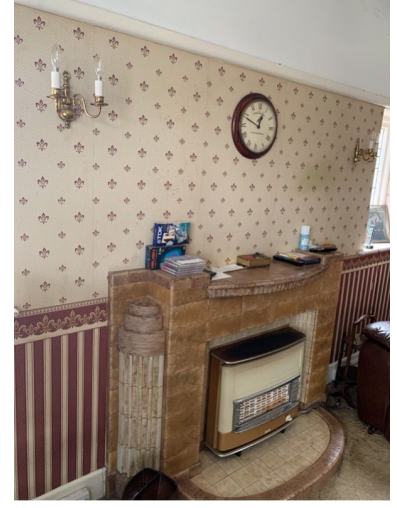
E5 Fireplaces, Chimney Breast and Flues

Condition Rating - 1

All unused flues should be covered and ventilated to reduce any risk of rain penetration and internal condensation which could result in serious damp and decay.

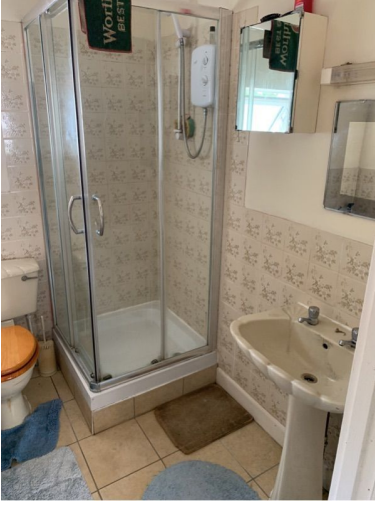
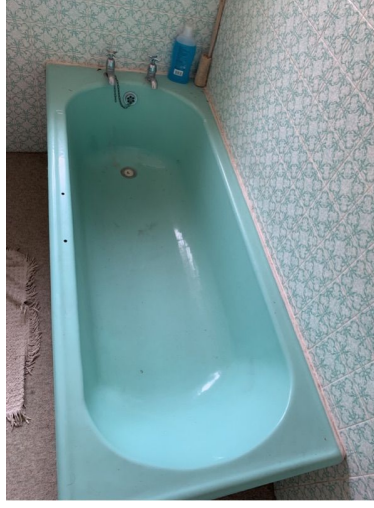
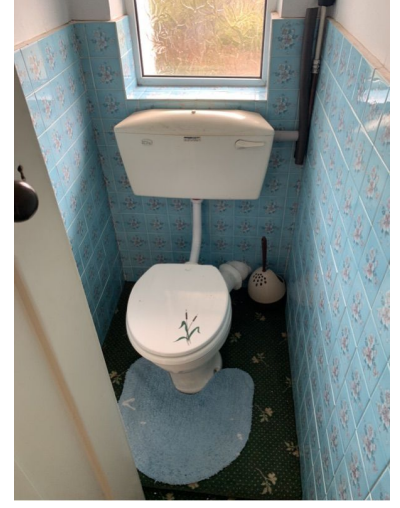
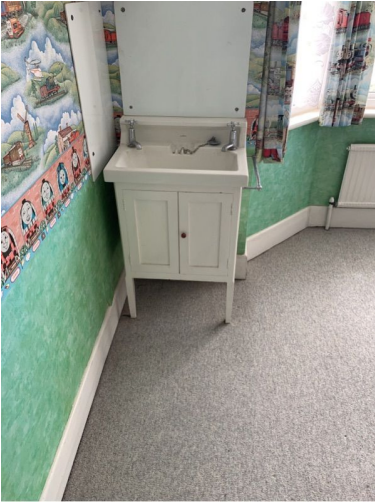
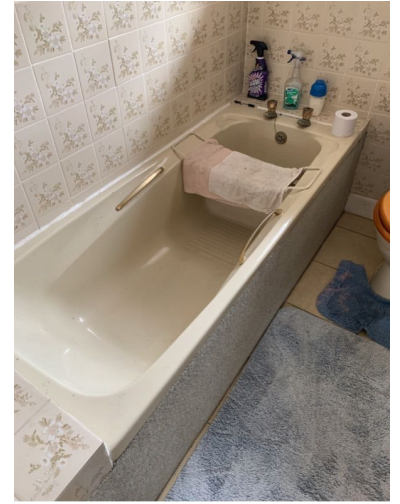
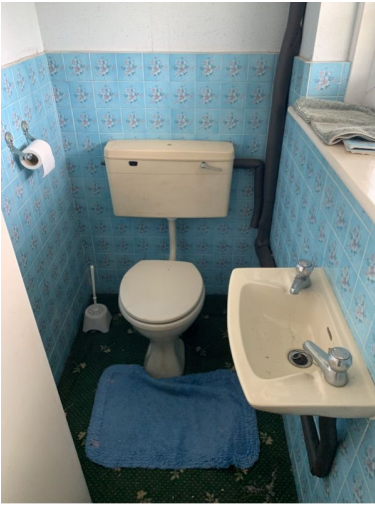
Units are dated and worn. The ensuite located in the main bedroom comprises of a dark cream acrylic bath and matching wash basin and toilet. There is also a single shower cubical to the corner.

There are sufficient sanitary provision for this size of property. There is a single shower cubical to the ensuite fitted with a Triton. Both the ensuite and family bathroom appear dated and would benefit from replacement.

Condition Rating - 1

Even though both utilities are dated and slightly worn they function perfectly well.

The electric shower should be inspected and tested periodically to ensure it is safe to use in a wet environment

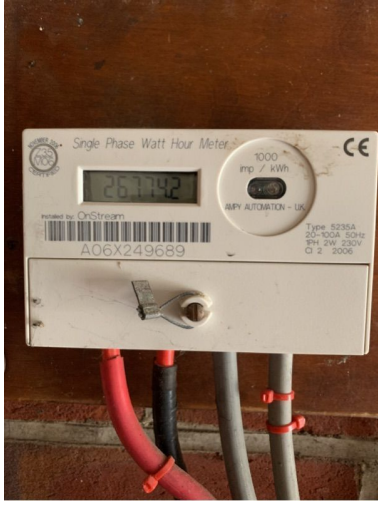
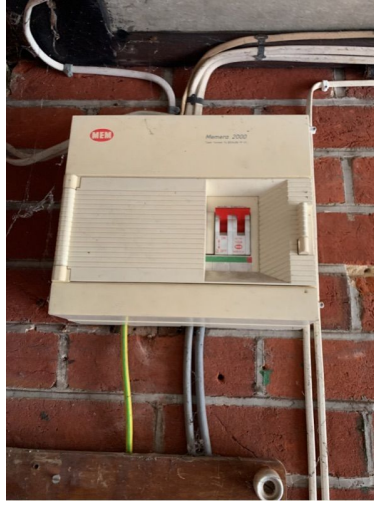
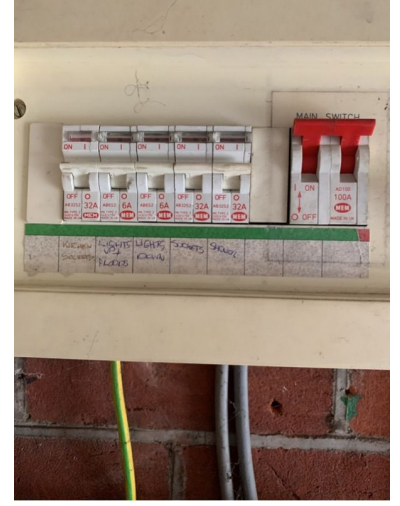
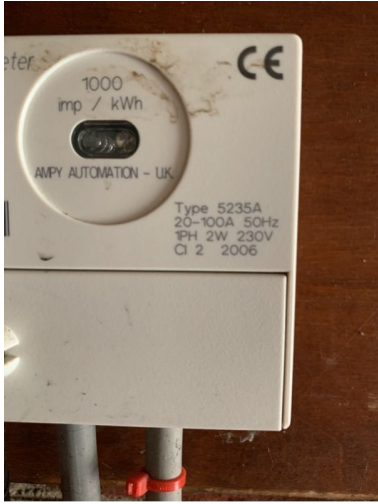
Condition Rating - 3

Your legal adviser should check whether the electrical alteration/extension work has Building Regulation approval or has been certified by an approved electrical contractor. We refer you to our comments in Section I.

Electrical faults are now the major cause of accidental fires in UK homes. The installation should be checked at least every 10 years, whenever changes are made to the property or when accidents occur which affect the electrical system. The consequences of an electric shock are far more severe in a bathroom or shower room as wet skin reduces the body's resistance. Electric showers should be checked more often for any disrepair to ensure they are safe to use.

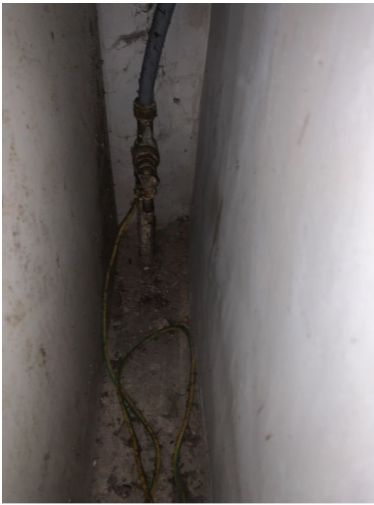
The internal stopcock we believe is in the cupboard in the hallway. The cold water pipework internally, where visible, is in copper and plastic. Water is stored in a plastic tank which can be found in the main roof space.

Condition Rating - 2

The main supply pipe, if original, may be reaching the end of its serviceable life.

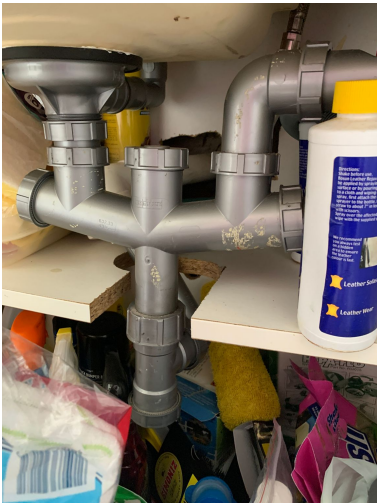
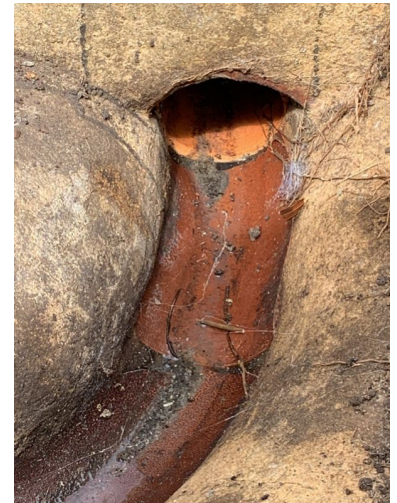
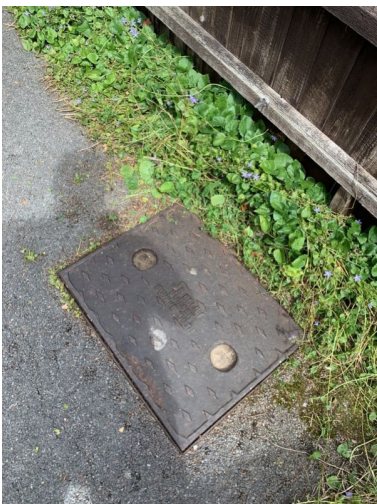
Condition Rating - 1

Although, there were no obvious defects the drainage is old and therefore it would be prudent to commission a camera inspection of the drains.

This should be carried out by a reputable and experienced contractor, see the 'What to do now' page in this report.

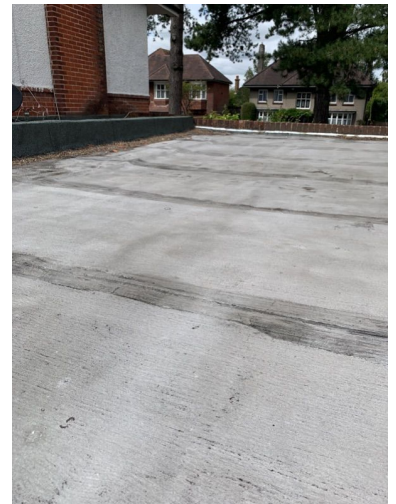
Although no repairs are required now, it is at least 45 years old so you must expect repairs in near future. When this occurs, you will have to use a contractor experienced in this type of work or an asbestos specialist.

Condition Rating - 1

No repair is currently needed. The property must be maintained in the normal way. Because of the possible asbestos content, you should get advice from a contractor experienced in this type of work or an asbestos specialist before the roof covering is disturbed in any way. Regular maintenance is needed.
