Japanese Knotweed Survey

JAPANESE
KNOTWEED
1 Sample St
Portsmouth
Hampshire
IBA 123

**November
26th 2022**

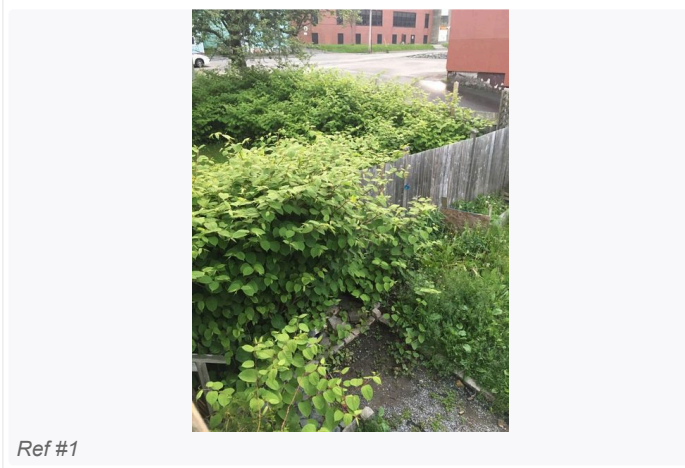
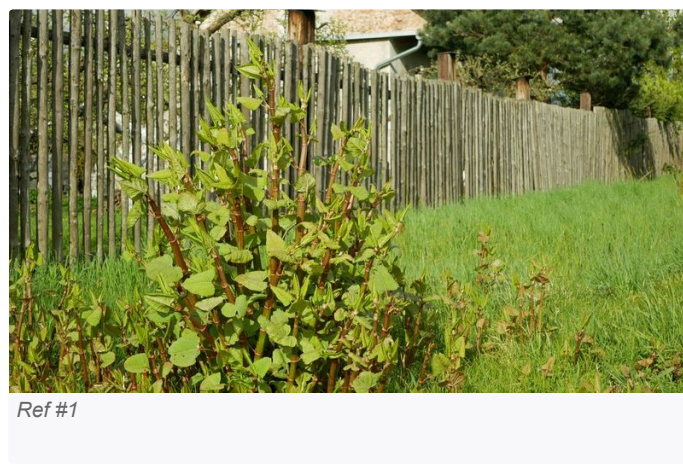
Ref	Detail	Information
-	Please provide contextual description of site and pictorial evidence	Pictures provided for example only
