Move In Inspection

Property inspected by Property Inspect

1 Sample Street
Irvine
California
92614

February
28th 2017

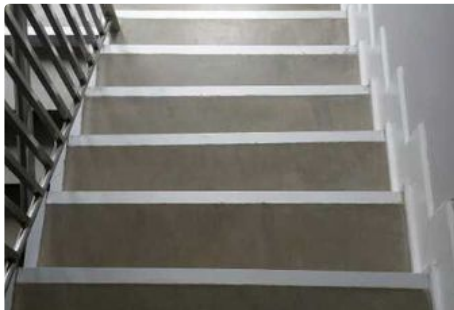
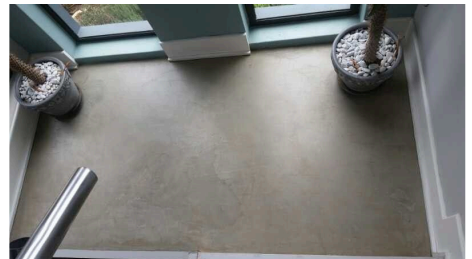
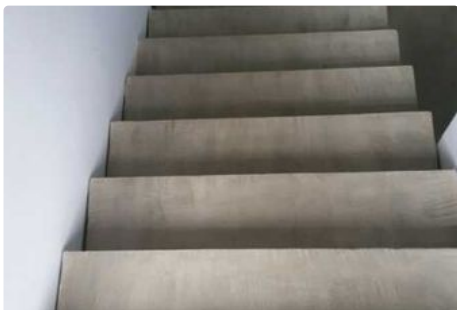
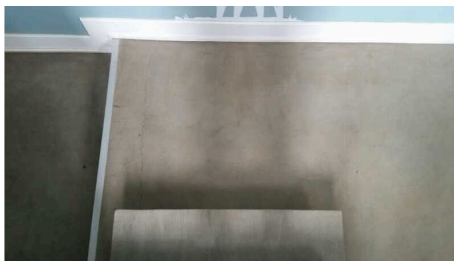
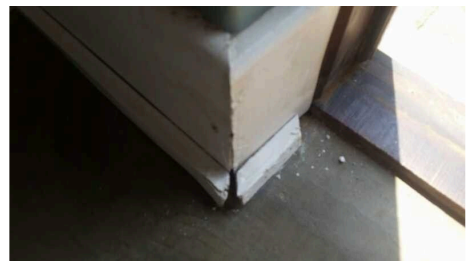
1. ENTRANCE HALL / STAIRS		
Ref	Name	Condition
1.1	Floor/Carpets/ Tiles	Floor covering is concrete in good condition Skirting at front door coming loose
1.2	Doors/ Frames/Handles/ Locks	Door in good condition can open and close properly without any visible damages or any marks

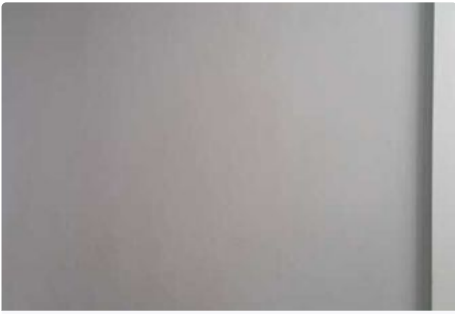
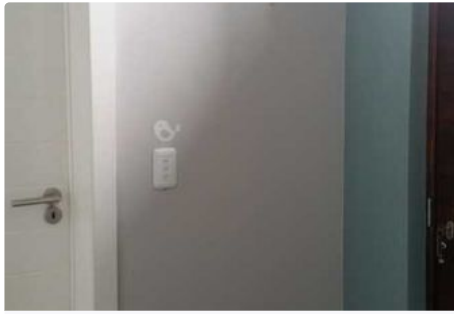
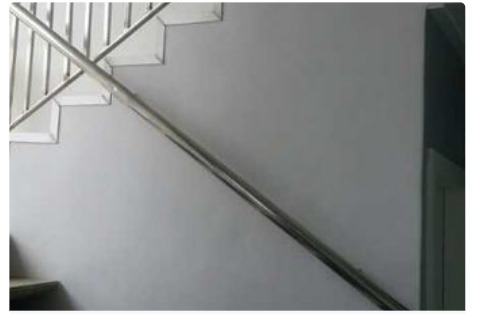
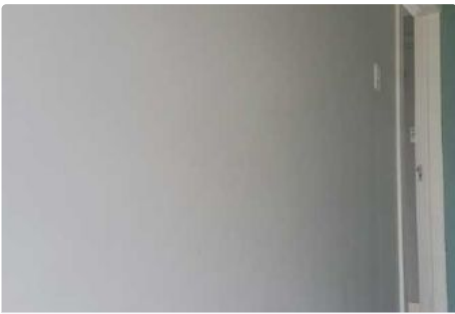
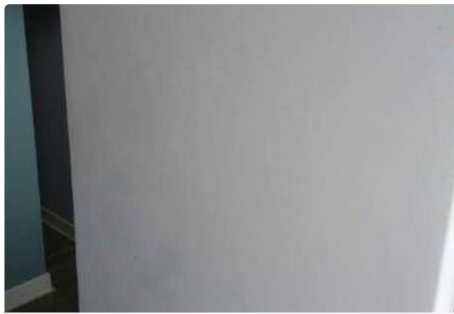
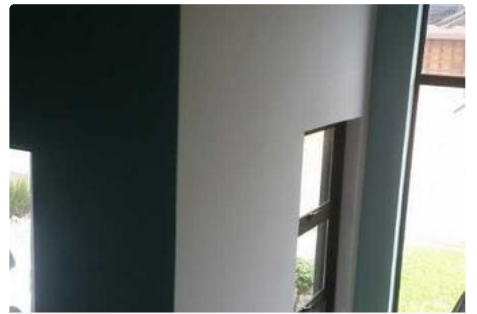
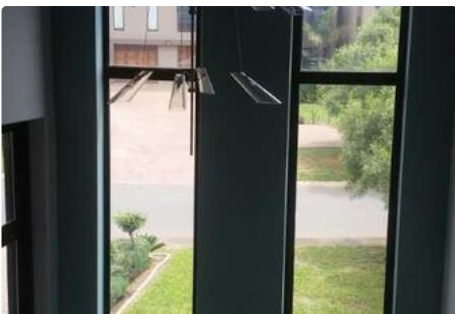
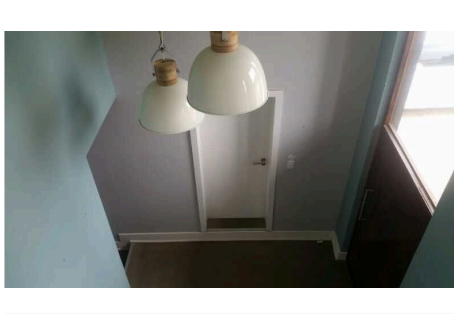
1.3	Walls	Walls in Fair good condition Normal wear and tear 2 hilties in the wall next to the garage door
1.4	Light Switches	Light switches in working condition with covers intact

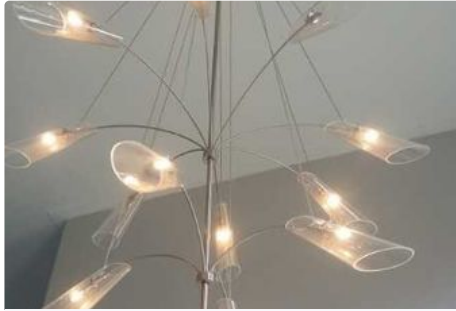
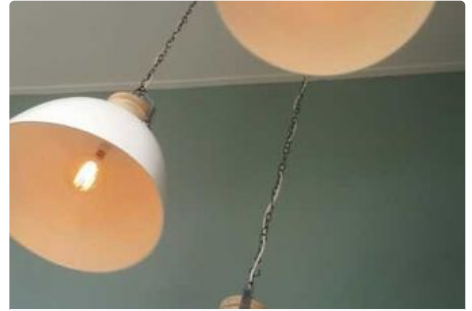
1.5	Light fittings	Lights in working condition No visible damages or any breakages Lights at entrance hall or three globes working Lights by stairs 1 globe fused

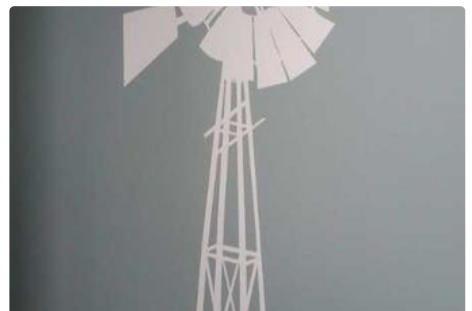
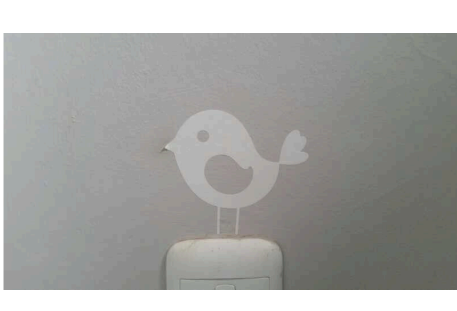
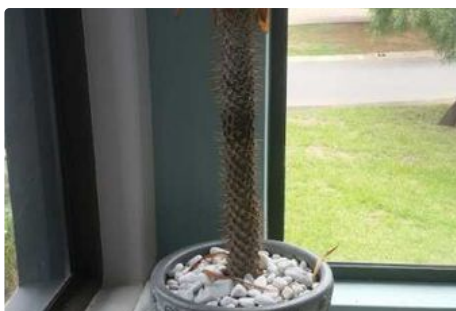
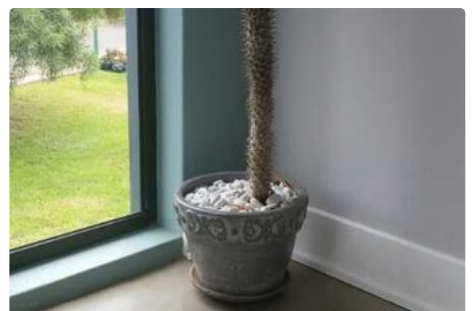
1.8	Other	Two stickers against walls 2 pot plants on the stairs left by the owner. Tenant must please see to the plants water them and don't let them die

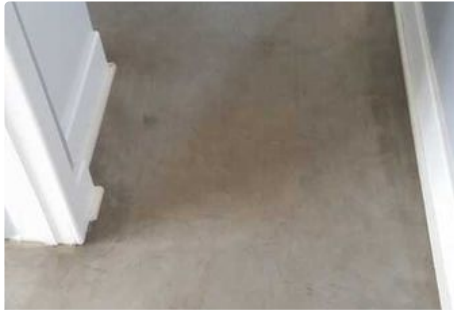
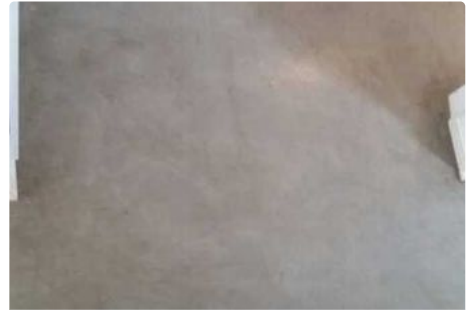
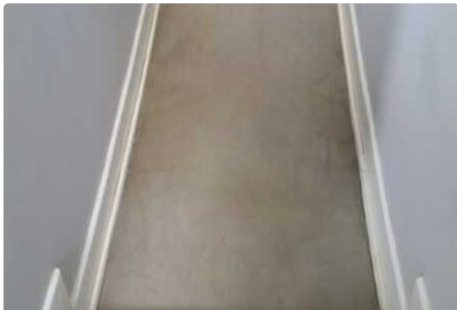
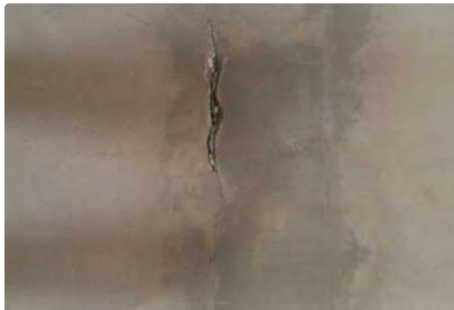
Ref	Name	Condition
2.1	Floor/Carpets/ Tiles	Concrete floor with cracks visible
2.2	Walls	Walls in fear good condition normal wear and tear
2.3	Light Switches	Light switches in working condition with covers intact
2.4	Light fittings	Light fittings in working condition with all globes working
2.5	Ceiling	Ceiling in good condition with no visible damages or any marks
2.6	Curtains/ Curtain Rail/ Blinds	Blinds in perfect condition can open and close properly
2.7	Other	1 key m36b-door underneath stairs

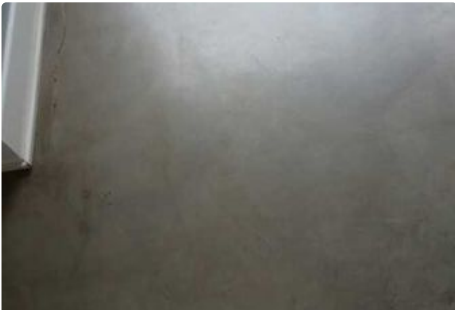
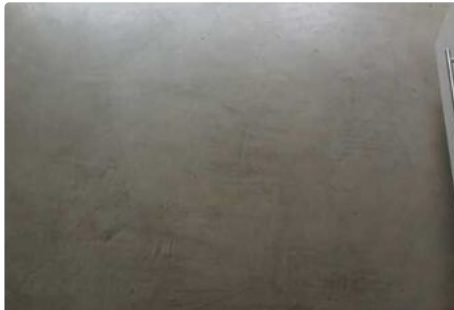
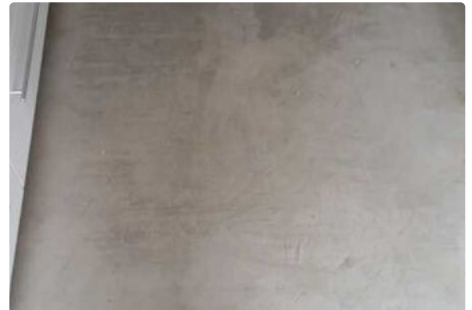
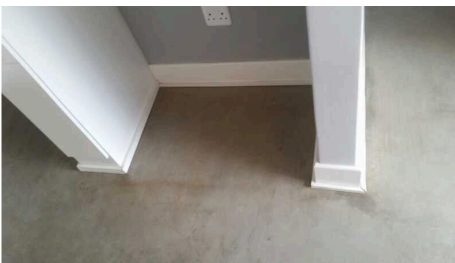
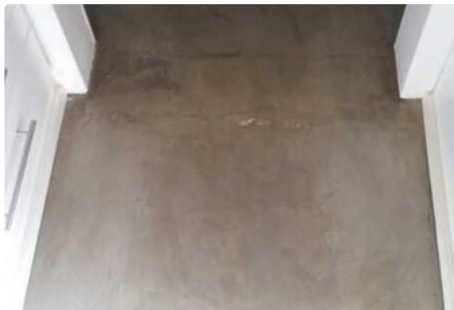
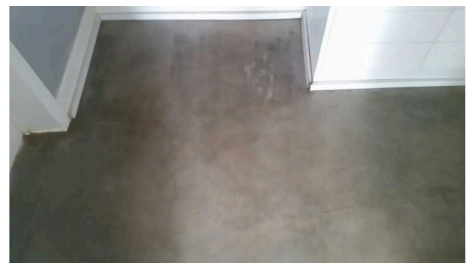
Ref # 3.1

Ref	Name	Condition
3.1	Floor/Carpets/ Tiles	Floor covering is concrete fair wear and tare with visible cracks
3.2	Doors/ Frames/Handles/ Locks	Door in good condition can open and close properly and lock no visible damages but fair wear and tear Sliding door in good condition can close and open comfortably No Cracked Glass
3.3	Walls	One Hilti next to the sliding door Holes have been painted not in good condition and clearly visible Normal fair wear and tare and scratch marks
3.4	Light Switches	Light switches in working condition and covers intact
3.5	Light fittings	Light fittings in working condition all Shades intact no breakages and all globes working
3.6	Windows/ Frames/Handles	Windows can open and close properly no broken glass 1 curtain pole about the sliding door

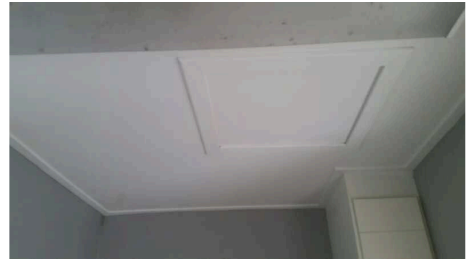
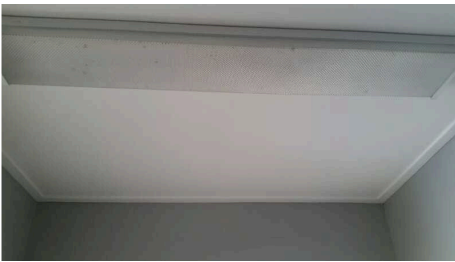
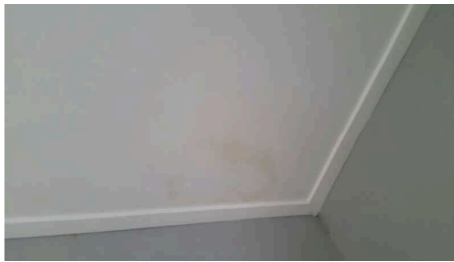
Ref # 3.7

3. KITCHEN (CONT.)		
3.7	Ceiling	Ceiling in good condition however one visible damp mark in the scullery appears to have a leak
3.8	Plugs	All plugs in working order with covers intact
3.9	Curtains/ Curtain Rail/ Blinds	
3.10	Cupboards/ cabinets	All cupboards in very good condition can open and close properly with all Hinges and handles intact all draws can open comfortably water damage to the two doors below the zinc in the kitchen and not the scullery Countertop in the scullery damages on the top in front of the sink
3.11	Oven & Hob/ stove	Gas stove part of the unit in very very good condition no scratches or any visible damages glass panel intact with no cracks or damages and all in working order
3.12	Sink/Taps	All 3 zinks in very good condition no visible damages all tabs in working order

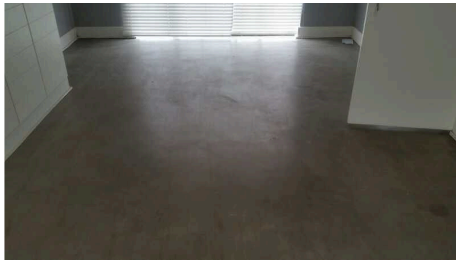
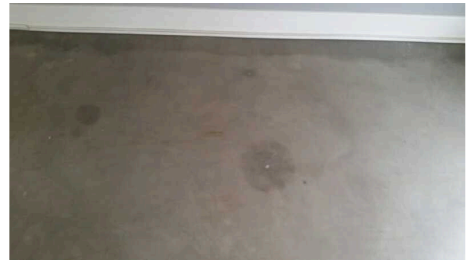
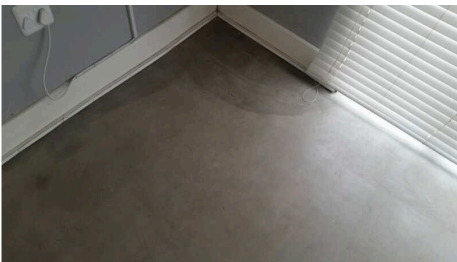
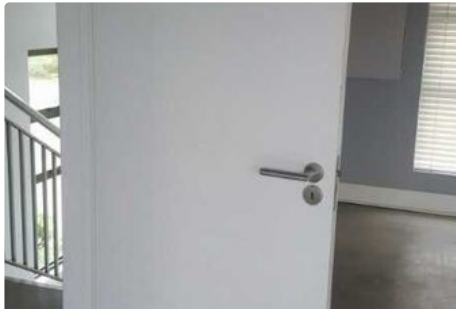
Ref	Name	Condition
4.1	Floor/Carpets/ Tiles	Flooring is concrete in good condition stains coming through as shown on photos Skirtings swollen
4.2	Doors/ Frames/Handles/ Locks	Door in good condition can open and close properly and lock. No visible damages or any holes
4.3	Walls	Walls in fair good condition with normal wear and tear A few light marks and scratches Peeling paint
4.4	Light Switches	Light switches in working condition with covers intact
4.5	Light fittings	All lights working no visible damages on the globe fused
4.6	Windows/ Frames/Handles	Windows in good condition can open and close properly with no Cracked Glass Sliding door in good condition can open and close properly without any Cracked Glass

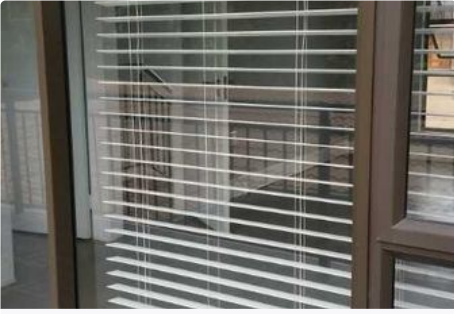
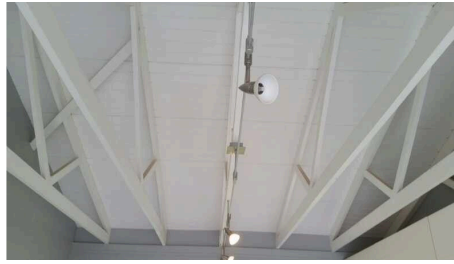
4. BEDROOM 1 MAIN (CONT.)		
4.7	Ceiling	Ceiling in good condition without any visible damages
4.8	Plugs	All plugs in working order with covers intact
4.9	Curtains/ Curtain Rail/ Blinds	All Blinds in perfect condition can open and close properly No damages
4.10	BIC's	Build in cupboards in good condition can open and close properly with all Handles and Hinges intact All draws intact and can open comfortably
4.11	Other	New air-con installed with remote fast and against wall Heater fastened against wall and in working condition TV bracket fastened inside cupboards and forms part of the rental

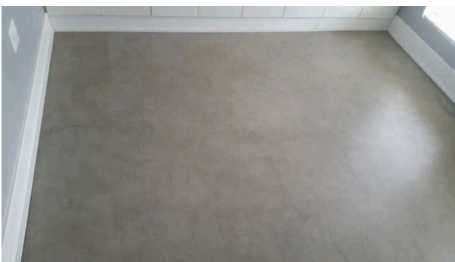
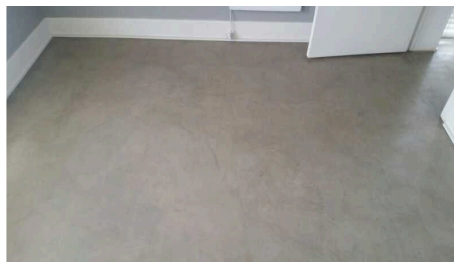
Ref	Name	Condition
5.1	Floor/Carpets/ Tiles	Floor covering is concrete and in Fair good condition
5.2	Doors/ Frames/Handles/ Locks	Door in good condition can open and close properly and lock Double-sided glue stuck at the back of the door

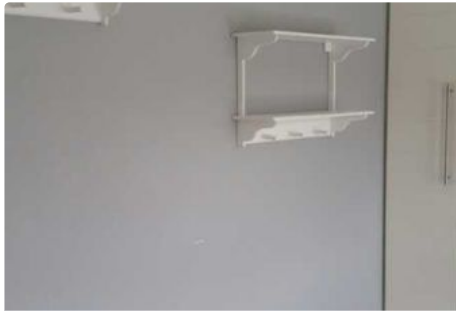
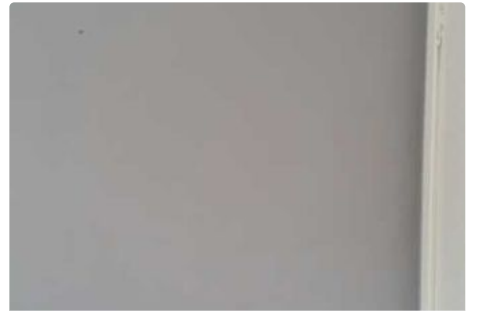
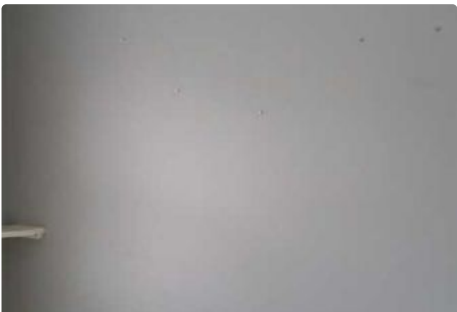
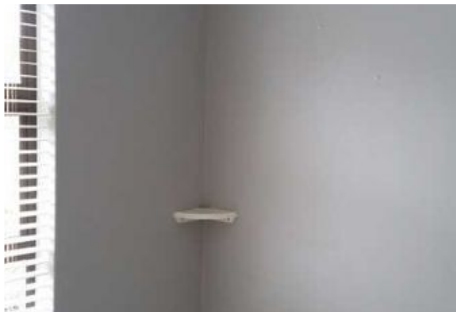
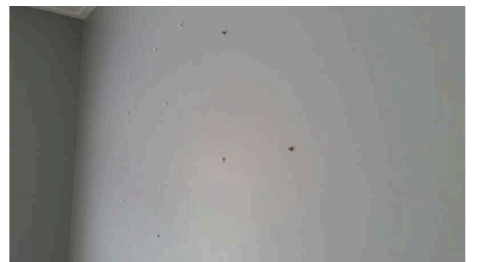
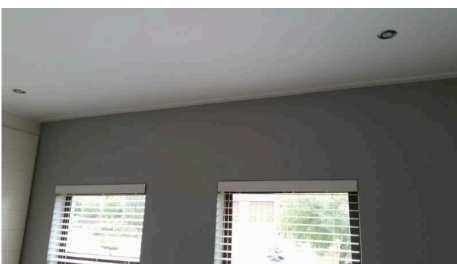
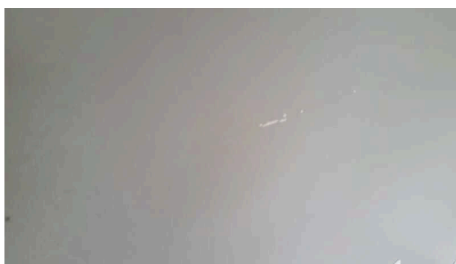
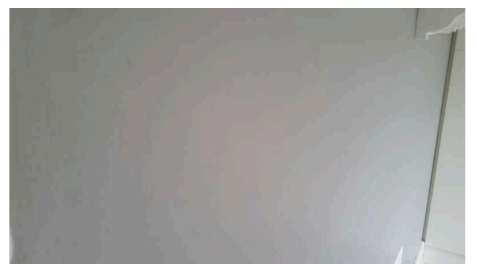
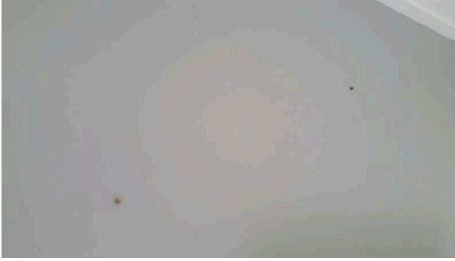
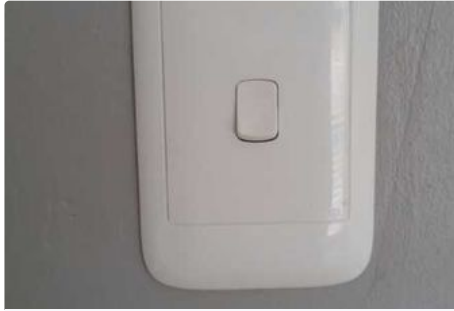
5.3	Walls	Overall 14 hilties inside the wall A few light marks and scratches
5.4	Light Switches	Light switches in working condition with covers intact
5.5	Light fittings	Four downlighters in working condition with all globes working and no damages

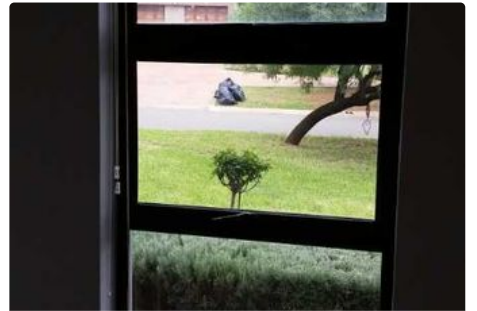
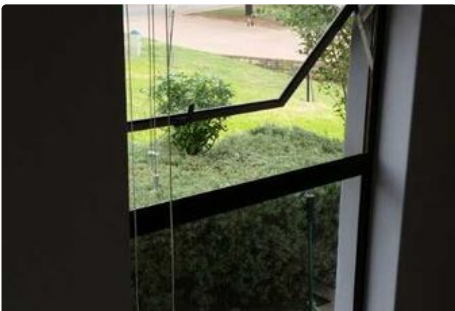
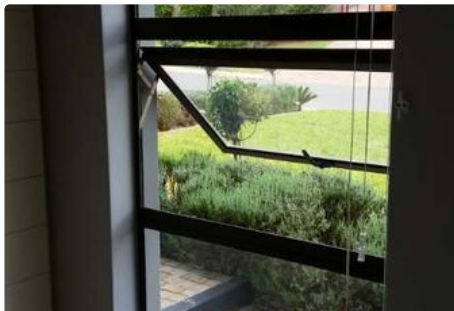
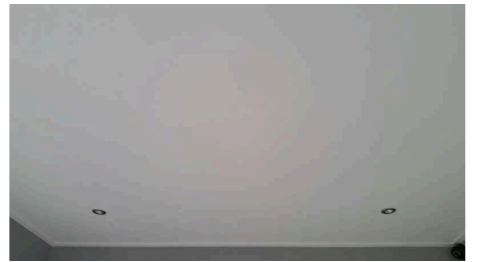
5.6	Windows/ Frames/Handles	All windows in good condition can open and close properly with no cracked Windows
5.7	Ceiling	Ceiling in good condition without any visible damages or marks

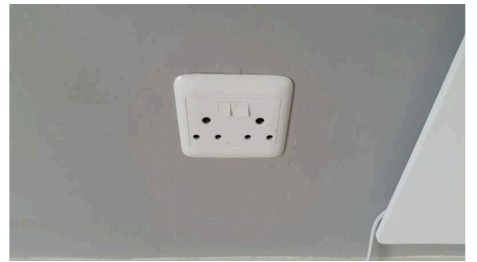
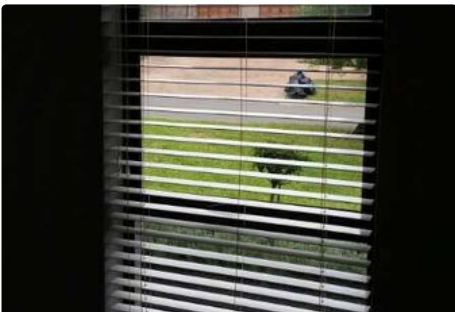
5.8	Plugs	All plugs in working condition with covers intact
5.9	Curtains/ Curtain Rail/ Blinds	Blinds in very good condition no breakages can open and close properly

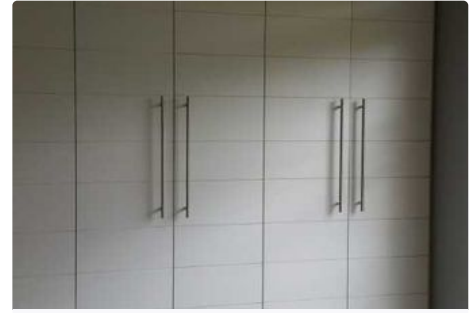
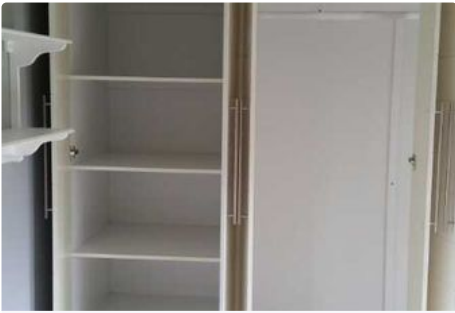
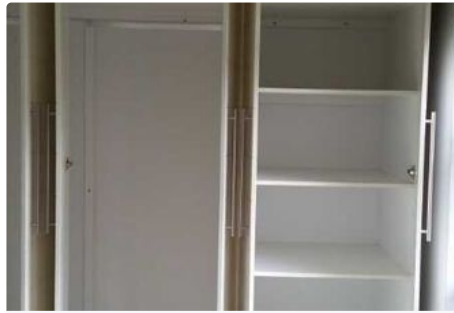
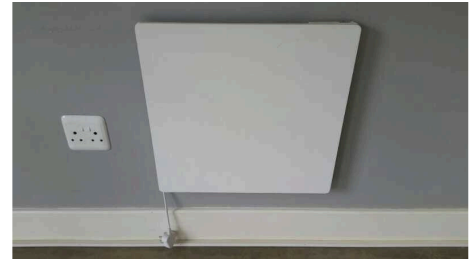
5.10	BIC's	All build in cupboards in very good condition can open and close properly with all Handles and Hinges intact all shelves also in good condition

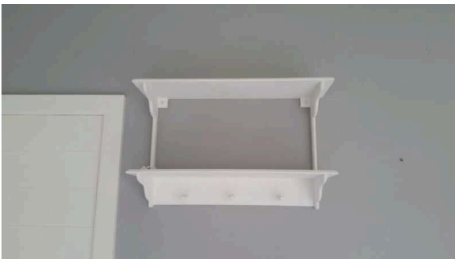
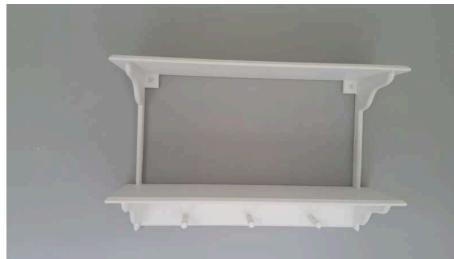
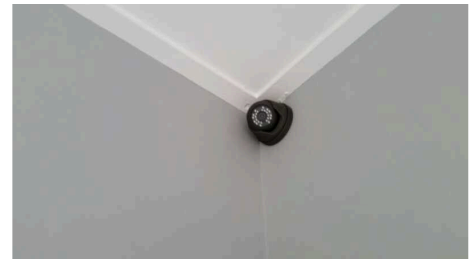
5.11	Other	Two wooden shelves against the wall Panel heater fastened against the wall and in working condition Nanny cam in the room

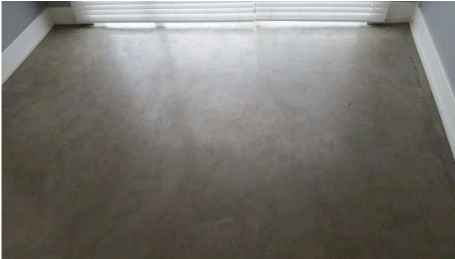
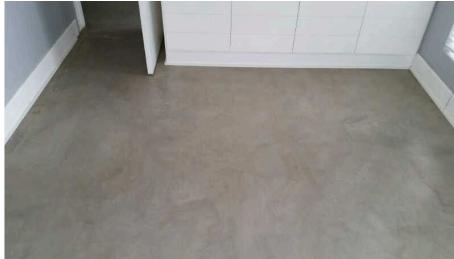
Ref	Name	Condition
6.1	Floor/Carpets/ Tiles	Floor covering is concrete in good condition with visible cracks and normal wear and tear
6.2	Doors/ Frames/Handles/ Locks	Door in good condition can open and close properly and lock no visible damages or any holes in the door Sliding door can open and close properly and lock no Cracked Glass
6.3	Walls	Seven hilties in walls Few small chips
6.4	Light Switches	Light switches in working order with covers intact
6.5	Light fittings	Light fittings is downlighters all in working order with all globes working no visible damages
6.6	Windows/ Frames/Handles	All windows in good condition can open and close properly with no Cracked Glass
6.7	Ceiling	Ceiling in good condition with no visible damages or any holes

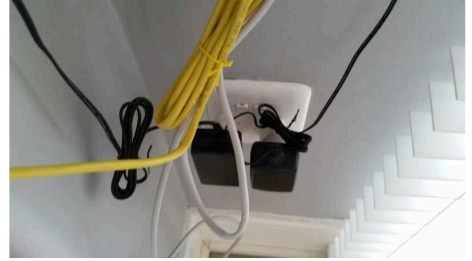
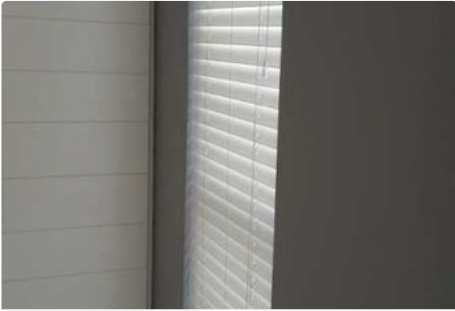
Ref # 6.8

6.8	Plugs	All plugs in working order with covers intact
6.9	Curtains/ Curtain Rail/ Blinds	Blinds in perfect condition can open and close properly without any damages
6.10	BIC's	Build in cupboards in good condition can open and close properly with all Hinges and handles intact and all shelves in good condition
6.11	Other	Fibre and other connections connected in this room

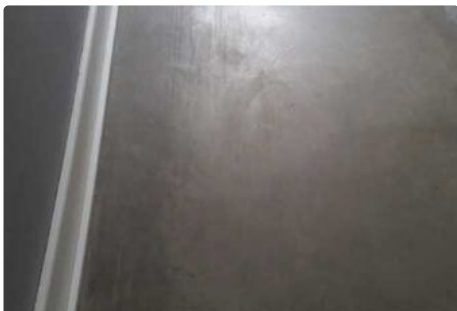
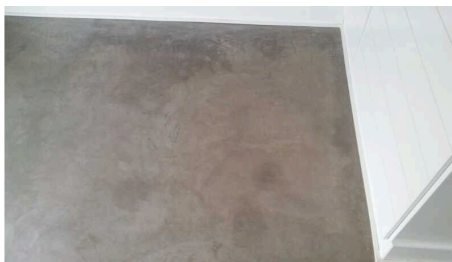
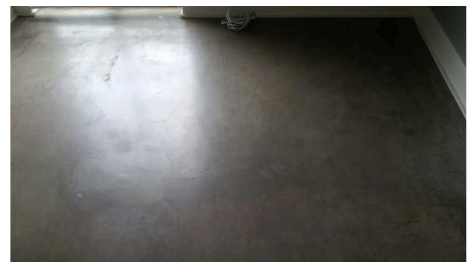
Ref # 7.1

Ref	Name	Condition
7.1	Floor/Carpets/ Tiles	Floors covering is concrete in fair good condition
7.2	Doors/ Frames/Handles/ Locks	Door in good condition can open and close properly and lock no holes or any damages to door

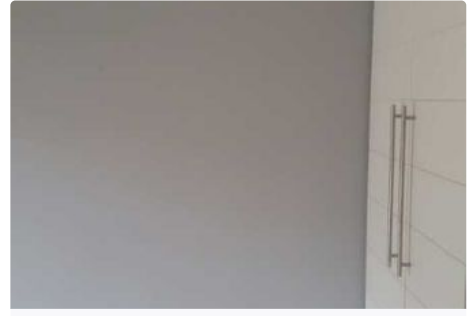
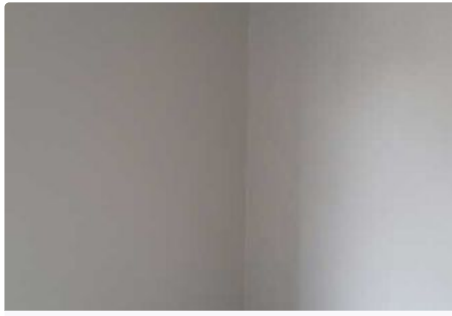
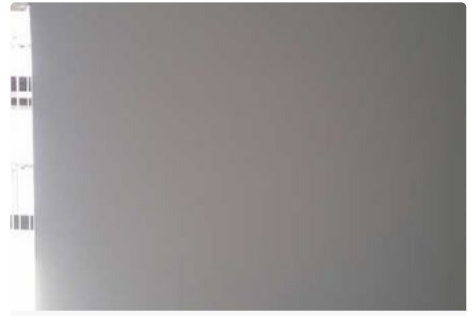
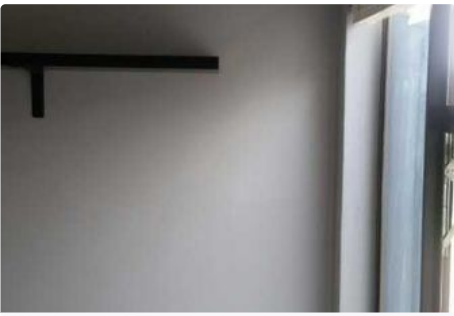
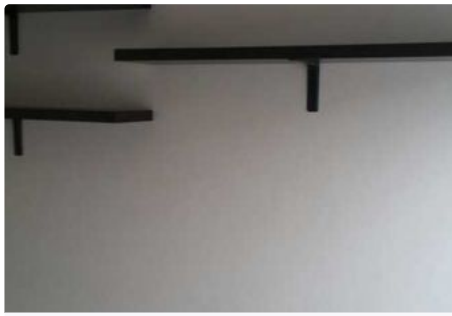
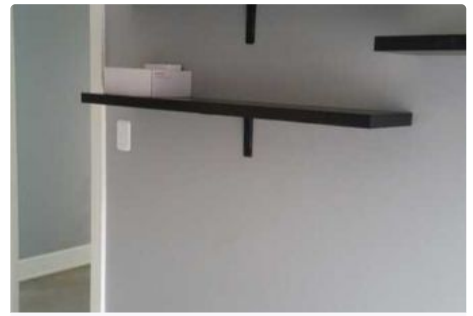
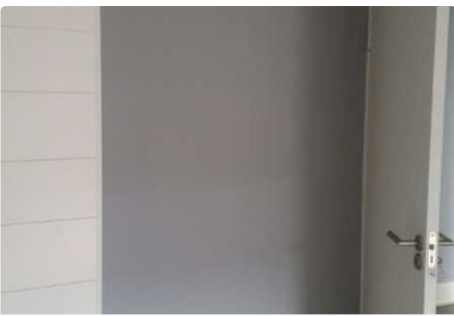
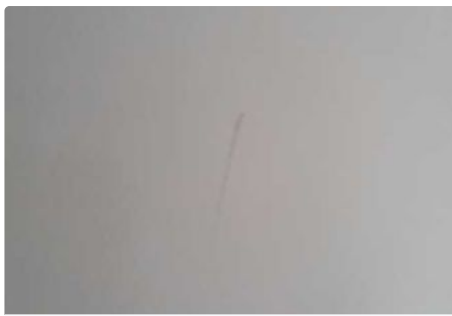
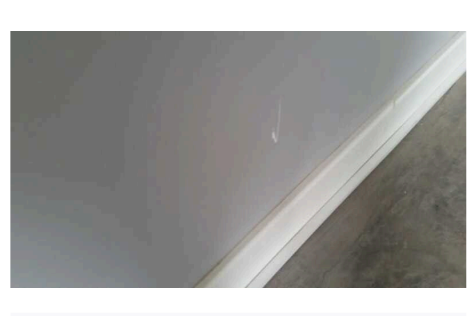
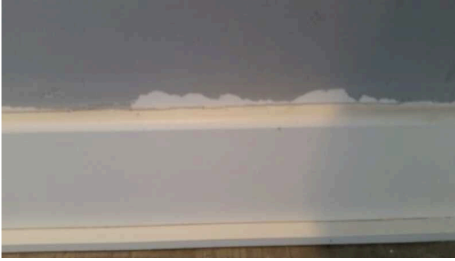
Ref # 7.3

7.3	Walls	No nails in walls Peeling paint Lightly scratched and worn in areas
7.4	Light Switches	Light switches in working order with covers intact
7.5	Light fittings	Light in working order as well as globes no visible damages

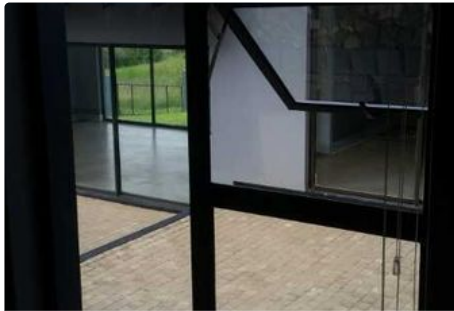
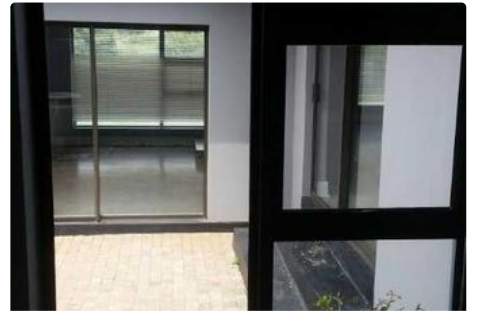
Ref # 7.6

7.6	Windows/ Frames/Handles	All windows in good condition can open and close properly without any cracked Windows or damages
7.7	Ceiling	Ceiling in good condition no visible marks or any damages

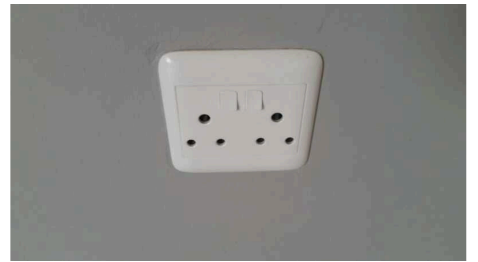
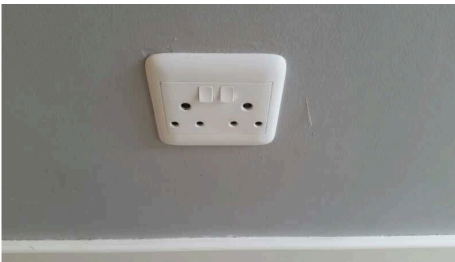
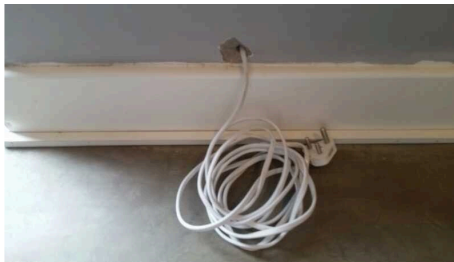
Ref # 7.8

7.8	Plugs	All plugs in working condition with covers intact
7.9	Curtains/ Curtain Rail/ Blinds	All Blinds in perfect condition can open and close properly without any damages

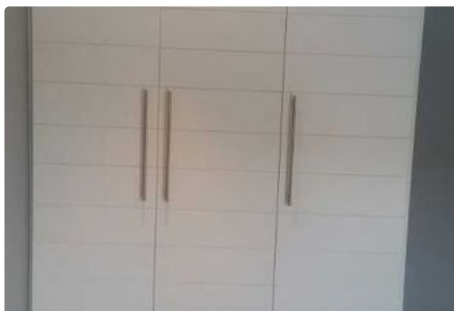
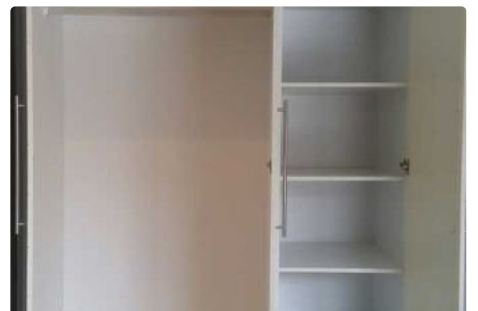
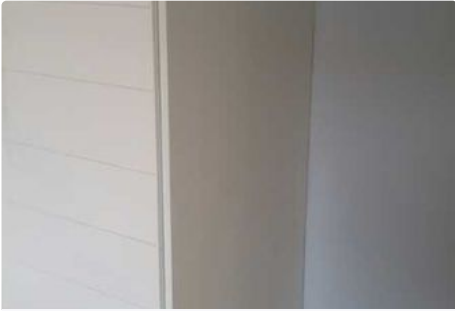
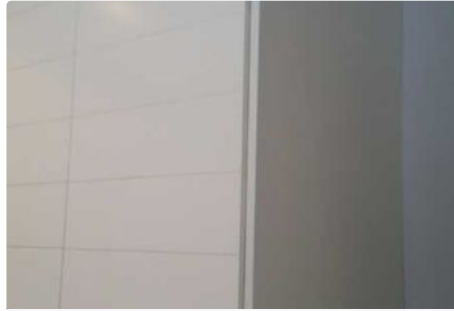
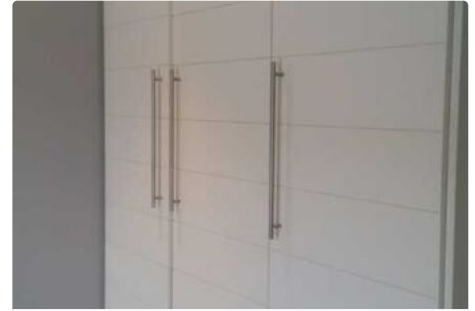
Ref # 7.10

7.10	BIC's	Build in cupboards in good condition can open and close properly with all Hinges and handles intact no broken shelves in very good condition

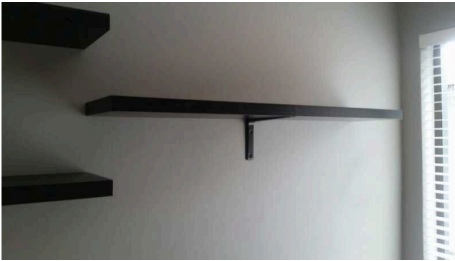
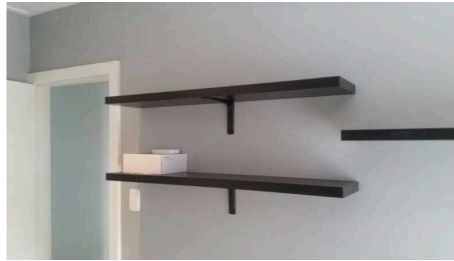
Ref # 7.11

7.11	Other	3 floating shelves part of the property

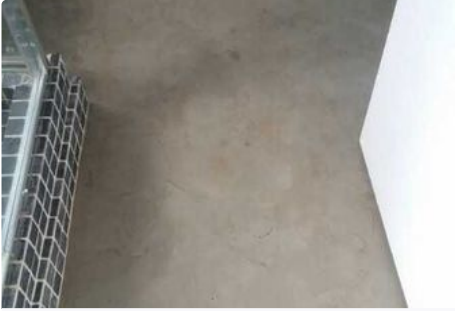
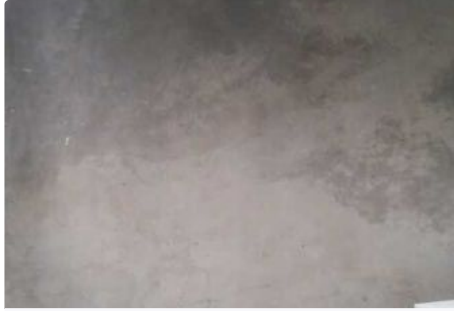
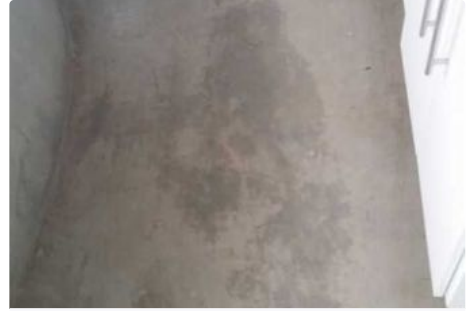
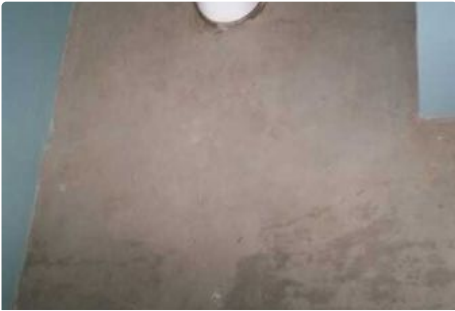
Ref	Name	Condition
8.1	Floor/Carpets/ Tiles	Floor covering is concrete in good condition with the wear and tear
8.2	Doors/ Frames/Handles/ Locks	Door in good condition can open and close properly and lock, two hooks at the back of the door further no visible damages or any holes

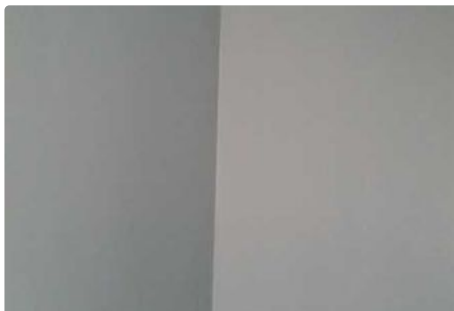
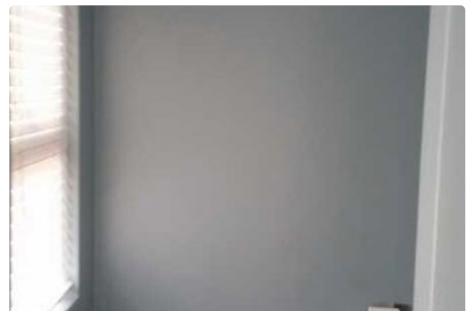
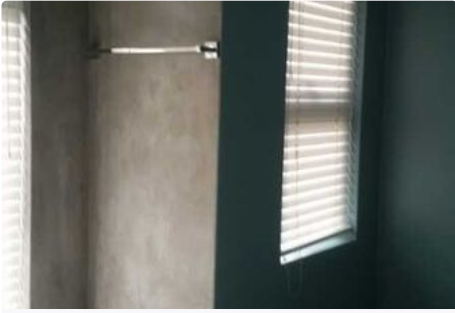
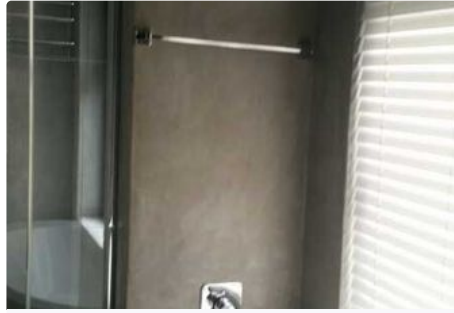
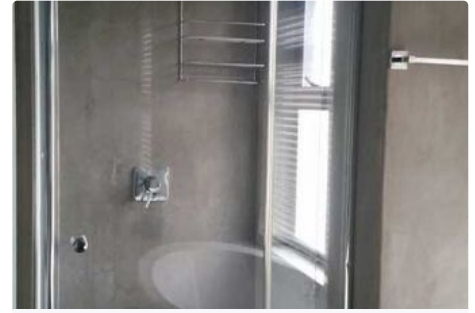
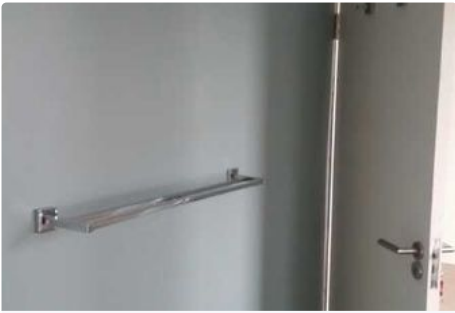
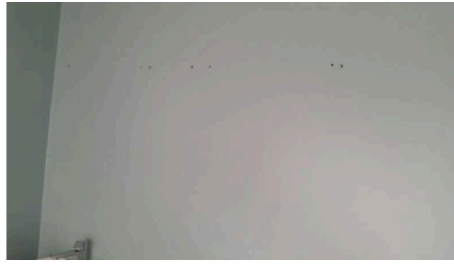
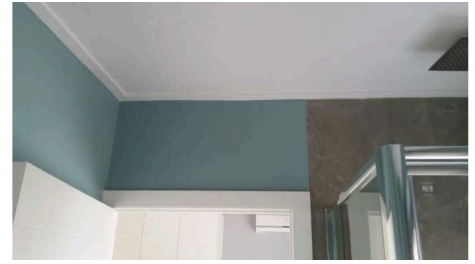
8.3	Walls	Eight hilties in the wall where the previous Mirror was further on in good condition
8.4	Light Switches	Light switch in working condition with cover intact

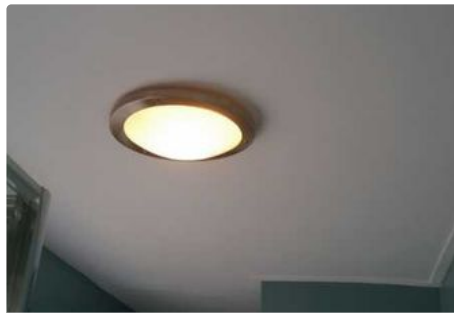
Ref # 8.5

8.5	Light fittings	Light in working condition with shade intact and no visible breakages
8.6	Windows/ Frames/Handles	Can open and close properly with no cracked Windows or any visible damages

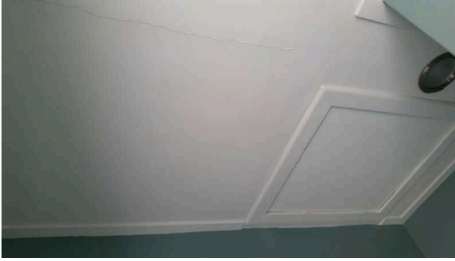
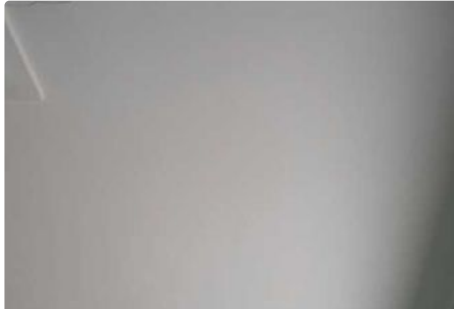
8.7	Ceiling	Ceiling in Fair good condition with no holes or marks but a visible crack between the toilet section and the bath section
8.8	Curtains/ Curtain Rail/ Blinds	All Blinds in perfect condition can open and close properly without any damages

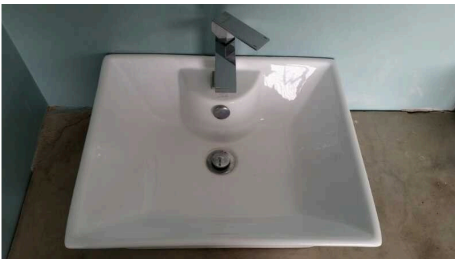
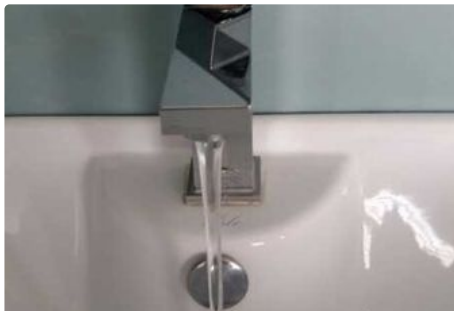
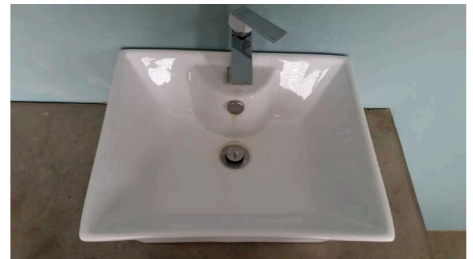
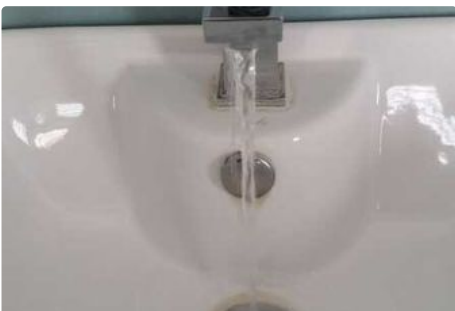
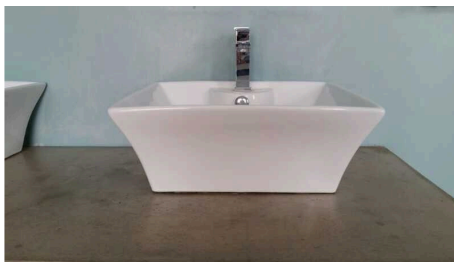
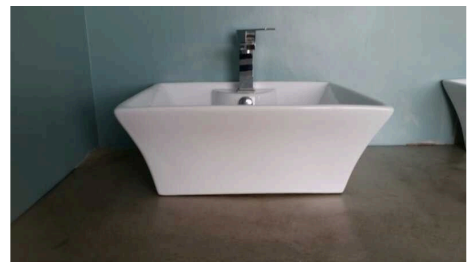
8.9	Basin/Taps	Both basis in good condition no cracks or chip marks All taps in working condition Each with pop-up plug
8.10	Toilet	Toilets in good condition as well as seat no breakages and in working order

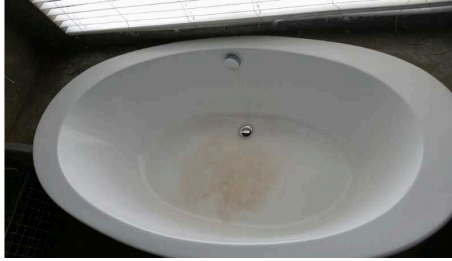
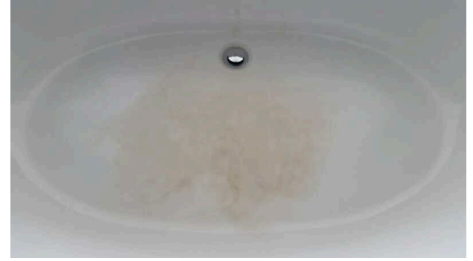
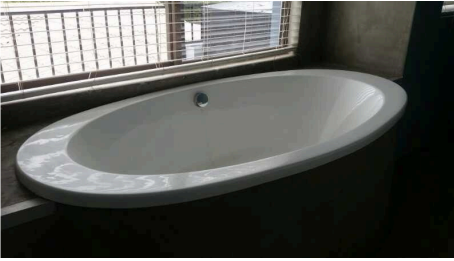
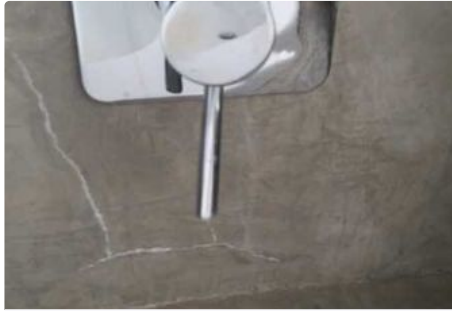
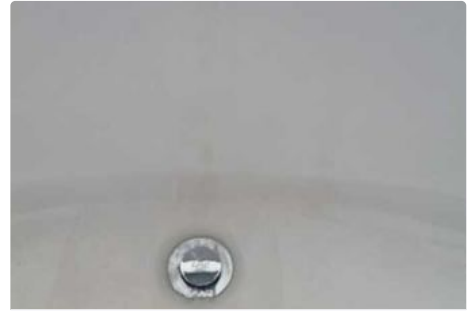
Ref # 8.11

8.11	Bath	Bath needs to be re marbled further no cracks or any Chip marks tap in working condition with 1 pop-up plug

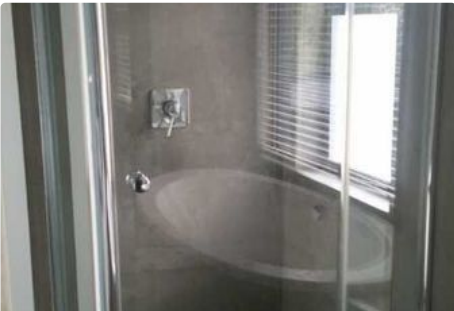
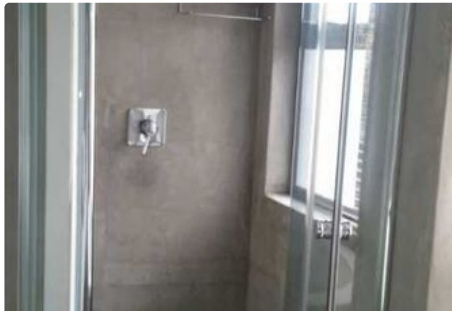
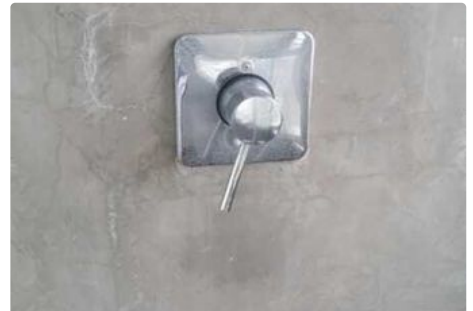
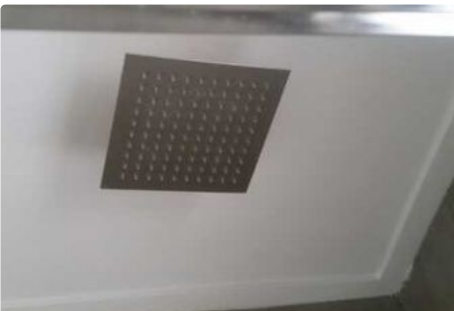
Ref # 8.12

8.12	Shower	Shower in good condition glass panels dirty from watermarks Glass panels can open and close properly without any cracks or damages Tap and shower head in working condition
8.13	Cupboards/ cabinets	Cupboards in good condition with all Handles and Hinges attached can open and close properly no visible damages
8.14	Towel Rail/ Accessories	Please see attached photos

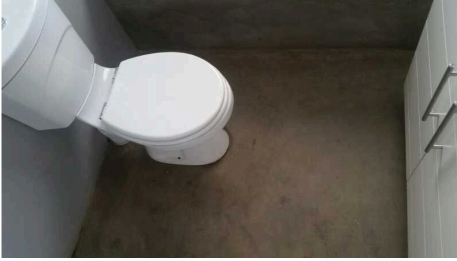
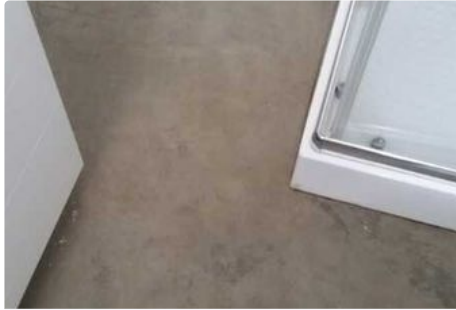
Ref # 9.1

Ref	Name	Condition
9.1	Floor/Carpets/ Tiles	Floor covering is concrete in good condition
9.2	Doors/ Frames/Handles/ Locks	Door in good condition can open and close properly and lock it behind the door to hold has been closed and visible No for the holes or any damages

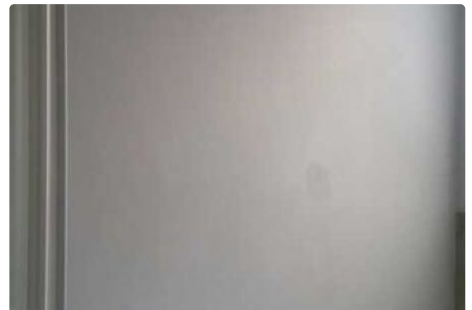
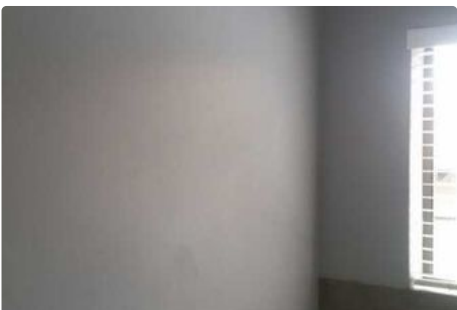
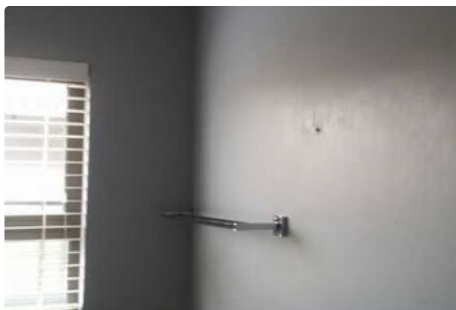
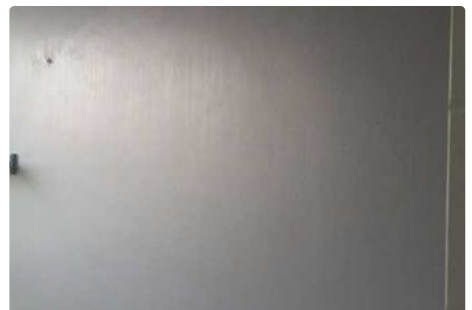
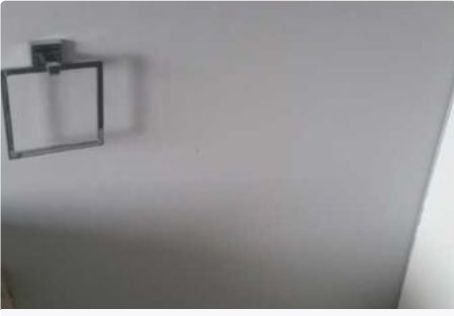
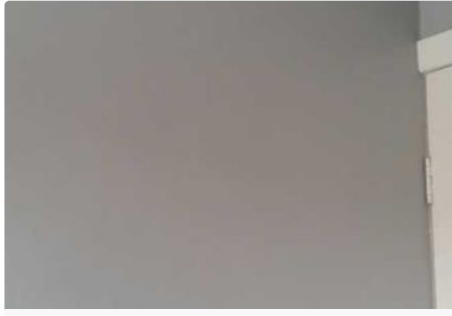
Ref # 9.3

9.3	Walls	Two hilties against the wall where the previous mirror was further in good condition with normal wear and tear
9.4	Light Switches	Light switch in working condition with cover intact

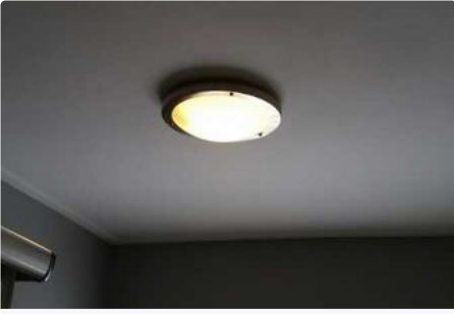
Ref # 9.5

9.5	Light fittings	Light fitting in good condition with shade intact, no visible breakages and bulb in working order
9.6	Windows/ Frames/Handles	Window in good condition can open and close properly no cracked Windows

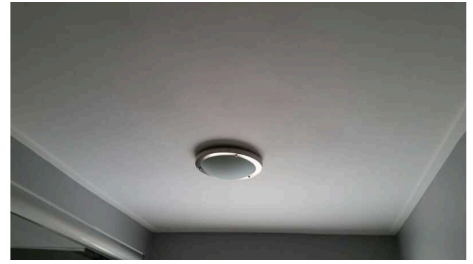
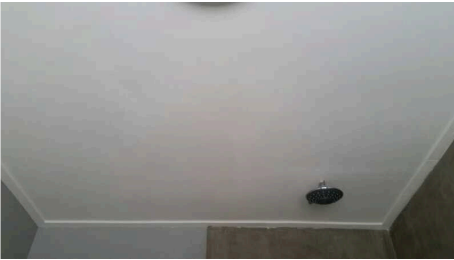
Ref # 9.7

9.7	Ceiling	Ceiling also in good condition no visible damages or any holes
9.8	Curtains/ Curtain Rail/ Blinds	All Blinds in good condition can open and close properly with no breakages

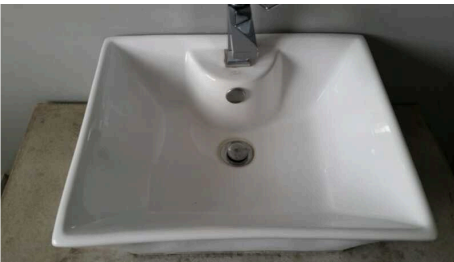
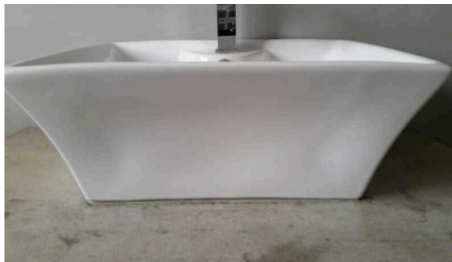
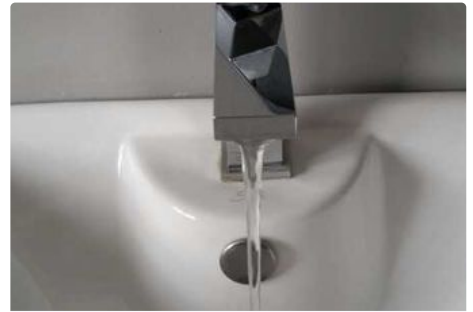
Ref # 9.9

9.9	Basin/Taps	Basin in good condition no cracks or chip marks with 1 pop-up plug and tap in working order
9.10	Toilet	Toilet in good condition as well as the toilet seat flush function working perfectly No breakages

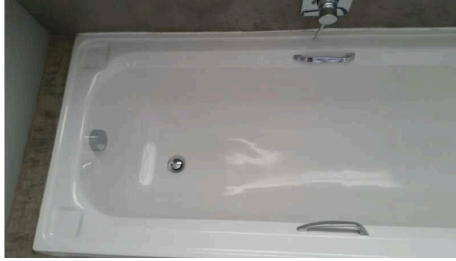
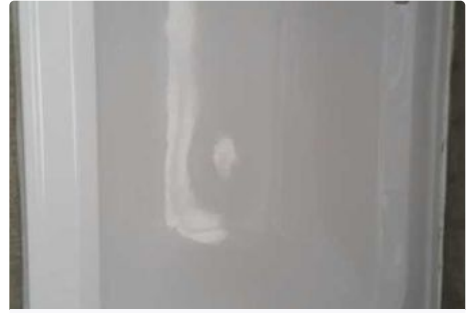
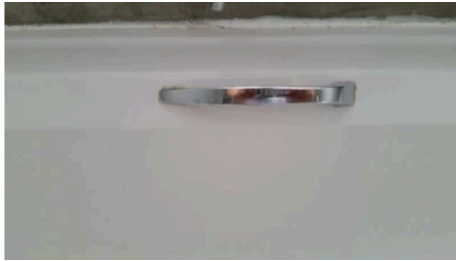
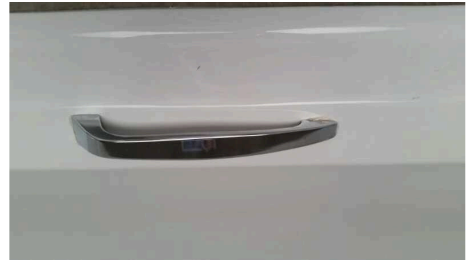
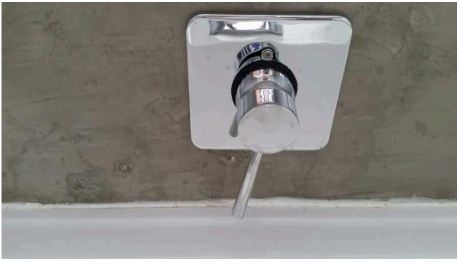
Ref # 9.11

9.11	Bath	Bath in fair good condition. 1 stain inside the box near the plug. Tap in working condition. no further damages to report

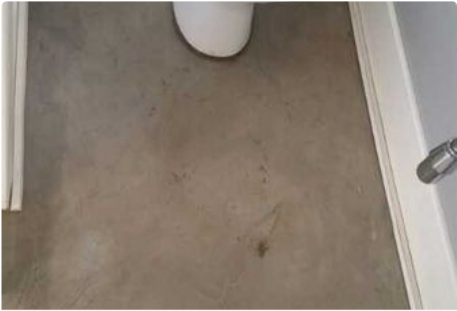
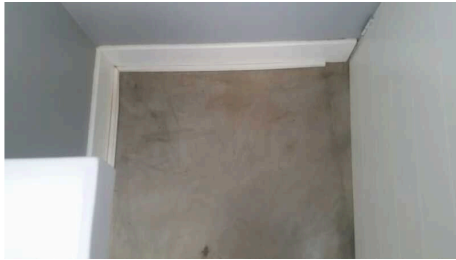
Ref # 10.1

Ref	Name	Condition
10.1	Floor/ Carpets/Tiles	Floors in good condition
10.2	Doors/ Frames/Handles/ Locks	Door in good condition can open and close properly with one key and can lock comfortably No holes or damages to the door
10.3	Walls	Walls in good condition without any holes or any damages to report
10.4	Light Switches	Light switch in working condition with cover intact
10.5	Light fittings	Light in working condition with globe working shade intact without any breakages
10.6	Windows/ Frames/Handles	Window can open and close properly without any damages or cracked Windows
10.7	Ceiling	Ceiling in good condition without any damages or holes
10.8	Basin/Taps	Basin in good condition working and basin without any cracks or chip marks 1 pop-up plug
