Move In Inspection

Property inspected by Property Inspect

1 Sample Street
Irvine
California
92614

February
28th 2017

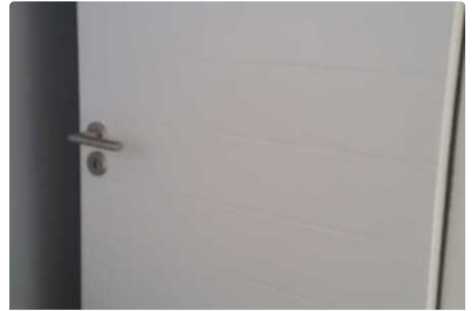
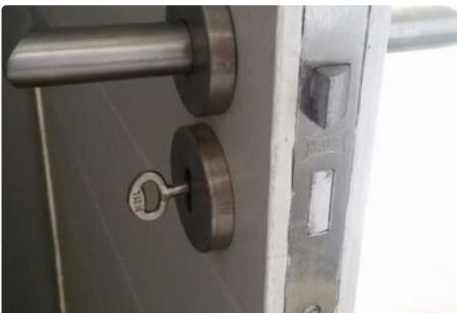
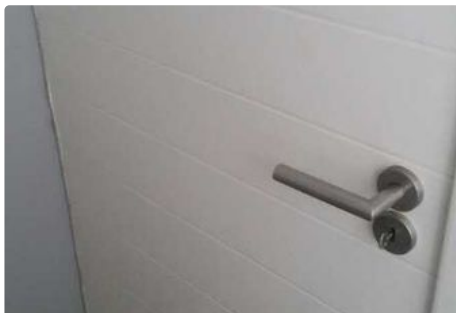
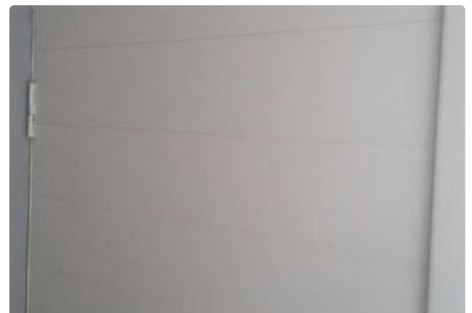
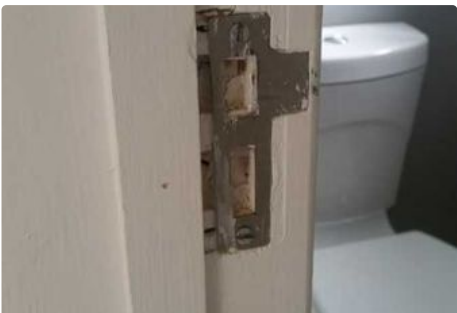
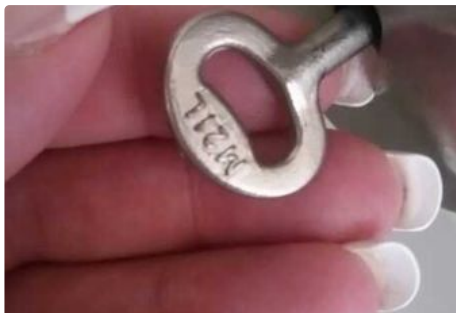
Ref # 10.2

Ref	Name	Condition
10.1	Floor/ Carpets/Tiles	Floors in good condition
10.2	Doors/ Frames/Handles/ Locks	Door in good condition can open and close properly with one key and can lock comfortably No holes or damages to the door
10.3	Walls	Walls in good condition without any holes or any damages to report
10.4	Light Switches	Light switch in working condition with cover intact
10.5	Light fittings	Light in working condition with globe working shade intact without any breakages
10.6	Windows/ Frames/Handles	Window can open and close properly without any damages or cracked Windows
10.7	Ceiling	Ceiling in good condition without any damages or holes
10.8	Basin/Taps	Basin in good condition working and basin without any cracks or chip marks 1 pop-up plug

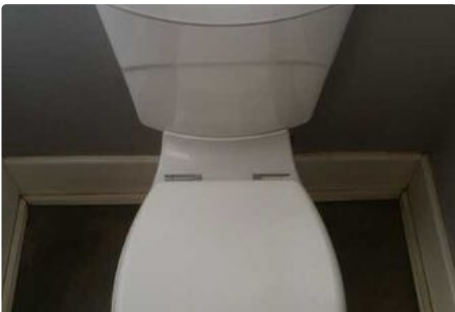
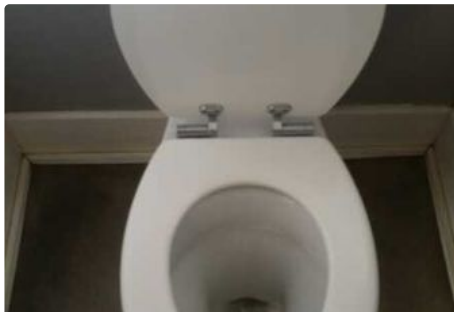
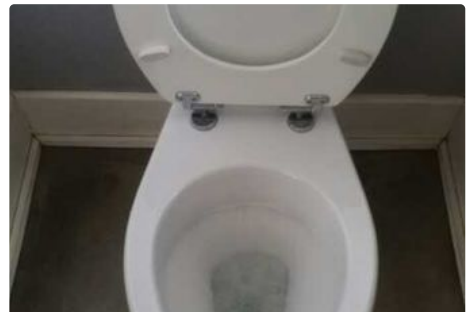
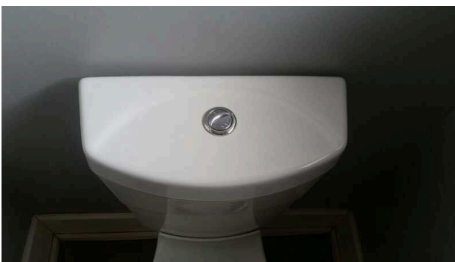
Ref # 10.9

10.9	Toilet	Toilet in working condition with seat intact no damages to report
10.10	Towel Rail/ Accessories	See photos attached

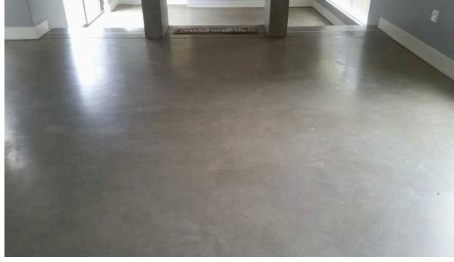
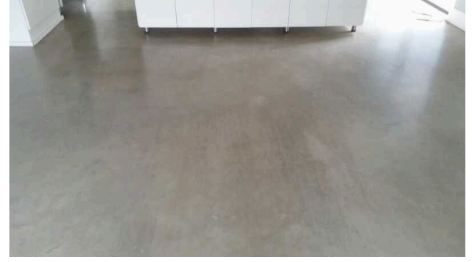
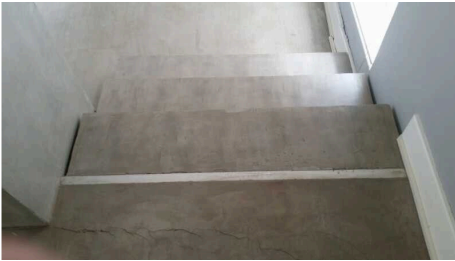
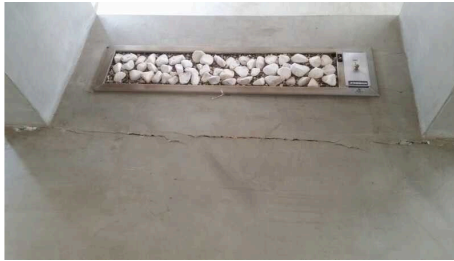
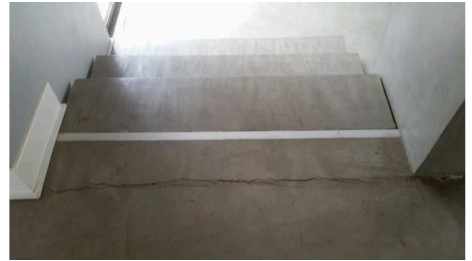
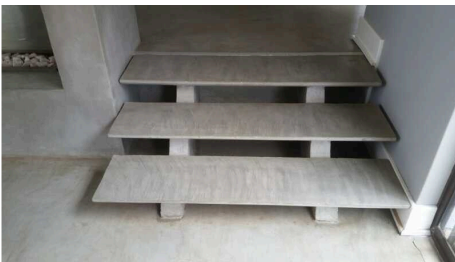
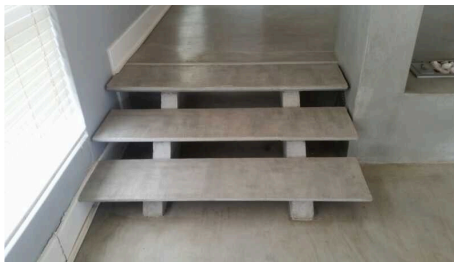
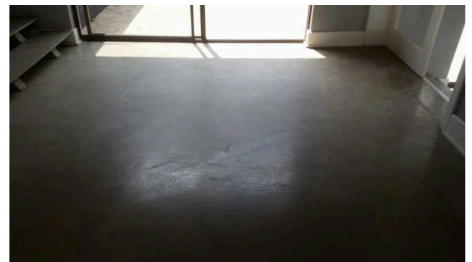
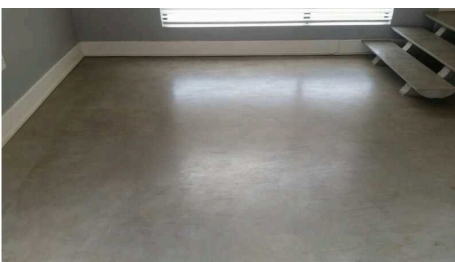
Ref # 11.1

Ref	Name	Condition
11.1	Floor/ Carpets/Tiles	Floor in Fair good condition with cracks visible on the edges Construction flaw
11.2	Doors/ Frames/Handles/ Locks	Sliding Doors can open and close comfortably with no Cracked Glass Door leading to the braai in good condition without any holes although a little bit of chip marks around the lock. 2 keys without codes and can open and close properly and lock

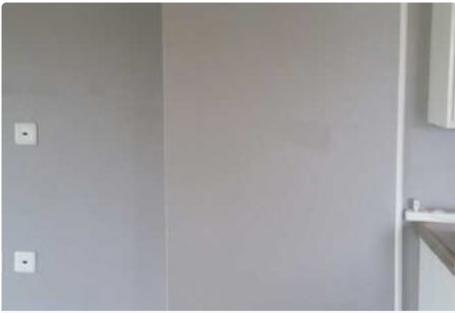
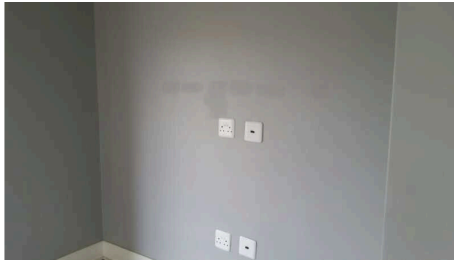
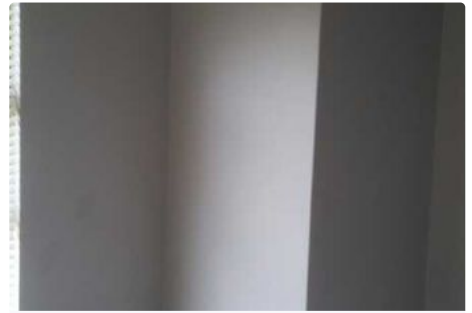
Ref # 11.3

11.3	Walls	Walls have been badly painted with closed holes standing out. Only holes painted and not the entire wall Stickers in good condition and forms part of the property

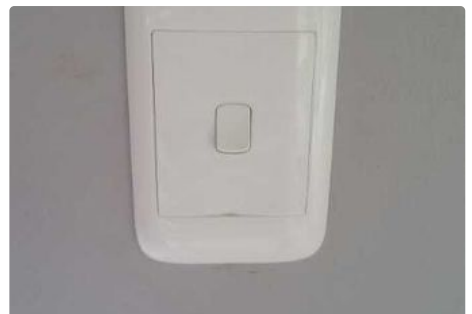
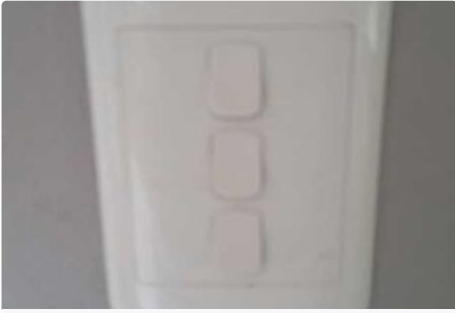
11.4	Light Switches	Light switches in working condition with covers intact
11.5	Light fittings	Light fittings in working condition with all globes working No damages to report

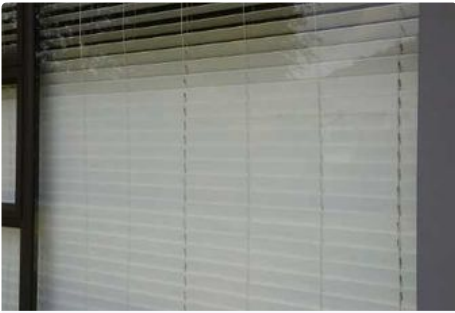
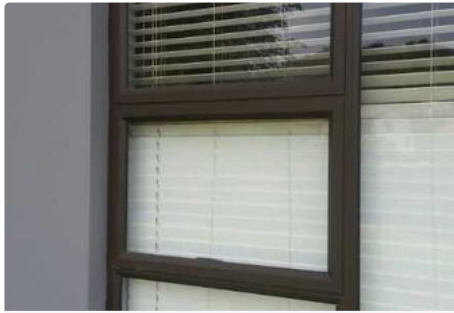
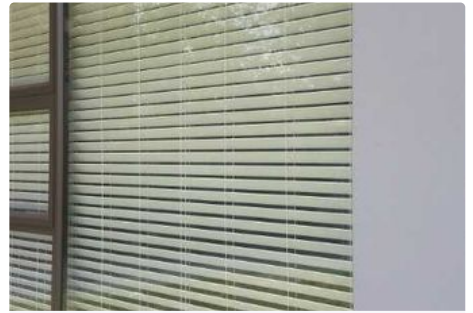
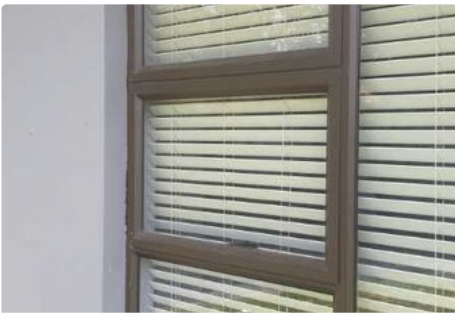
11.6	Windows/ Frames/Handles	All windows can open and close properly and no Cracked Glass
11.7	Ceiling	Ceiling in good condition without any visible damages to report

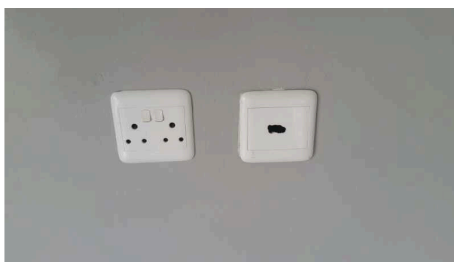
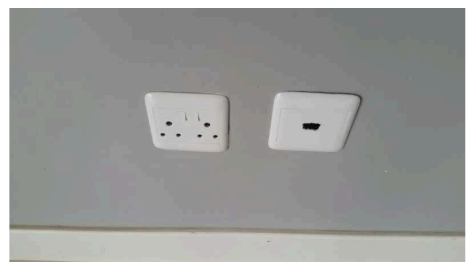
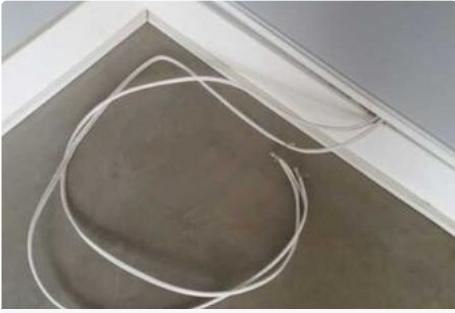
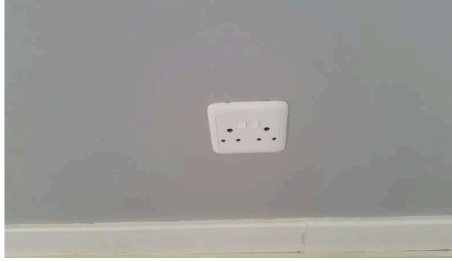
11.8	Plugs	1 point of the plug broken further all plugs in working condition and covers intact
11.9	Curtains/ Curtain Rail/ Blinds	All Blinds in working condition can open and close properly

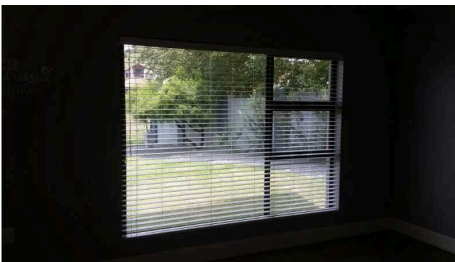
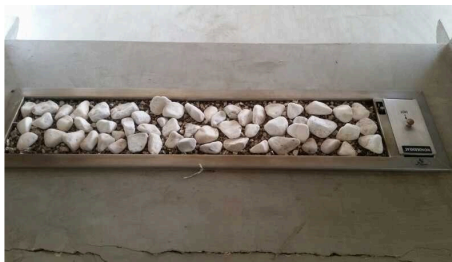
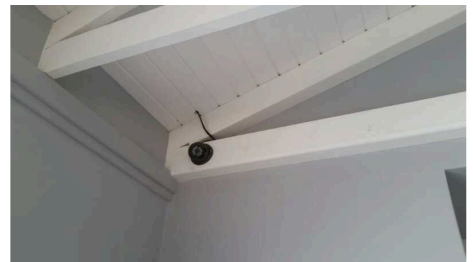
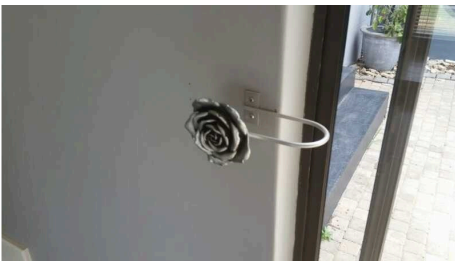
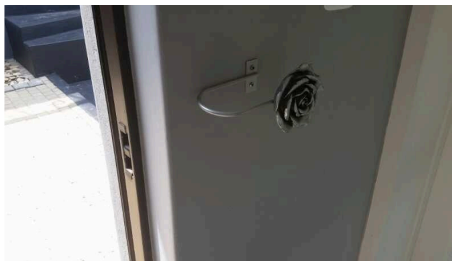
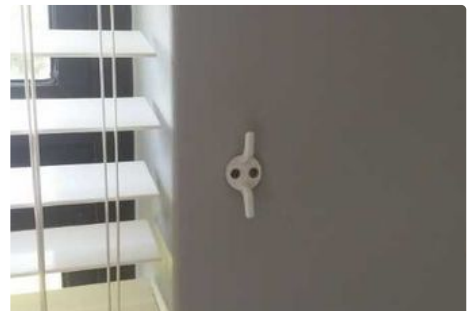
11.10	Other	Fireplace in working condition Nanny cam installed and in working condition Tie backs for the curtains forms part of the property Tiebacks for the blinds also forms part of the property See photo of wall sticker

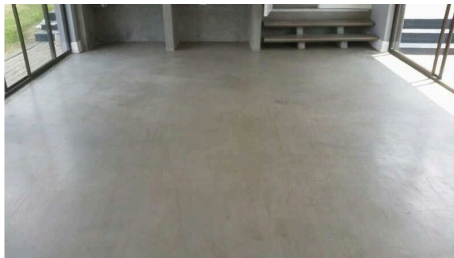
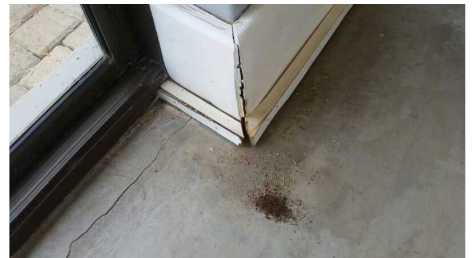
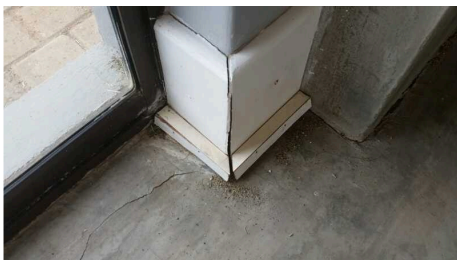
12. UTILITY ROOM		
Ref	Name	Condition
12.1	Floor/ Carpets/Tiles	Cement floor in fair good condition with visible cracks around the edges and at the doors. Foundation problems

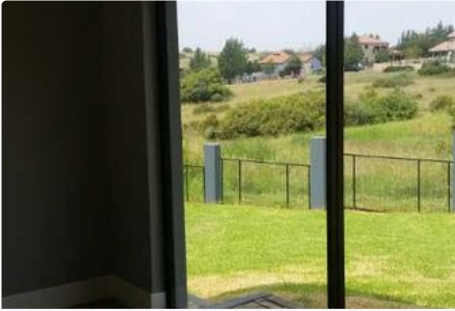
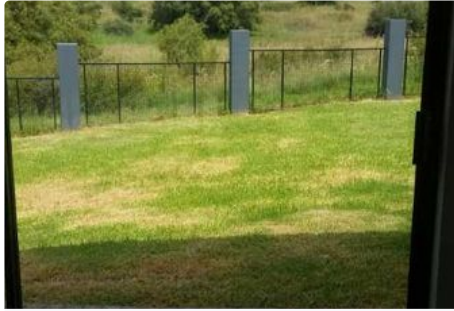
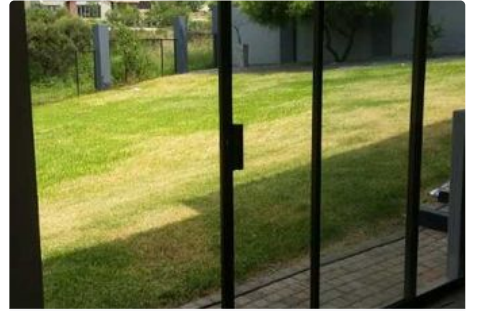
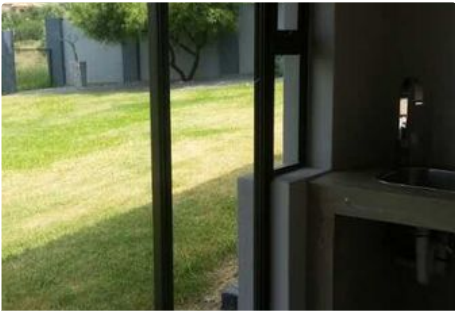
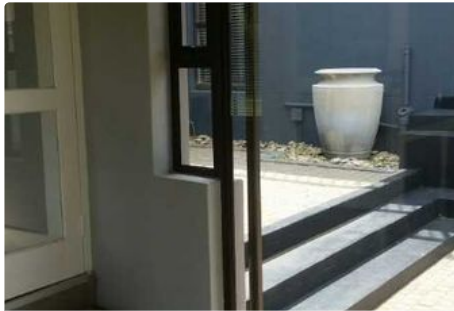
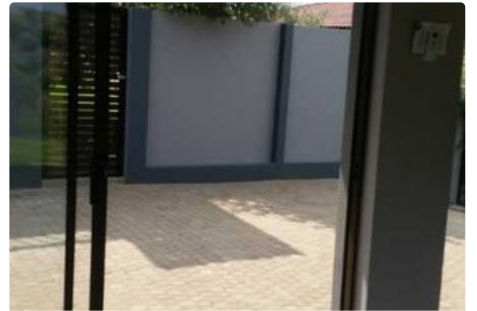
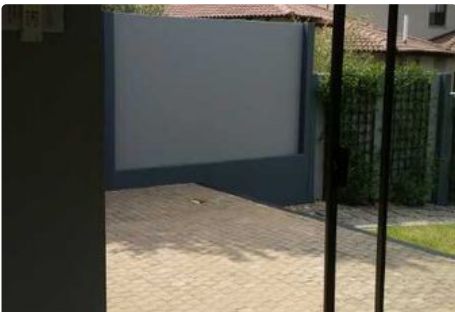
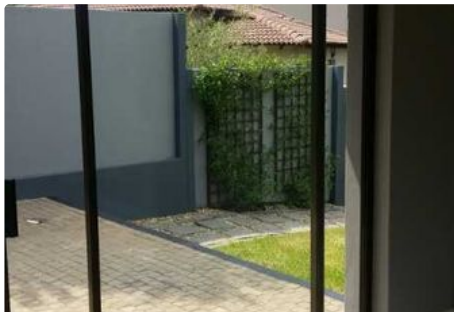
Ref # 12.2

12.2	Doors/ Frames/Handles/ Locks	All sliding doors can open and close properly and no Cracked Glass No damages to report
12.3	Walls	Only 1 Hilti in the Wall behind the door leading to the dining room further all walls in very good condition no damages to report

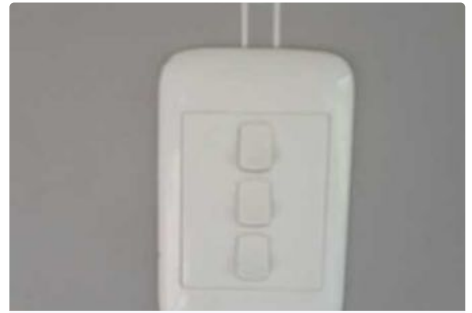
Ref # 12.4

12.4	Light Switches	Light switch in working condition with cover intact
12.5	Light fittings	Light fittings in working condition with all globes working no damages to report

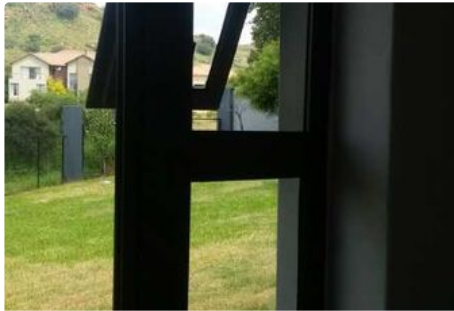
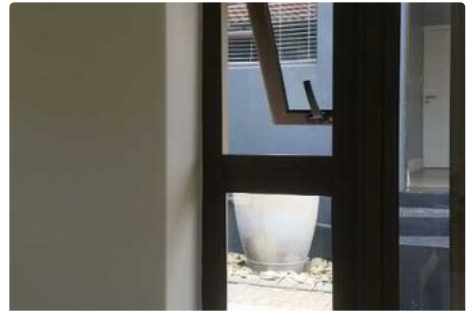
Ref # 12.6

12.6	Windows/ Frames/Handles	Only One Window which can open and close properly and no Cracked Glass
12.7	Ceiling	Ceiling in good condition without any damages to report

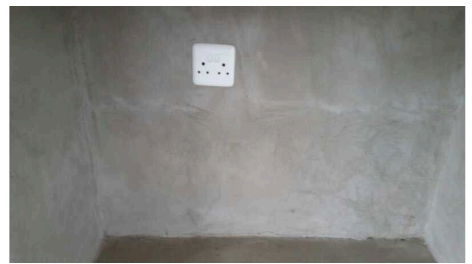
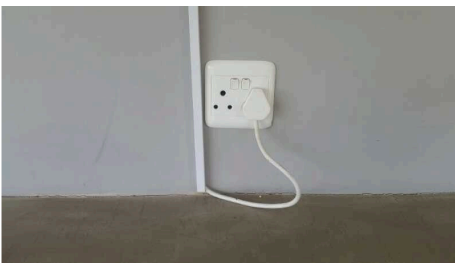
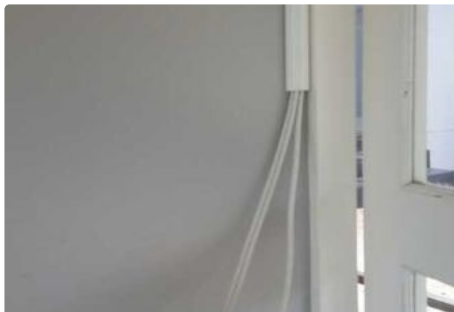
Ref # 12.8

12.8	Plugs	All plugs in working condition and cable for TV installed, forms part of the property
12.9	Curtains/ Curtain Rail/ Blinds	One single silver pipe above all of the sliding doors

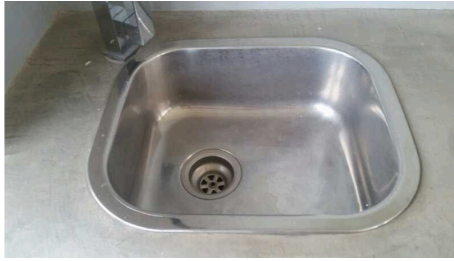
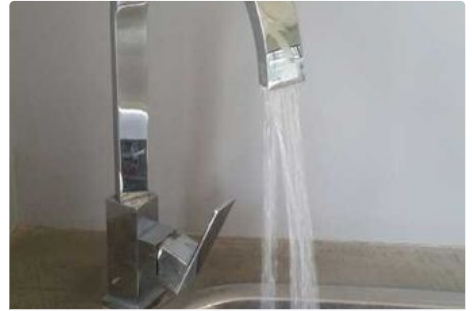
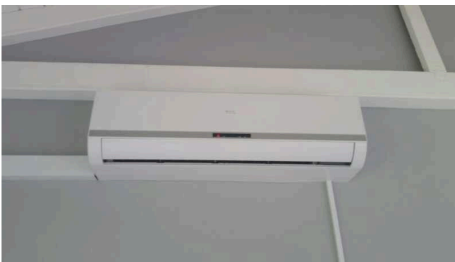
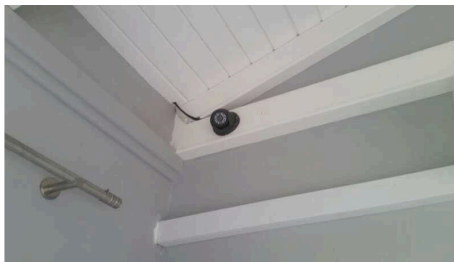
Ref # 12.10

12.10	Other	Basin in working condition without plug Nanny cam in the corner and working New aircon installed with manual and remote Braai in good condition with grit and can open and close properly no damages to report

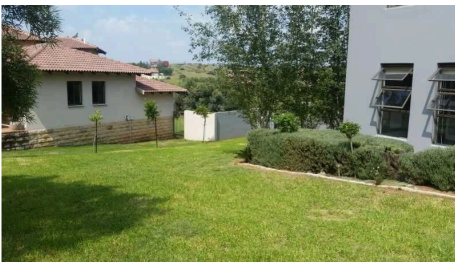
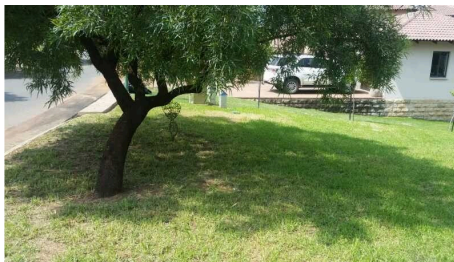
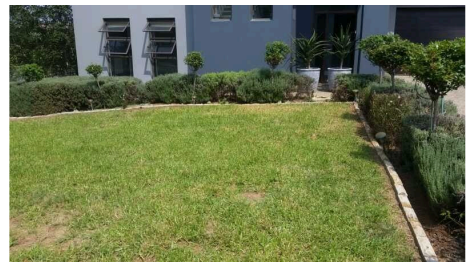
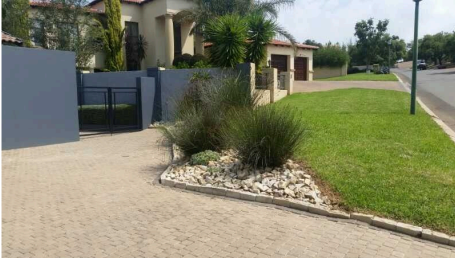
Ref	Name	Condition
14.1	Front	Well maintained and presented
14.2	Back	Well maintained

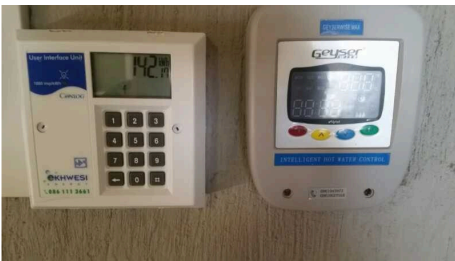
Ref # 16.1

Ref	Name	Description	Reading
16.1	Electric Meter	Electric metre in the garage Rainbird irrigation system in the garage Solar panels on the roof	88723
16.2	Water meter	Water metre and water card present at property

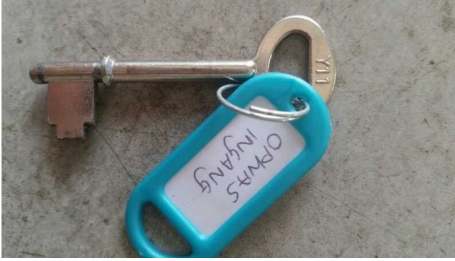
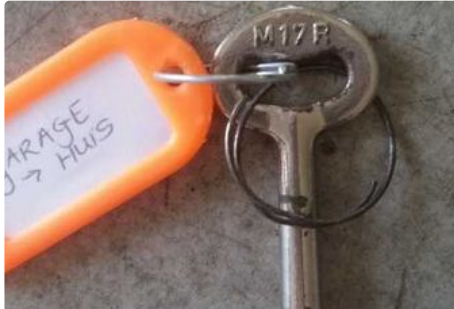
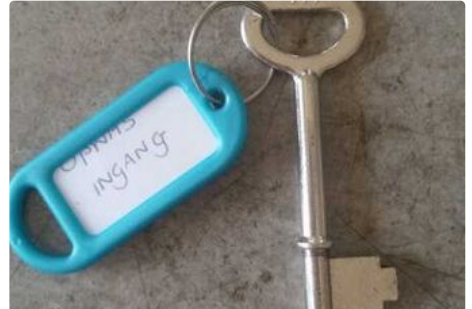
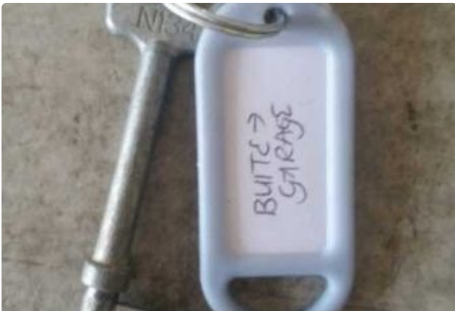
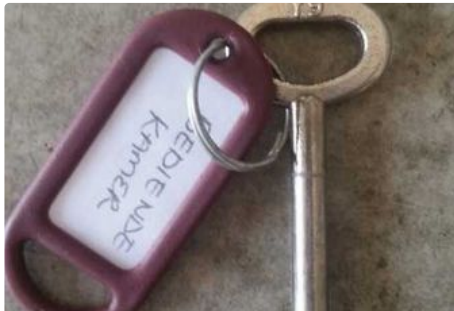
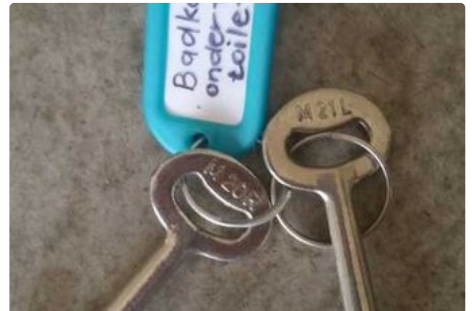
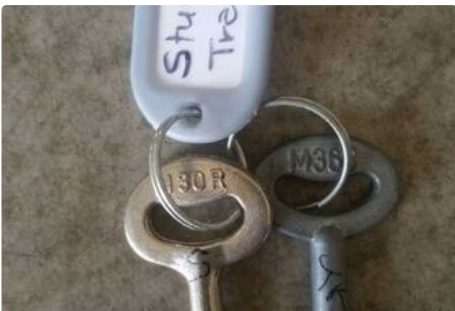
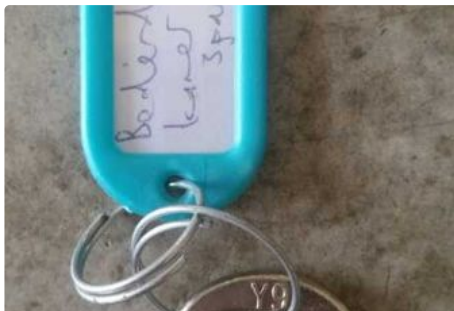
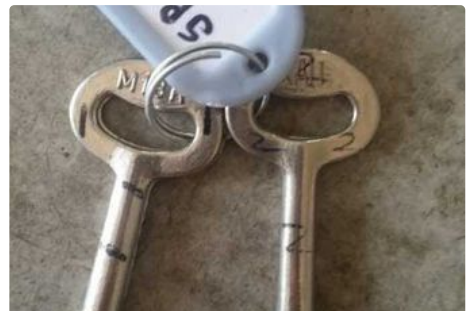
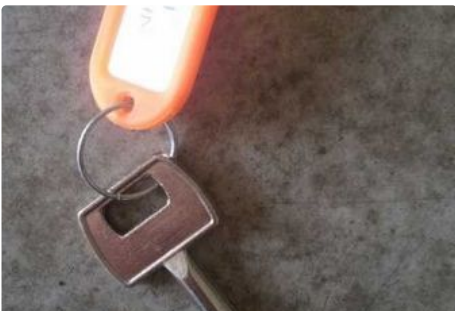
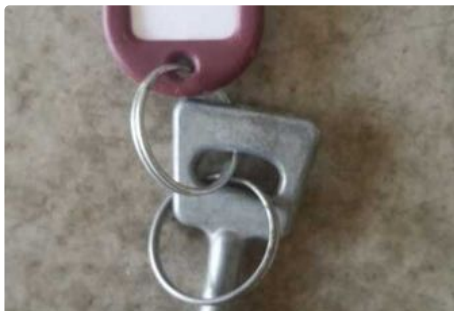
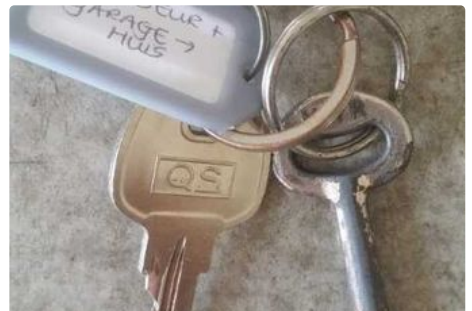
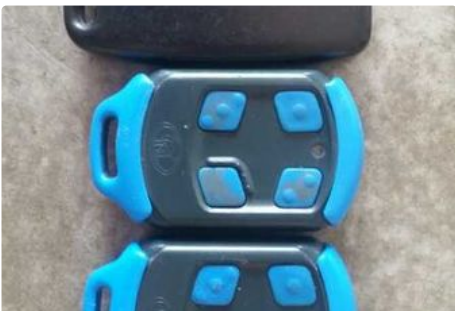
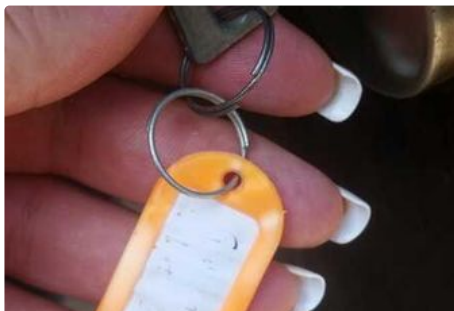
Ref #17

Ref	Name	Description
17.1	Tenant Proved at Move In	4 x front door main keys; 1 x room keys per tenant; 4 x garden and window keys
17.2	Returned at Move Out
