# Commercial Property

**ABC COMMERCIAL  
PROPERTY MANAGEMENT**

Commercial Small  
Warehouse  
Industrial Estate  
Anywhere  
PO1 1AB

**May  
14th 2021**

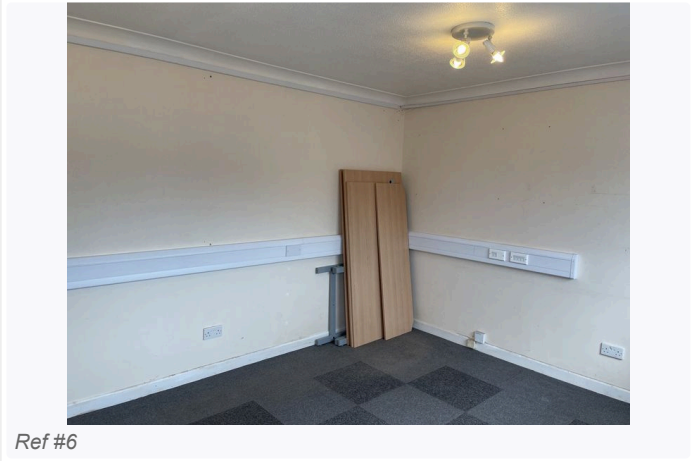
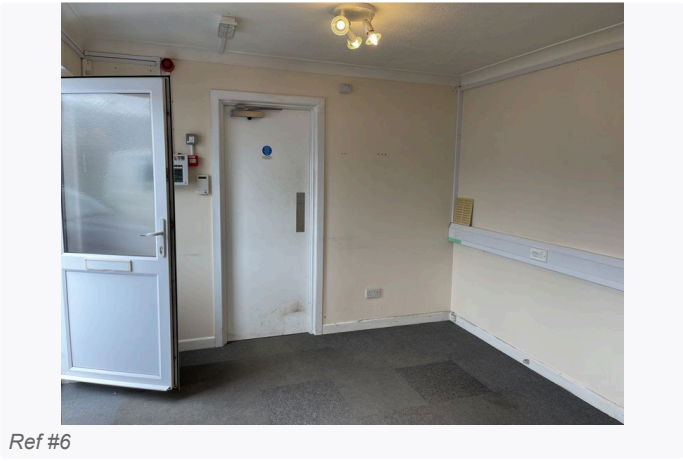
**6. RECEPTION**

6. RECEPTION (CONT.)			
Ref	Name	Description	Condition
6.1	Safety / Security	LPCB Fire alarm panel Wall mounted sensor Red emergency call point Red alarm sounder Carbon monoxide alarm  Emergency exit sign 2 x wall mounted brackets	Not tested Not tested Not tested Not tested Not tested

6.2	Pest Control	Pest control trap (1)	
6.3	Door	White UPVC Sensor plate	Minor damage to plate and handle; light marks and wear Not tested
6.4	Door Frame	White UPVC	Marks to lower aspects Cracking to frame surround

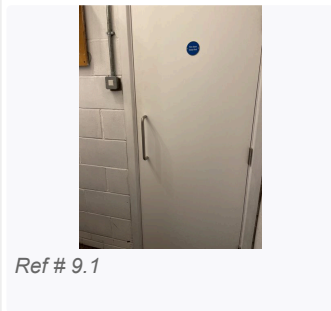
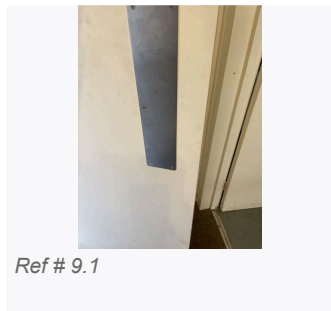
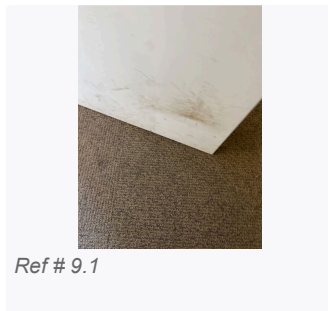
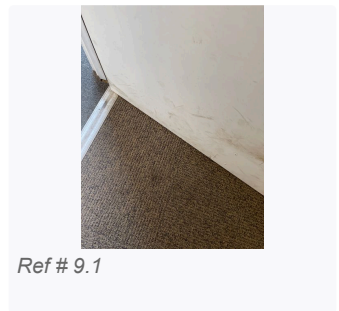
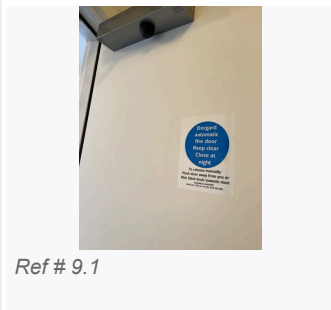
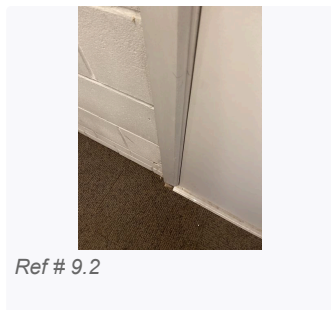
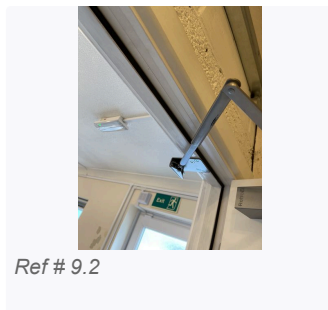
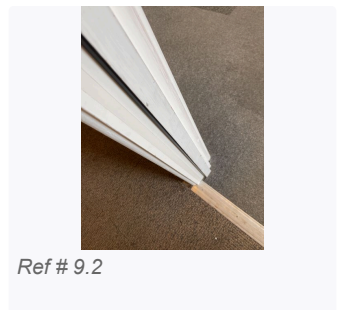
Ref	Name	Description	Condition
9.1	Door to Stairs / Reception	Painted white; fire door Metal pull handle; strike plate Self closer	Sticker Minor marks and defects
9.2	Door Frame	Painted white; fire safety strip	Minor marks and defects

9. STAIRS (CONT.)			
9.3	Ceiling	Painted white	Removal holes Minor marks and defects
9.4	Lighting	3 x Emergency lighting bulkheads 1 x circular plate; 3 x spotlights, bulbs 1 x spotlight, bulb	Not tested Working Working
9.5	Walls	Painted white; partial textures and breeze block  Fuse board; associated cabling Electric meter; associated cabling	Minor marks and defects  Not tested Not tested
9.6	Skirting	Painted white	Minor marks and defects
9.7	Switches	1 x Metal double light switch 1 x fused switch	Working Not tested
9.8	Socket	White plastic Wall mounted unit	Not tested
9.9	Heating	Not present	
9.10	Staircase	Painted dark grey wood - not carpeted Wall mounted handrail; to left wall	Visible wear to centre of treads Chipped to top of stairs- not extensive  Minor marks and defects
9.11	Flooring	Brown/black textured carpet tiles	Minor spots / stains

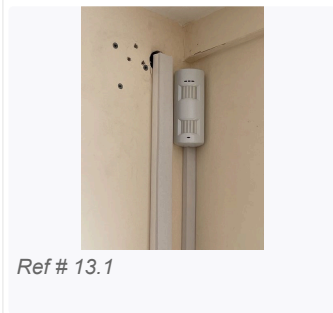
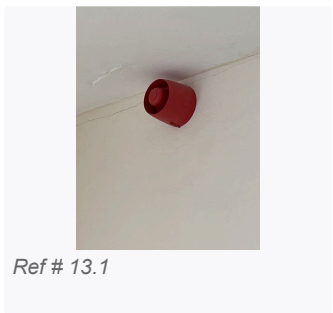
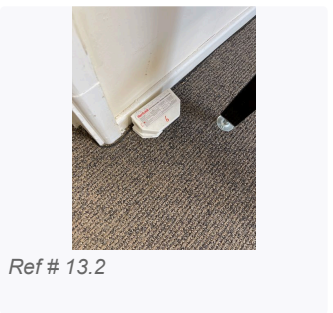
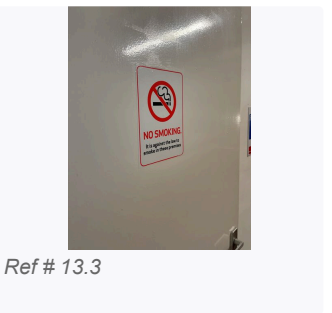
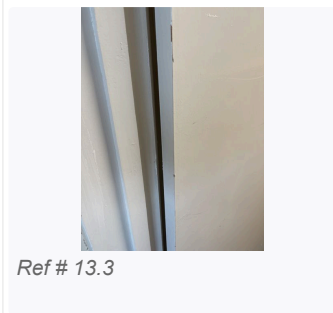
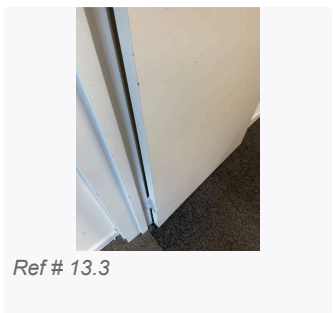
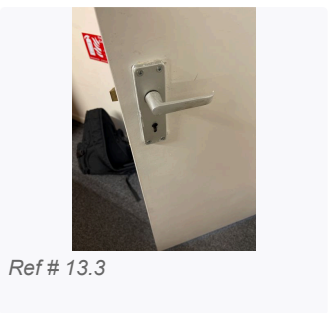
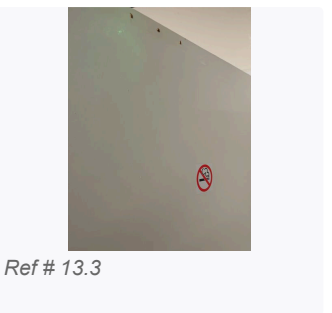
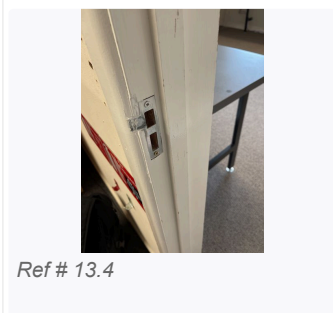
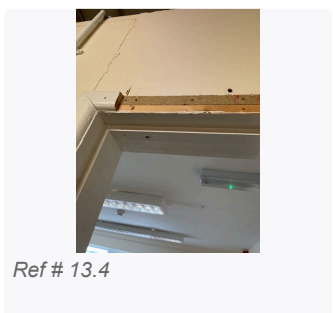
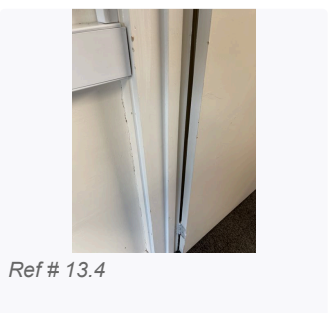
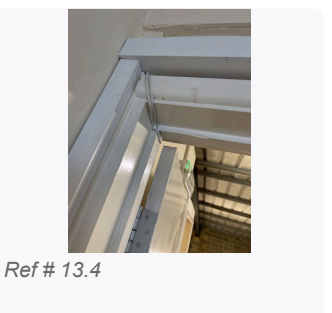
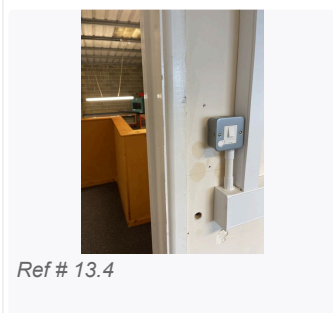
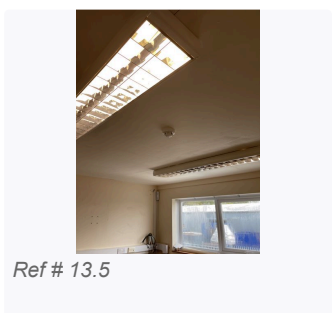
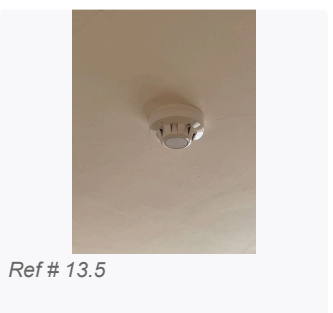
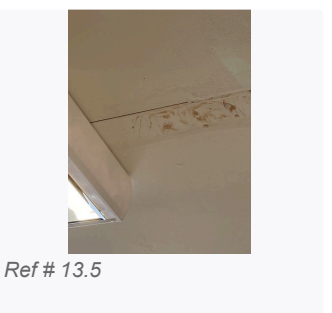
Ref	Name	Description	Condition
13.1	Security / Safety	Wall mounted sensor Red alarm sounder	Not tested Not tested
13.2	Pest Control	Pest control trap	
13.3	Door	Painted white; metal lever handles, lock, no key No Smoking stickers	Minor marks and defects

13.4	Door Frame	Painted white	External: missing section to top left Internal: cabling to top left  Minor marks and defects
13.5	Ceiling	Painted white Integrated smoke detector	Removal marks / holes to right as you enter

13.6	Lighting	2 x Louvered florescent light units	Working
13.7	Walls	Painted Magnolia Conduit Grey speckled worktops metal supports Wall mounted metal data point cabinet; glass panel, lock with keys present Wall mounted grey metal cabinet; lock, 3 x keys - empty Honeywell data point cabinet - not accessed; associated cabling	Removal holes and large holes to entrance left; far left corner to sensor Some wires visible to back wall right of window Visible scratches to worktops  Minor marks and defects

13.8	Skirting	Painted white	Minor marks and defects
13.9	Window(s) / Sill	White UPVC; lever handle, lock, no key Stained wood sill	Condensation to both glass panels

13.10	Blinds	Brackets to top recess White paper blind	Not fitted
13.11	Switches	Metal Single fused switch White plastic 3 x fused switches	Not tested Not tested

13. TOP OFFICE (CONT.)			
13.12	Sockets	White plastic 16 x double sockets 10 x RJ45 network/data points 2 x open boxes - no plates 2 x Openreach points 2 x Opnereach telephone points	Not tested Not tested Not tested Not tested Not tested
13.13	Heating	None present	
13.14	Flooring	Grey flecked carpet tiles	Section missing to main back wall left under worktop Minor spots marks in places
