RICS Home Survey Level 2 + Valuation

HOME SURVEY TEST - Level 2 +
Valuation, Portsmouth, Hampshire,
PO1 1JJ

JP Chartered Surveyors

June 18th 2021

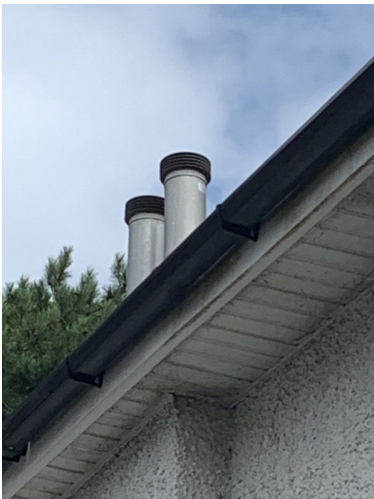
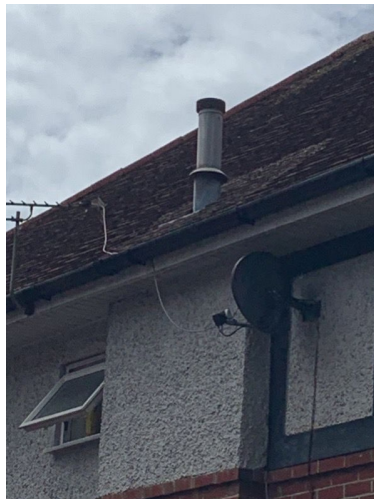
All chimneys have been removed down to ceiling level and replaced with flue terminals.
1 x flue situated to front of property. 2 x flues situated to rear of property. Sky satellite dish and T.V aerial located to left side of property.

The metal flues are in a satisfactory condition. No repairs are currently needed. Metal flues, fillets and flashings although they could not be seen from ground level they are very exposed and should be regularly inspected and maintained in good condition.

Condition Rating - 1

Your legal adviser should check that local authority approvals have been obtained, if necessary, for the stacks which have been removed.

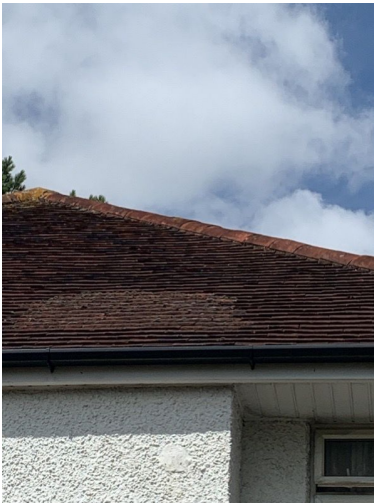
Pitched roof

The roof has a covering of clay tiles. Generally they are in good condition for their age with some small areas of lichen. (Lichen, or lichenized fungus, is actually two organisms functioning as a single, stable unit. Lichens comprise a fungus living in a symbiotic relationship with an alga or cyanobacterium, or both in some instances). There are about 17,000 species of lichen worldwide.

Clay hip and ridge tiles. The hip tiles are slightly uneven but appear in good condition for their age.

There are 3 areas of replacement tiles where the original chimney breast have been removed or replaced with flu terminals.

Condition Rating - 1

Due to there is no evidence of damp or leaking. The hip tiles are slightly uneven but function perfectly well. The lichen can be cleaned as part of the normal maintenance of the property.

However a point to note is a normal life span of a clay tiled roof is approximately 60 years according to BRE. As the age of this property is nearly 100 years old this should be factored into future maintenance costs.

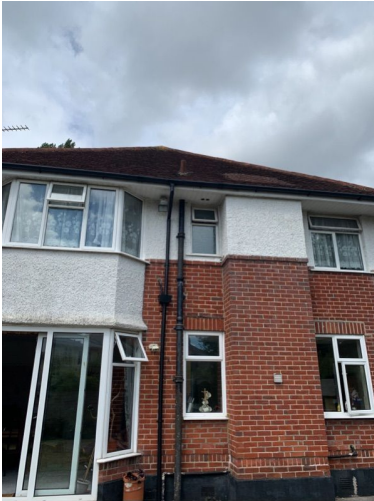
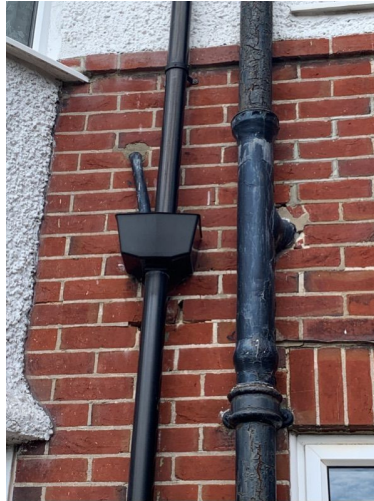
The guttering and downpipes are a black UPVC type material.

The waste water and soil pipes are of a mixture of plastic and cast iron material. The waste water leads into the soil pipe which discharges to below ground drainage. There is no caged cover over the top of the soil pipe to prevent obstructions and birds/animals blocking any ventilation. The original cast iron soil pipes although appear worn function perfectly well.

The type of trees to the front of the property have the ability to drop a larger amount of pine needles mainly around autumn time. If left unchecked these have the potential to block the guttering. I would recommend gutter covers to prevent this from occurring.

Condition Rating - 1

Due to a cage for the top of the soil pipe can be placed during normal maintenance. The gutter repair and cleaning can be completed during normal maintenance.

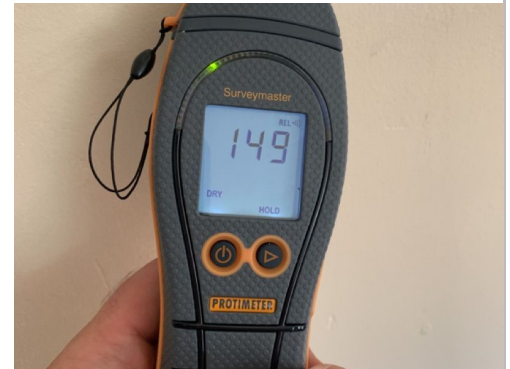
Condition Rating - 1

When replacing windows going forward ensure trickle vents are fitted to aid in ventilation and prevent any damp issues that may occur.

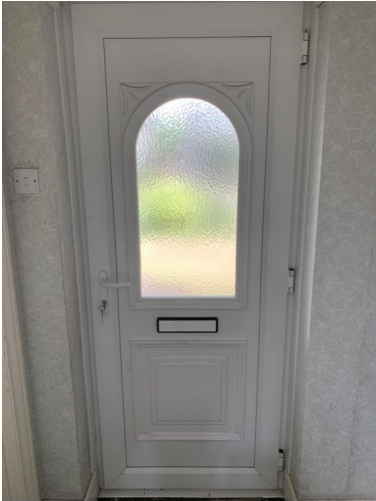
Condition Rating - 1

Since 2002, double glazing should have either Building Regulation approval or should have been installed by a contractor registered with an association such as FENSA, CERTAS or BM Trada which has been recognised by the Government under the 'Competent Person Scheme'. Your legal adviser should check this.

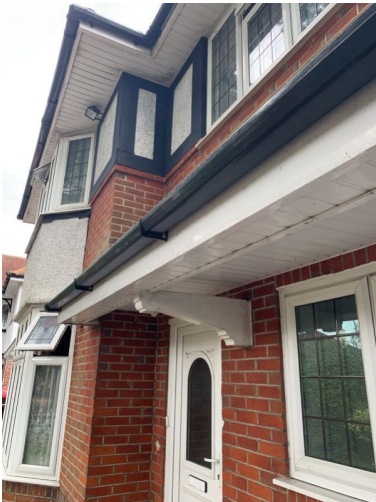
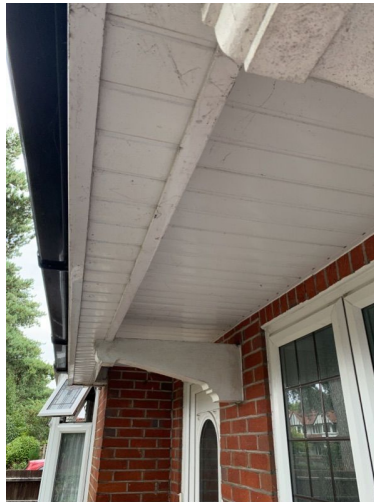
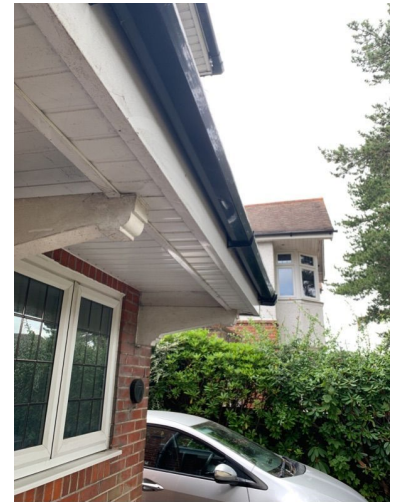
The lead flashing appears in good condition for its age.

Condition Rating - 1

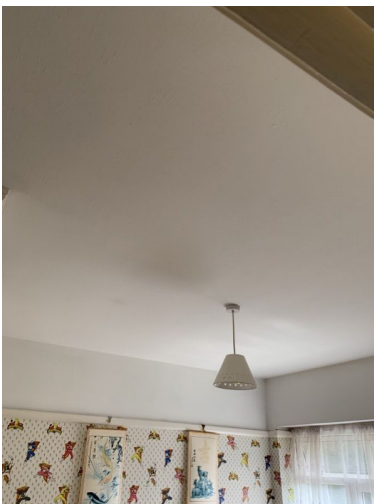
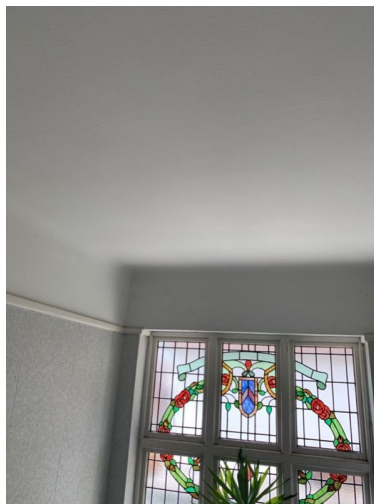
E2 Ceilings

Condition Rating - 1

Cracking in plaster often occurs due to movement of the floor above, the general ageing of the material and loss of adhesion over time and normal shrinkage of the material. The cracking is not considered serious or significant. If repaired and filled, the cracking may re-occur from time to time.

The original lath and plaster finishes are particularly susceptible to vibration and disturbance such as that experienced when carpets are fitted or new services installed. This causes the plaster to become detached from its backing and it may well be at the end of its serviceable life. Ongoing patch repairs will be necessary.

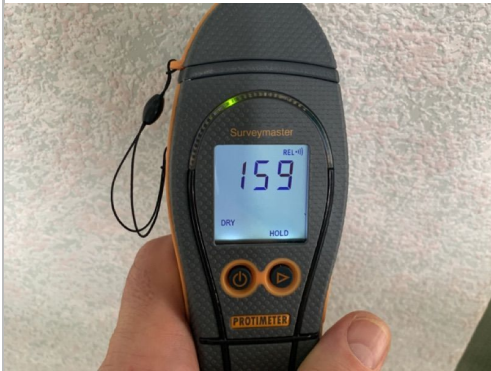
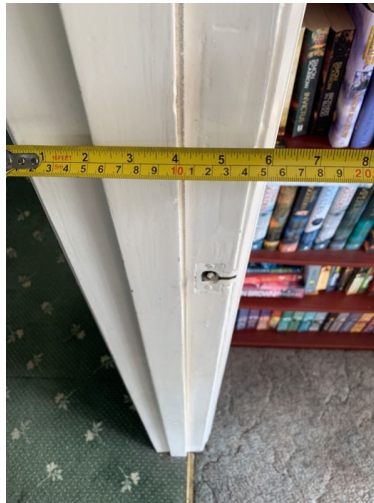
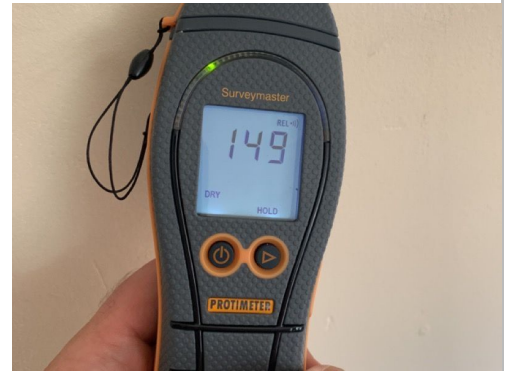
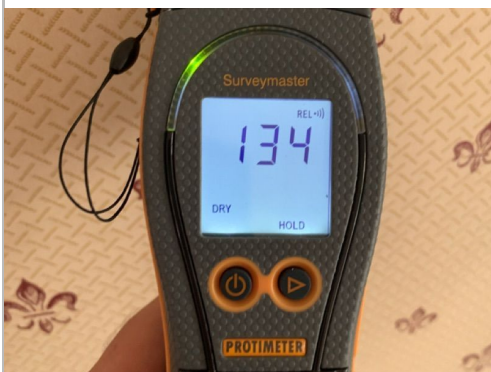
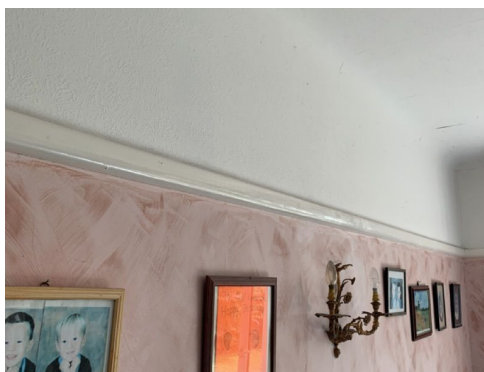
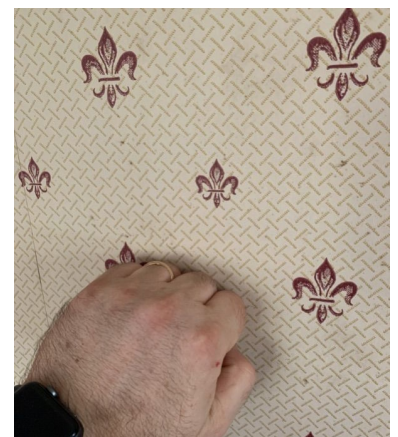
E3 Walls and Partitions

The walls and partitions are in satisfactory order but some are not true and plumb which is not unusual for a property of this age. Except for some minor cracking, the plaster finishes are also in acceptable condition. We found no evidence of significant dampness within the scope of our inspection and report. No repairs are currently needed. The walls should be checked periodically and the finishes inspected for any damp or decay. The walls and partitions are in satisfactory order. We found no evidence of significant dampness within the scope of our inspection and report. No repairs are currently needed. The walls should be checked periodically and the finishes inspected for any damp or decay.

Condition Rating - 1

Cracks in plaster often occur due to doors slamming violently, the general ageing of plaster and normal shrinkage over time. The cracking is not considered serious or significant. If the cracks are repaired and filled, they may re-occur from time to time.

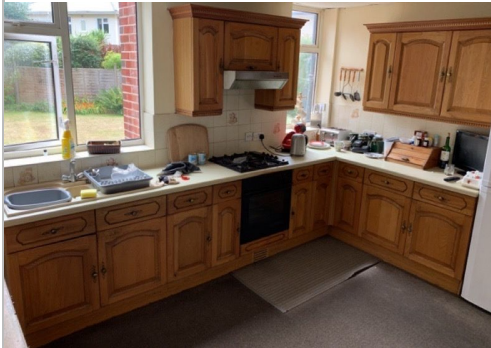
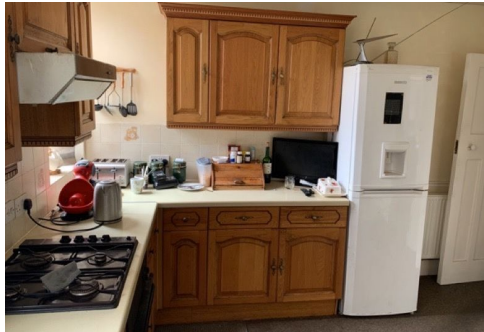
All fittings should be regularly maintained. The built-in fittings are generally in satisfactory condition. We have not carried out any tests and therefore cannot report on whether such fittings are fully functional.

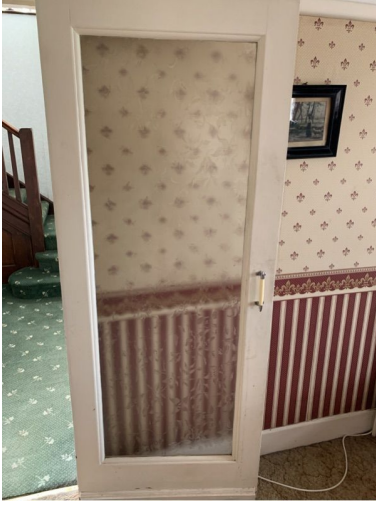
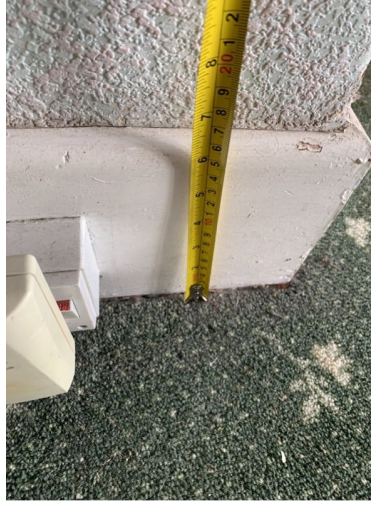
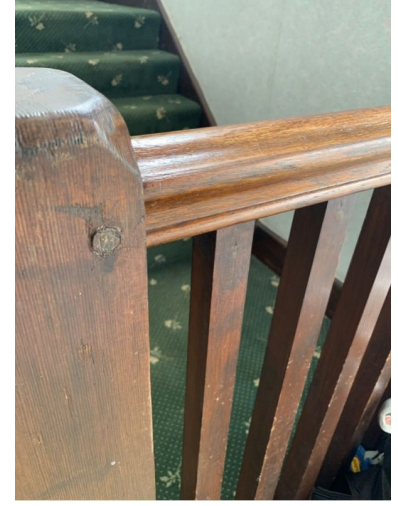
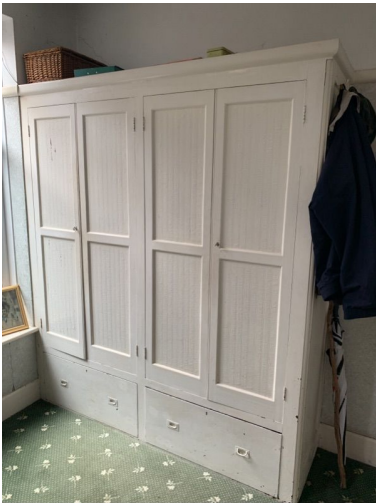
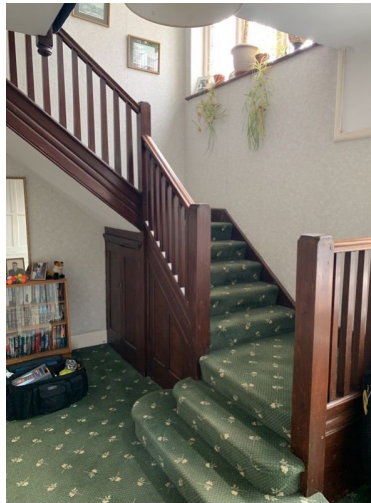
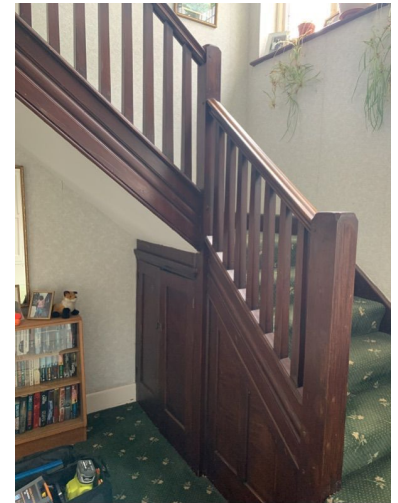
All internal doors are panelled hardwood doors painted white and appear in good condition for the age of property. There are no signs of wood boring insects.

Condition Rating - 3

This is due to the single panelled glazed doors that pose a serious risk to a person in the event of an accident or breakage.

In a property of this age and type it is possible that some of the paintwork may contain lead. Although this is a potential risk it is not sufficient to warrant urgent action to test all the decorated areas at this stage. You should instruct a reputable and experienced decorating contractor to check the paintwork after occupation.

These doors should be replaced at the earliest opportunity.

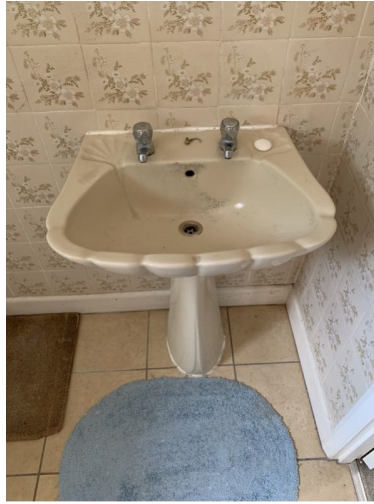
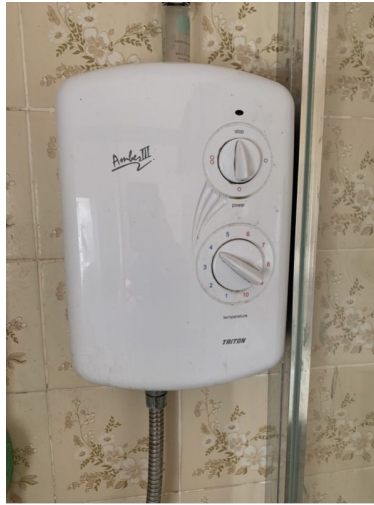
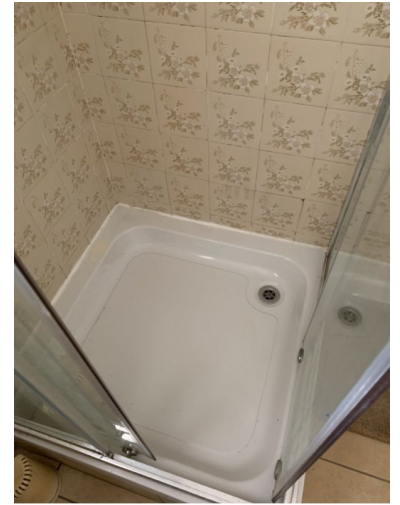
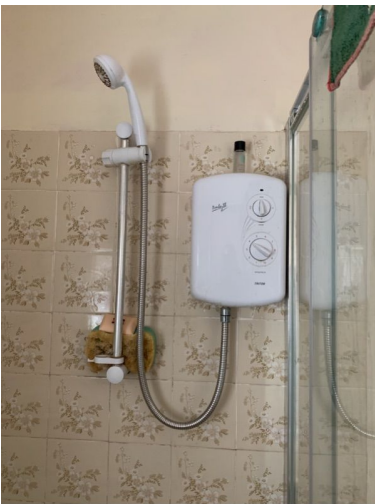
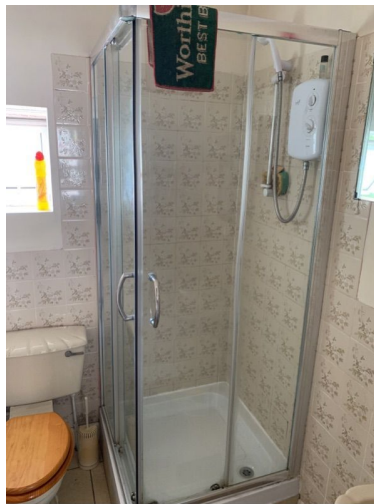
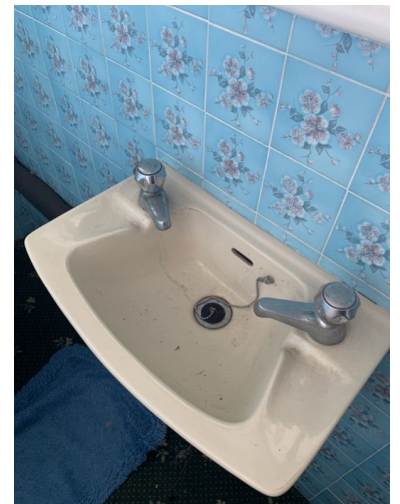
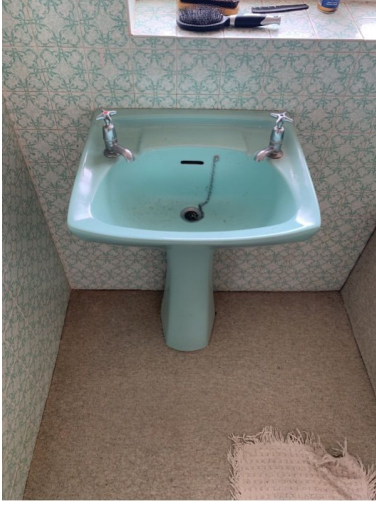
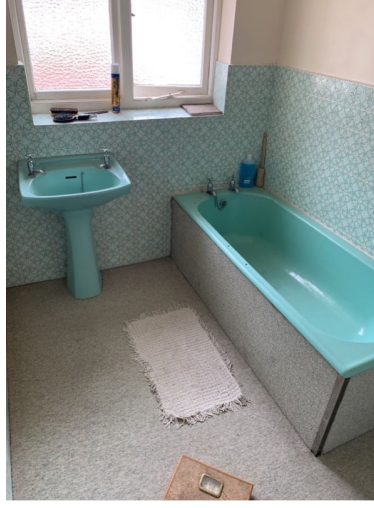
E8 Bathroom Fittings

Units are dated and worn. The ensuite located in the main bedroom comprises of a dark cream acrylic bath and matching wash basin and toilet. There is also a single shower cubical to the corner.

There are sufficient sanitary provision for this size of property. There is a single shower cubical to the ensuite fitted with a Triton. Both the ensuite and family bathroom appear dated and would benefit from replacement.

Condition Rating - 1

Even though both utilities are dated and slightly worn they function perfectly well.

The electric shower should be inspected and tested periodically to ensure it is safe to use in a wet environment

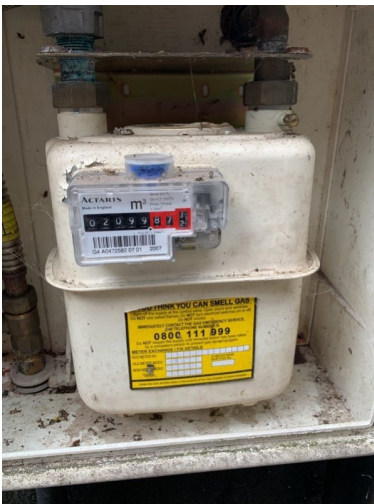
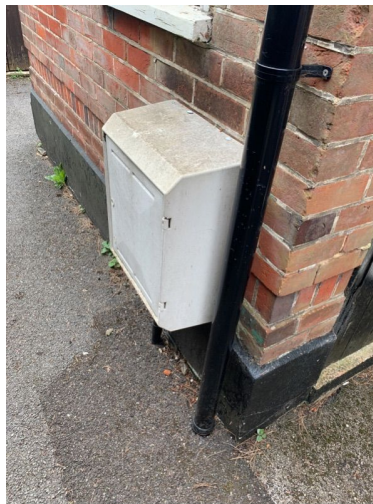
There is mains gas running to the property. The gas meter is located east elevation external to the property. There is no evidence of a Gas Safety Certificate. The pipe work that can be seen appears in good condition. There is no evidence of installation or maintenance certification.

Condition Rating - 3

The installation should be inspected and tested every 12 months. If it has not been inspected within the last 12 months, then it should not be used until a full test of the system has been carried out and any faults/shortcomings rectified.

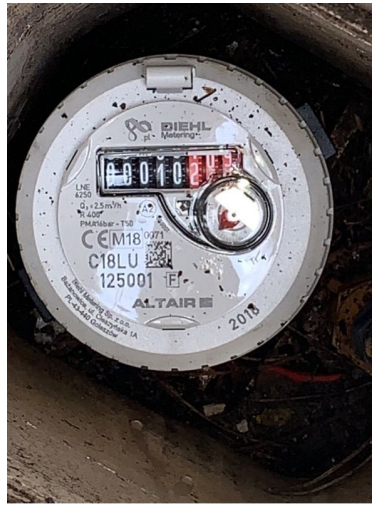
The internal stopcock we believe is in the cupboard in the hallway. The cold water pipework internally, where visible, is in copper and plastic. Water is stored in a plastic tank which can be found in the main roof space.

Condition Rating - 2

The main supply pipe, if original, may be reaching the end of its serviceable life.

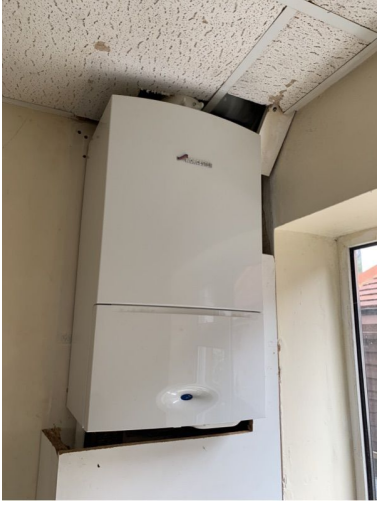
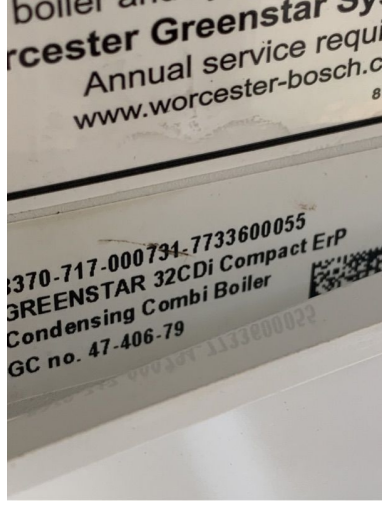
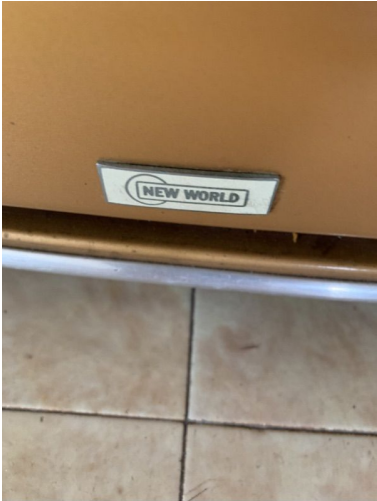
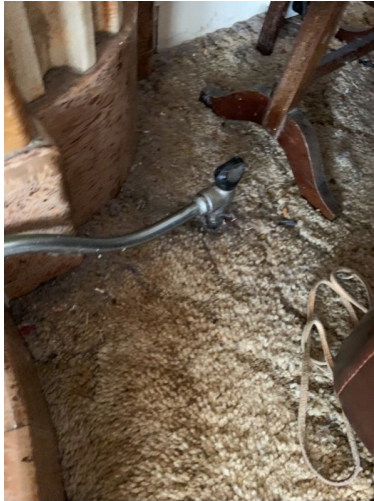
F4 Heating

Central heating and hot water is provided by a gas boiler which is located in a cupboard in the back bedroom. The central heating pipes, where visible, are in copper. The boiler is served by an expansion tank which can be found in the roof space. We do not know of any service agreement for the boiler and heating system.

The heating was not on when we inspected. No obvious defects were seen but we have only carried out a visual inspection of the system and therefore cannot comment in detail on its working condition.

Condition Rating - 3

You should ask an appropriate person to inspect and report on the boiler and heating system this should be done before exchange of contracts. You should follow the advice set out in the 'What to do now' page in this report.

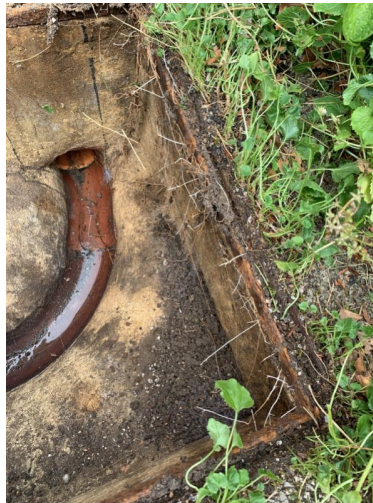
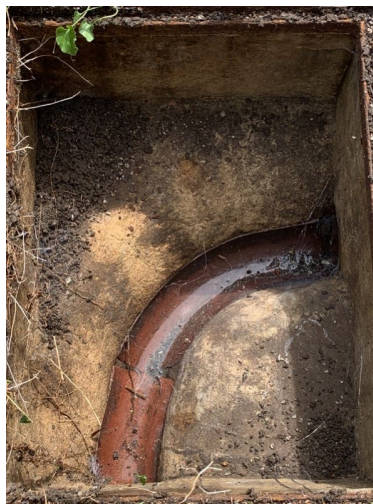
Condition Rating - 1

Although, there were no obvious defects the drainage is old and therefore it would be prudent to commission a camera inspection of the drains.

This should be carried out by a reputable and experienced contractor, see the 'What to do now' page in this report.

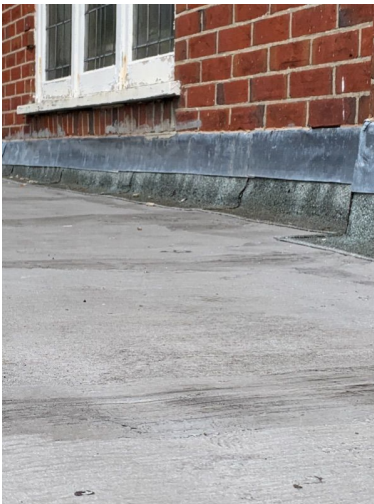
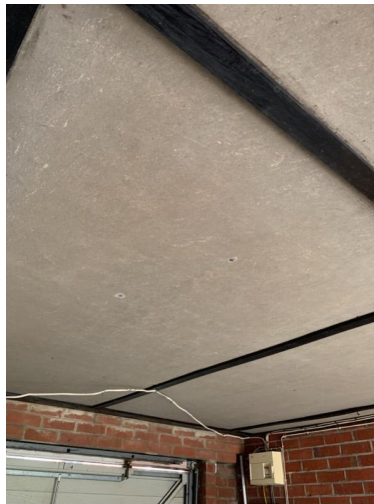
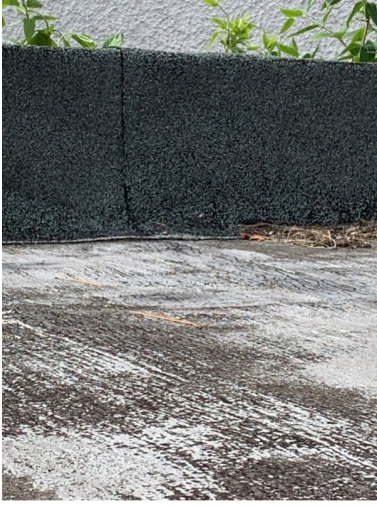
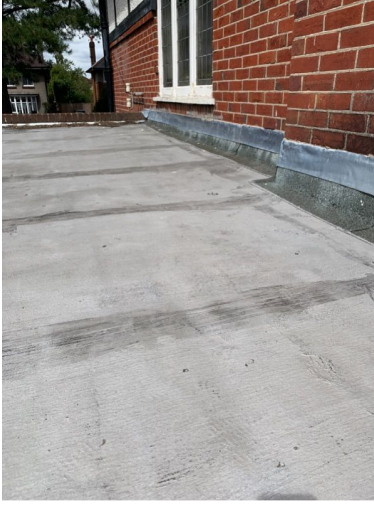
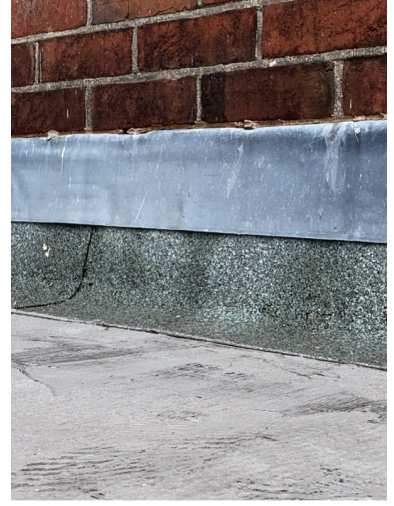
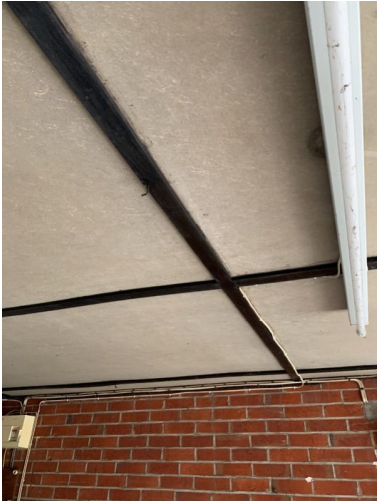
Although no repairs are required now, it is at least 45 years old so you must expect repairs in near future. When this occurs, you will have to use a contractor experienced in this type of work or an asbestos specialist.

Condition Rating - 1

No repair is currently needed. The property must be maintained in the normal way. Because of the possible asbestos content, you should get advice from a contractor experienced in this type of work or an asbestos specialist before the roof covering is disturbed in any way. Regular maintenance is needed.
